City of **Snohomish**

Facility Condition Assessment *Volume 2: Facility Details Report*

Prepared by MENG Analysis, December 2023

City of Snohomish
 Boys and Girls Club
 Boys and Girls Club

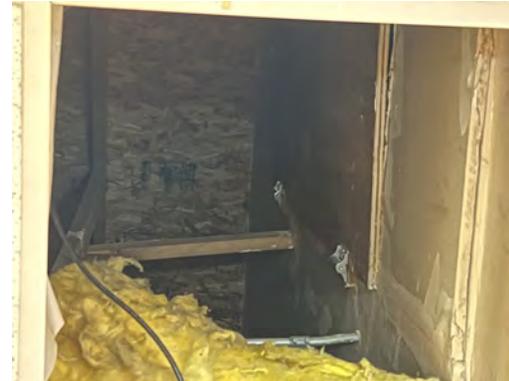
Deficient Material: Thermal Envelope

Add attic access hatches with fold-down ladders to two locations - replace compromised insulation and vapor retarder.

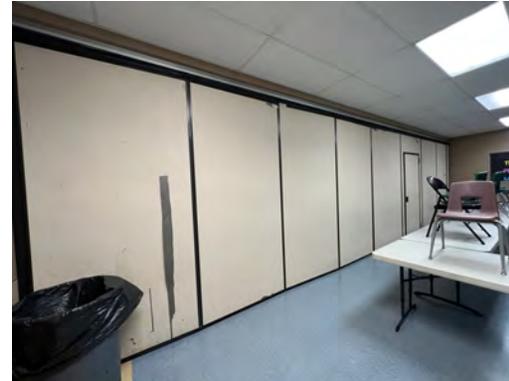
Deficient Material: Operable Partition

Operable partition is damaged significantly and components are inoperable.

Replace operable partition.

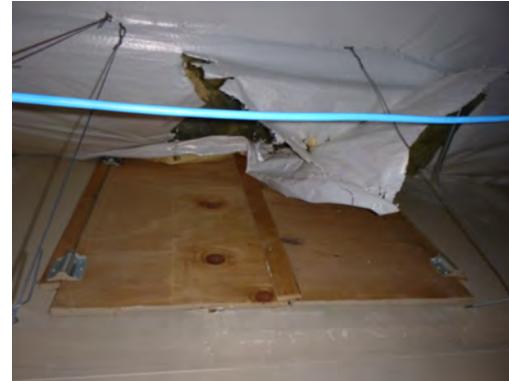
Deficient Material: Attic access

No permanent attic access to the two HVAC equipment platforms hampering maintenance and eventual replacement of these units.

In conjunction with attic located HVAC equipment replacement, construct permanent access.

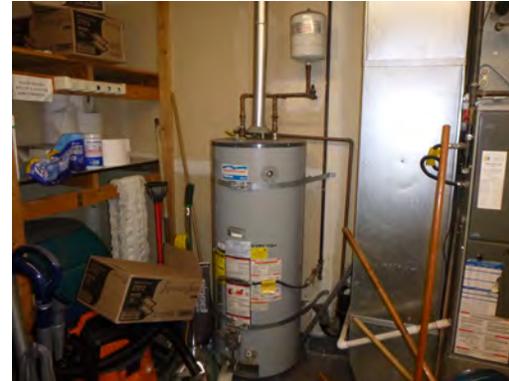
Deficient Material: Domestic Hot Water Heater
Aging domestic hot water heaters.

Remedial Action:
Budget to replace upon failure; upgrade to high-efficiency at the same time.

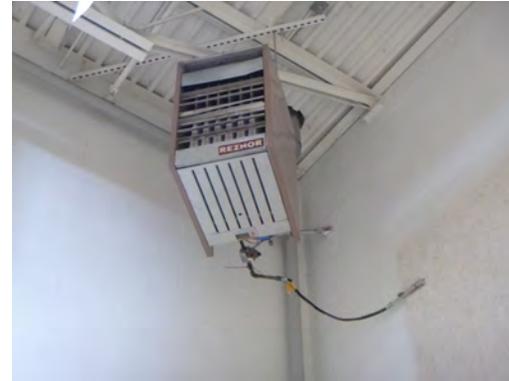
Deficient Material: Unit heater
Aging gym unit heaters.

Remedial Action:
Budget to replace upon failure.

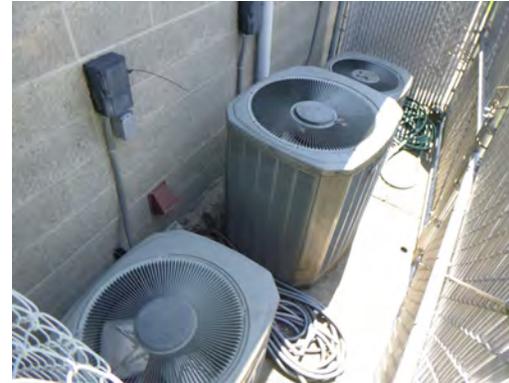
Deficient Material: Condensing units

Six failed condensing units and/or associated refrigerant piping.

Replace failed units immediately.

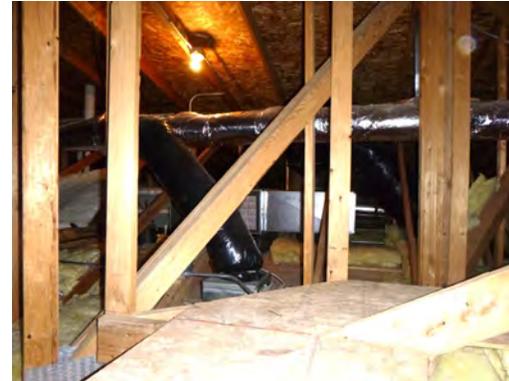
Deficient Material: Ductwork

Some damage or missing duct insulation, duct leakage detected in several locations, reports of uneven or insufficient heating and cooling, no apparent test, adjust, and balance (TAB) settings on observed balancing dampers.

Inspect, test, and repair ductwork, including Re-TAB to design requirements.

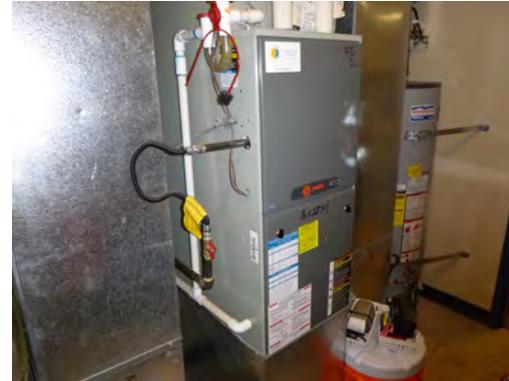
Deficient Material: Furnaces
Aging gas-fired furnaces.

Remedial Action:
Replace in kind with new high-efficiency type, including inside cooling coil.
