TECHNICAL MEMORANDUM

To: Brennan Collins, PM Public Works Department
From: Brad Thiele, Northwest Environmental Consulting, LLC
Date: December 12, 2024
Subject: **Wetland Boundary Confirmation**
Project: Homestead Park, City of Snohomish

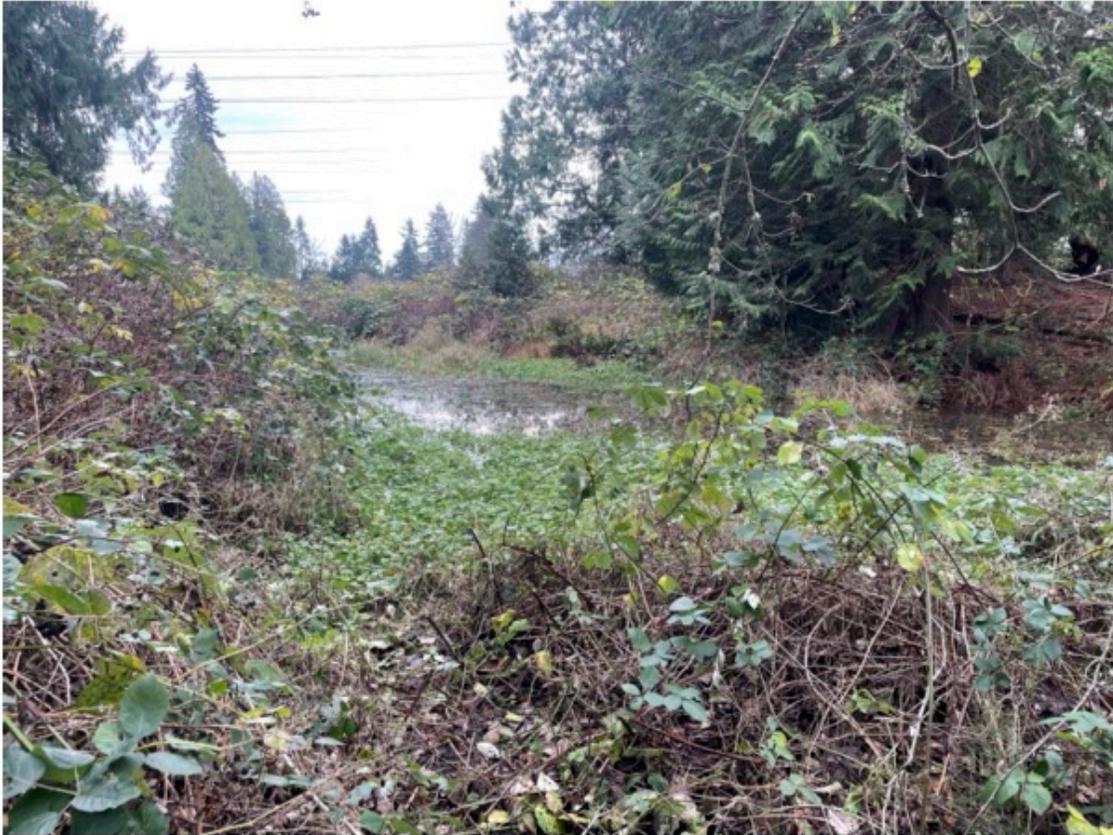
Wetland A was still forested along the edges with scrub shrub and emergent vegetation within the wetland boundaries. The wetland was in the same conditions and several wetland flags from the original delineation were present.

Photo 1 - Wetland A inundation.

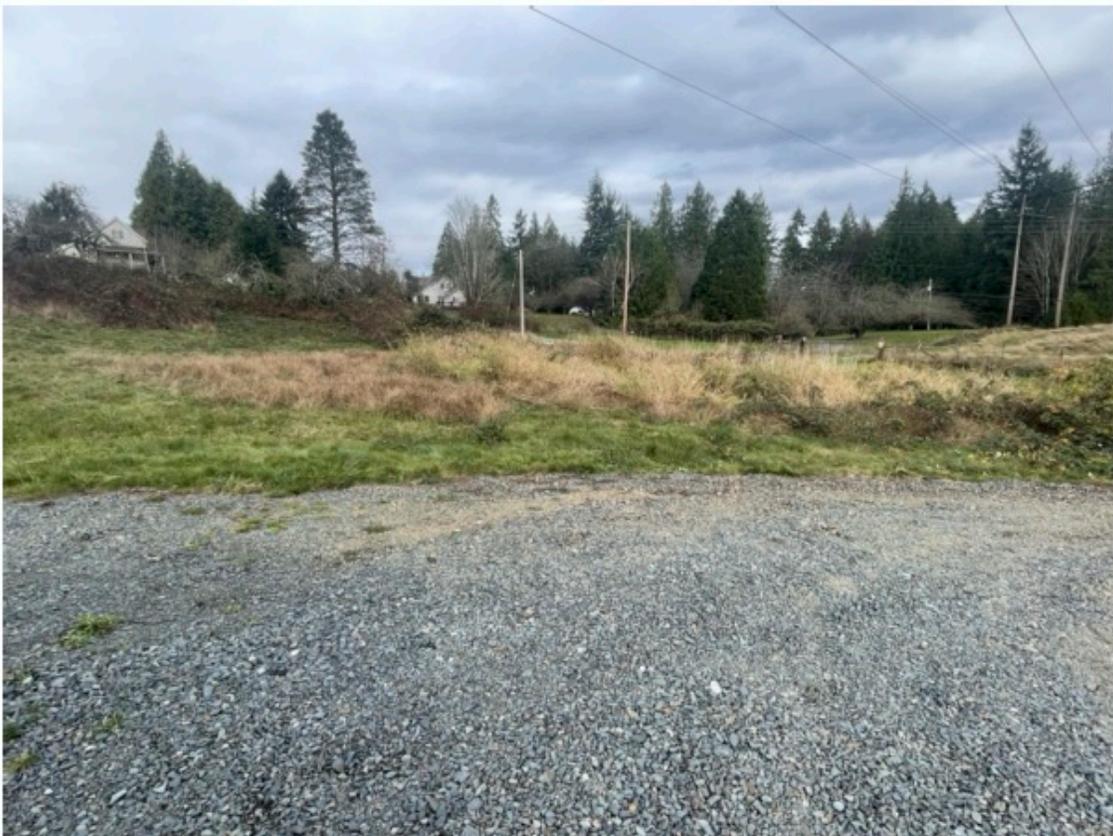
Wetland B was present adjacent to the gravel parking area. Wetland vegetation was dominated by soft rush and reed canary grass. The wetland was still in a topographic depression and was adjacent to Ludwig Road.

Photo 2 - Wetland B, emergent vegetation adjacent to parking area..

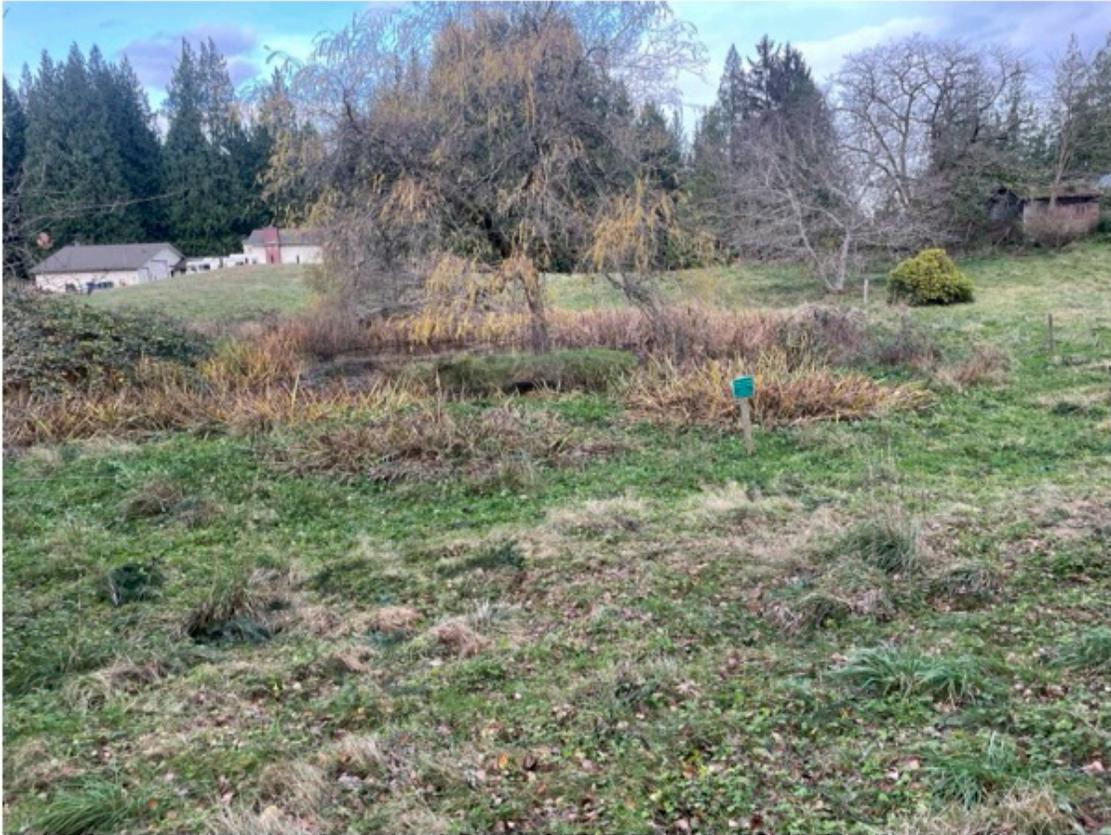
The man-made pond at the site was still present and unchanged. The pond was intentionally created from uplands is not regulated as wetland. See attached photos.

Photo 3 - Man-made pond.

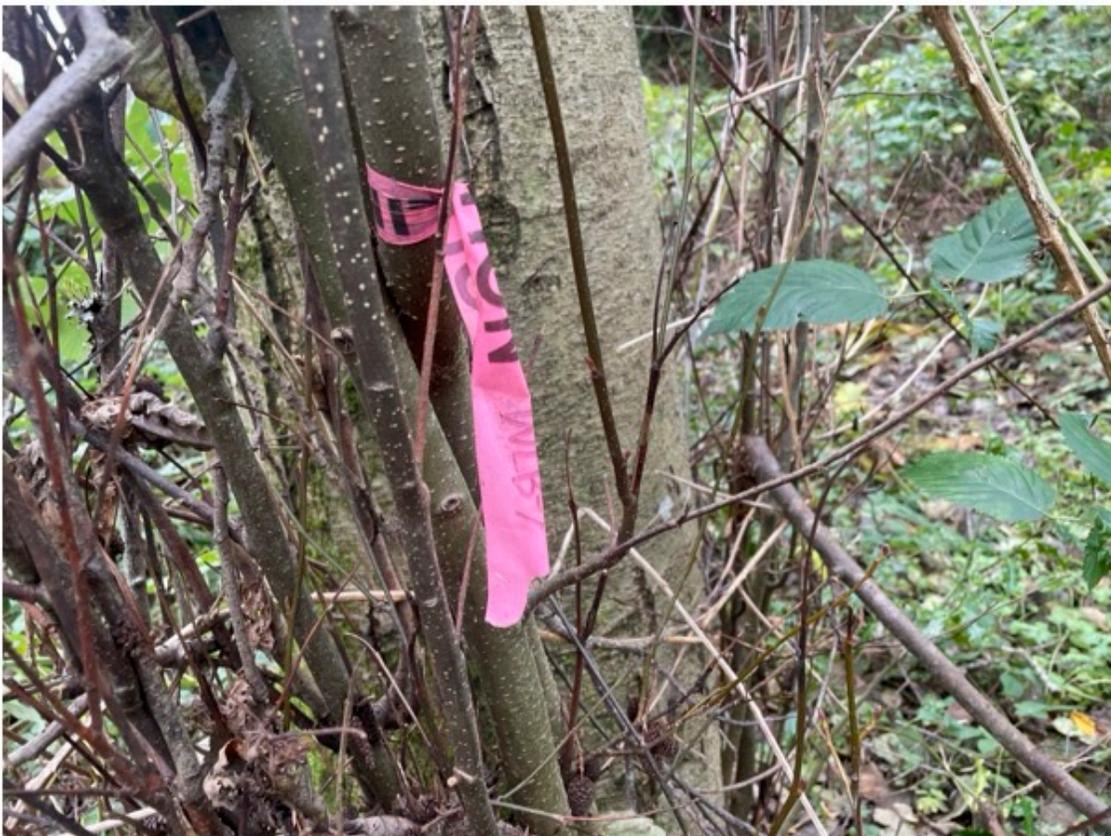
Photo 4 - Wetland flag from 2017 along the edge of Wetland A.
