City of **Snohomish**

Facility Condition Assessment *Volume 2: Facility Details Report*

Prepared by MENG Analysis, December 2023

City of Snohomish
 Boys and Girls Club
 Boys and Girls Club

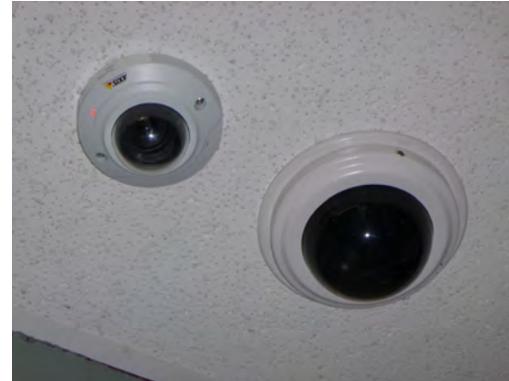
Deficient Material: **Electronic security**

Existing CCTV, perimeter monitoring, and intrusion detection systems all failed.

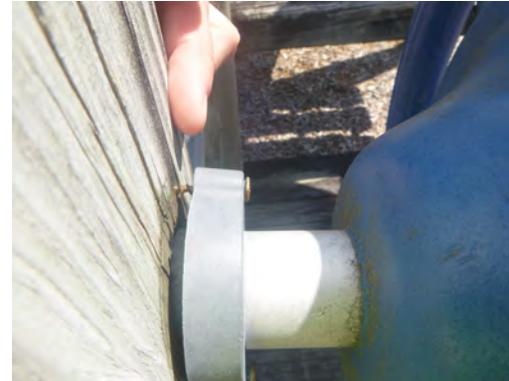
Deficient Material: Play Equipment

Play systems past useful life, not ADA accessible, and not up to modern play equipment safety standards. Two-swing rusting metal swing set with rubber seats and chains, weathered timber climbing big toy with stainless metal slide, tire swing on chains, monkey bars, and ships wheel (loose connections and screws loose). Spring-mounted cast metal rocking horse (spring assembly may not meet current safety standards).

Remove and replace play equipment with modern safety rated and ADA accessible play systems.

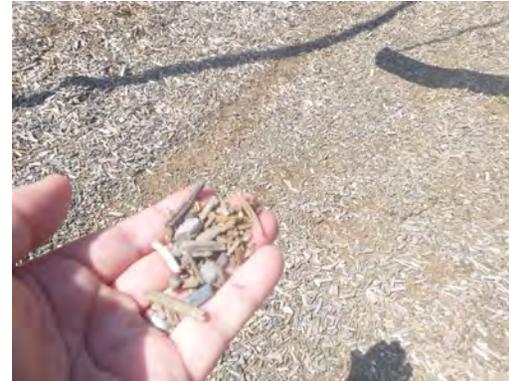
Deficient Material: Play Surfacing

No ADA access to play area, play surface not ADA-accessible or -compliant. Wood chip surfacing well past end of life and no longer in compliance with play surface impact ratings. Deep pits from wear in play traffic areas and now with mixed gravel. Sections of perimeter retainer curbs rotting.

Remove and replace curbs and play surfacing. Prep and replace with ADA-accessible and safety impact compliant play surfacing.

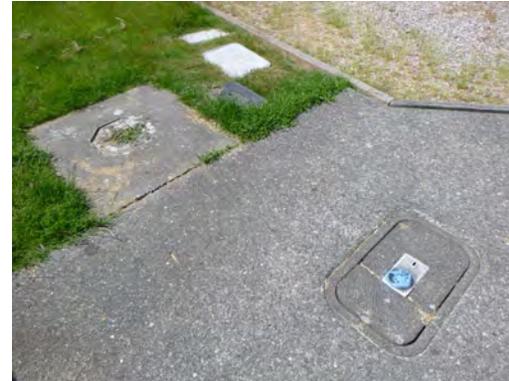
Deficient Material: Water Service

Water service is turned off with drinking fountain missing and irrigation system non-functional.

Replace drinking fountain, restore water service, and renew the irrigation system.

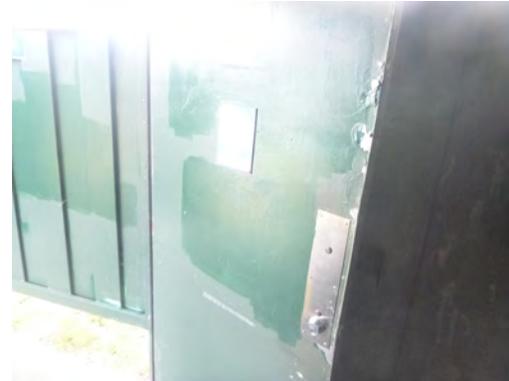
Deficient Material: Doors and Door Hardware

Some warping damage due to attempted break-ins and vandalism abuse, doors stick in frames.

Remove the replace doors and hardware.

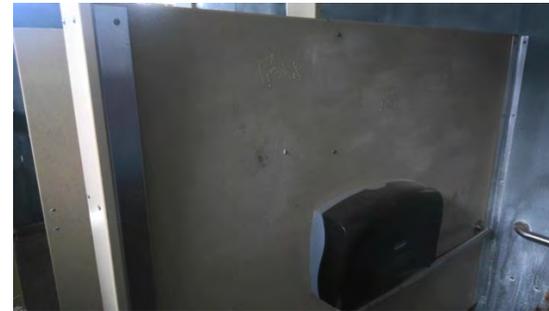
Deficient Material: Toilet Partitions

High-density polyethylene toilet partitions, worn and doors don't shut correctly (hinge and hardware issues). Graffiti carved and burned in.

Remove and replace with a system and hardware that can withstand heavy abuse.

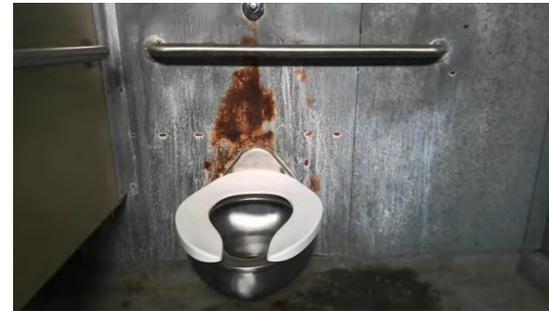
Deficient Material: Metal Walls

Significant areas of corrosion. Daylight visible through exterior and interior wall panel joints, and into adjacent plumbing/storage room.

Remove oxidation and coat. Consider adding stainless panels over walls in women's room for appearance, sanitation, and to avoid real or perceived privacy issues from next room.

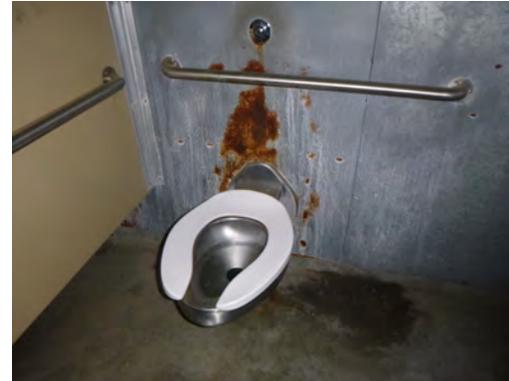
Deficient Material: Fixtures & trim

Fixtures and trim with variety of vandalism and wear and tear damage.

Fully service and restore all fixtures to operable condition, after vandalism issue is solved.

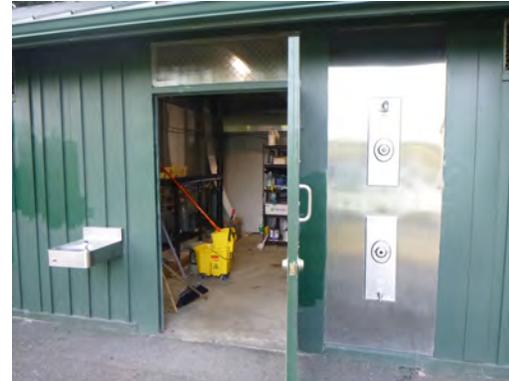
Deficient Material: Ventilation

No ventilation for plumbing chase space and approximately half the design ventilation for the men's and women's restrooms. Additionally, the chase space has been fitted with a heater to semi-heat the space, but without any observed insulation.

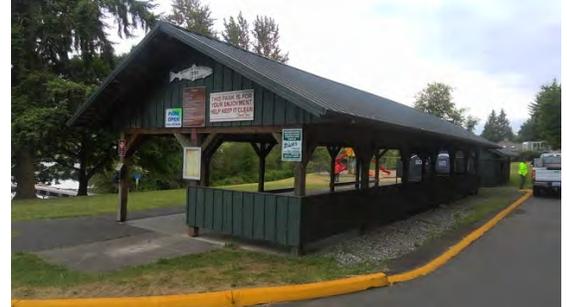
Deficient Material: Roof Framing

Further recommendations for seismic strengthening the connections by a structural engineer are advisable.

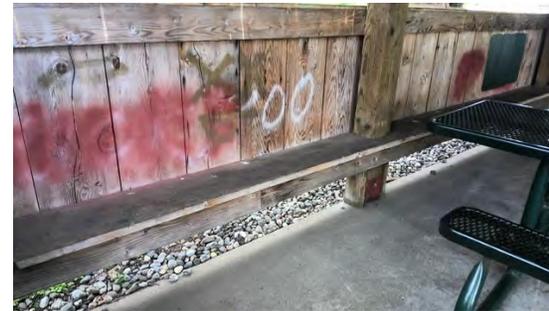
Deficient Material: Other

Settlement of adjacent asphalt or uplift of the slab edge has created a significant trip hazard at the end adjacent to the restroom.

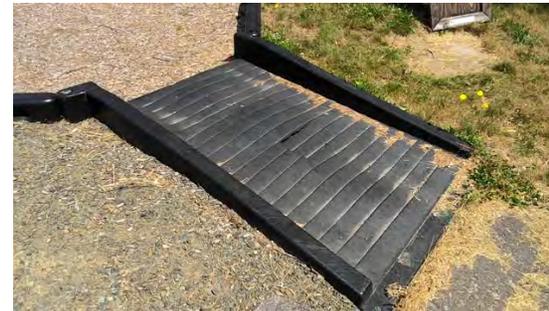
Deficient Material: Play Area

Play chip surface has degraded and compacted, and ADA access ramp is broken and non-compliant.

Replace ADA access with fully-compliant ADA access path descending fully into base of play area. Prep and replace play chip surfacing. Alternatively, consider replacing play chips with rubberized play area safety and accessible surfacing.

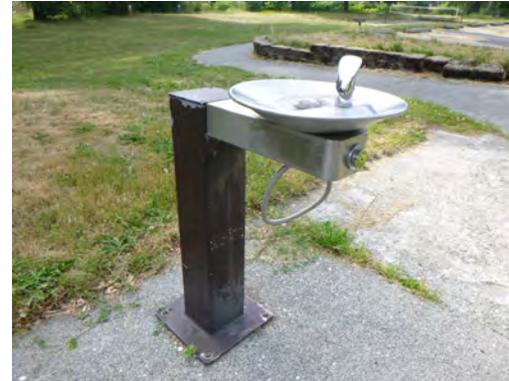
Deficient Material: Drinking fountains

Restore all missing drinking fountains and restore service to the one currently remaining.

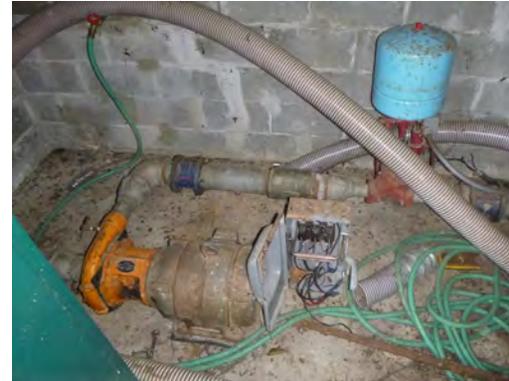
Deficient Material: Irrigation

The irrigation system pump and portions of distribution to Field No. 1 are failed.

Replace pump system and failed portions of irrigation distribution.

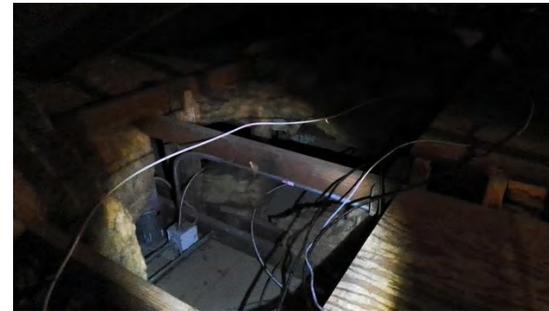
Deficient Material: Insulation

Numerous large areas missing attic insulation coverage.

For energy efficiency and thermal comfort, reinstall all missing insulation. Consider upgrading entire insulation system to meet or exceed R-49 (current code). Also, insulate all exposed ductwork run through attic space.

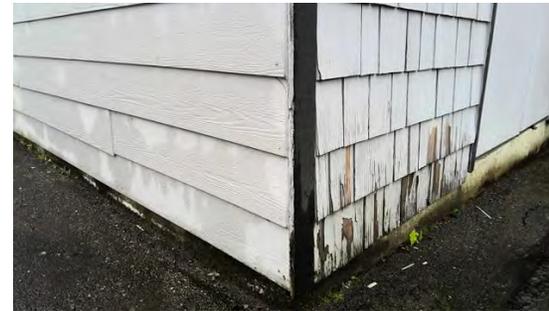
Deficient Material: Siding

Moisture and other damage to paint and shingle siding above roof at gable and northeast corner. Areas remain unfinished where prior outdoor canopy was removed. Sealant at cement fiber seams failing. The south 1998 addition cell windows and door trims are rotten and falling apart.

Replace cell window and door frame trim and reseal seams at lap siding, including replacing door and window frames. Replace damaged shingles, prime, and repaint walls where repair work occurred.

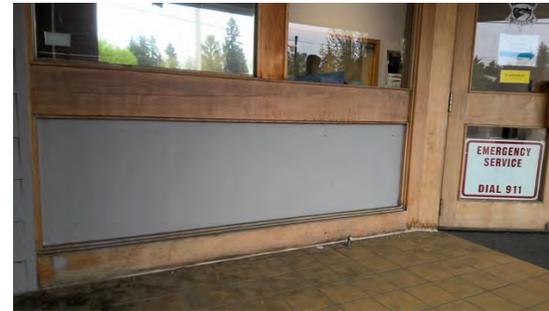
Deficient Material: Wood Trim

Portions of entry area wood trim, entry doors, and window frames are weathered and stained. Some cracked panels.

Repair or replace cracked trim, strip, restain, and seal (varnish) exposed wood elements. Consider replacing with alternative modern-looking systems along with a window replacement project, if occurring.

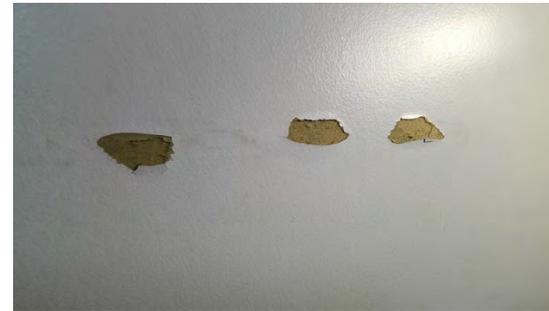
Deficient Material: Gypsum Wall Board and Paint

Areas of wear and tear and some gouges at upper floor.

Spot prep, patch, and touch up paint in high-traffic doorways and other spots with damage.

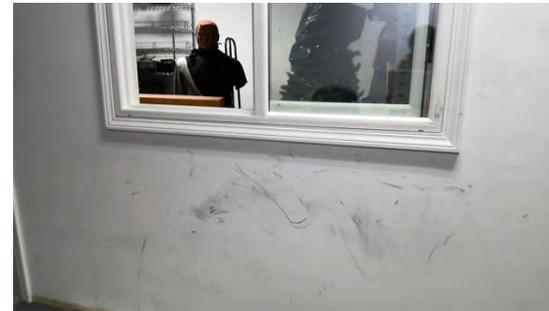
Deficient Material: Painted Gypsum Wall Board

No recent modernization and a mix of damaged wall and paint finishes at lower floor.

Repair and refinish walls at lower floor.

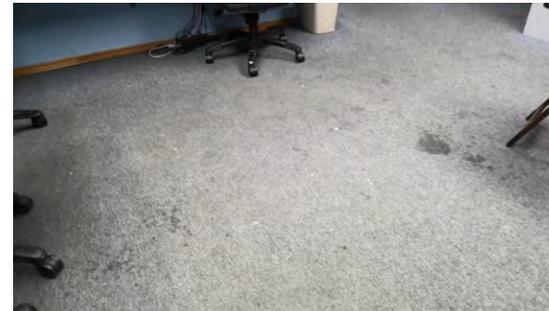
Deficient Material: Carpet

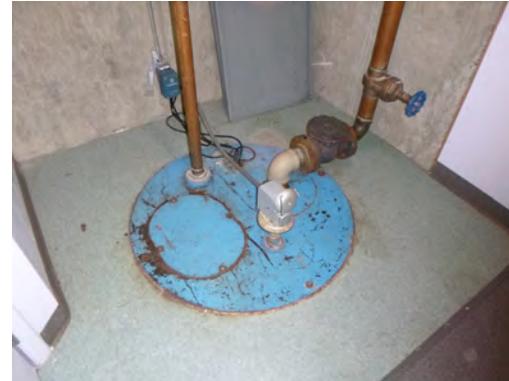
Deficient Material: Ejector pump

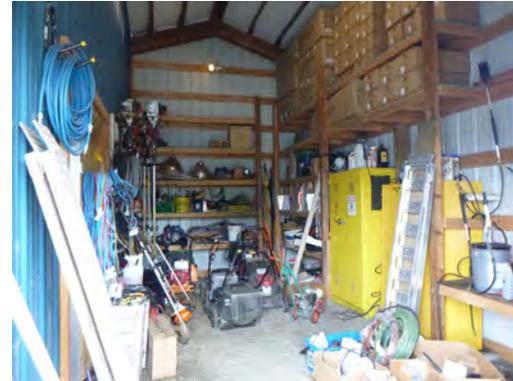
Deficient Material: Fire alarm
No fire alarm.

Remedial Action:
Install fire alarm.

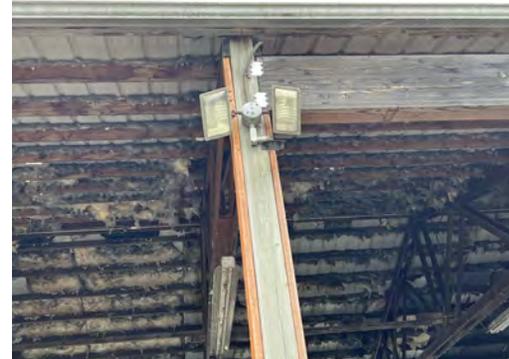
Deficient Material: Wood Structure
Columns replaced with glulam beams.

Remedial Action:
Complete a structural load analysis to determine if the remaining structure is adequate.

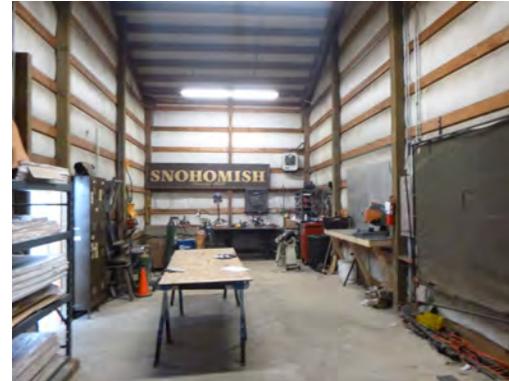
Deficient Material: Fire alarm
No fire alarm.

Remedial Action:
Install fire alarm.

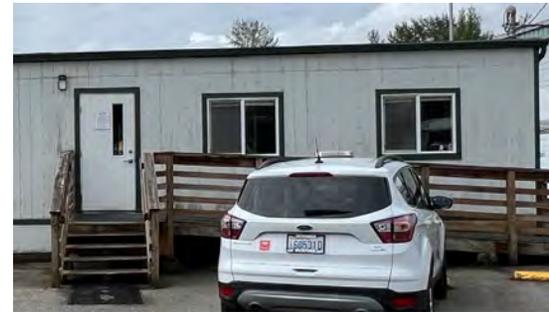
Deficient Material: Stair and Ramp

Replace stair and ramp with prefabricated metal.

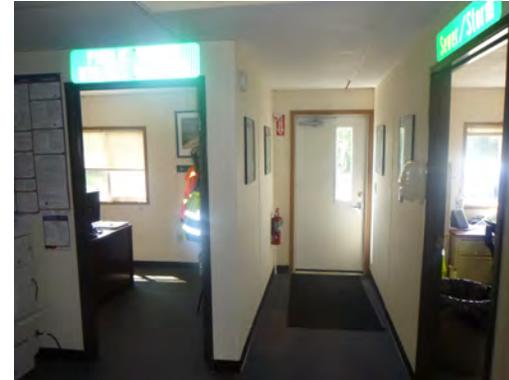
Deficient Material: Ductwork

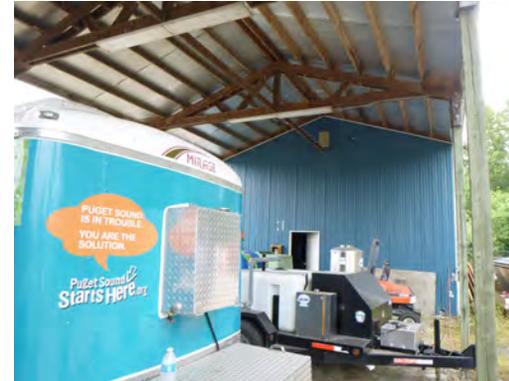
Deficient Material: Fire alarm
No fire alarm.

Remedial Action:
Install fire alarm.

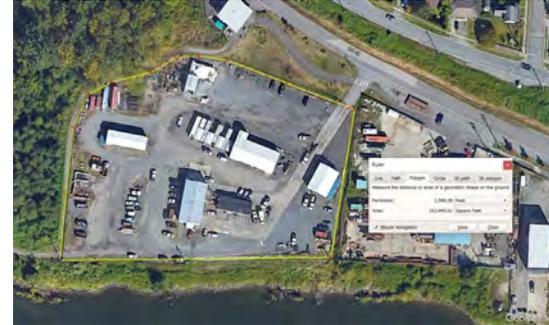
Deficient Material: Location

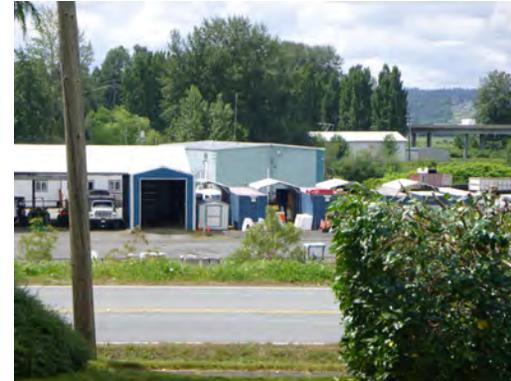
Deficient Material: Generator

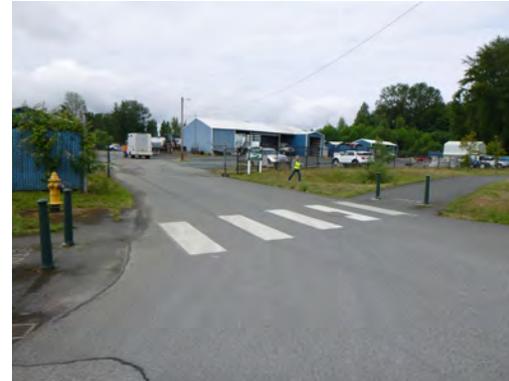
Deficient Material: CPTED

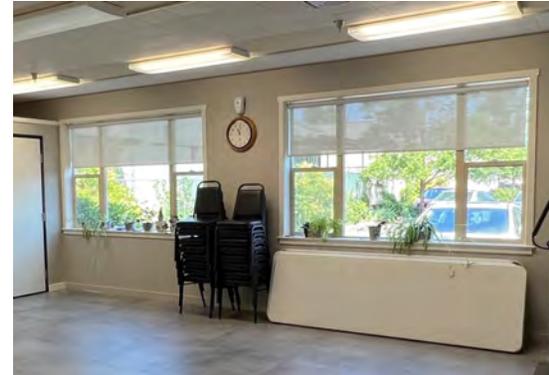
Deficient Material: Aluminum Windows

Windows are losing seals at a quick rate for only being 15 years old. Budget to replace many more of them over the next five years.

Replace window sashes with broken seals. Consider using more durable materials to extend the life of the windows.

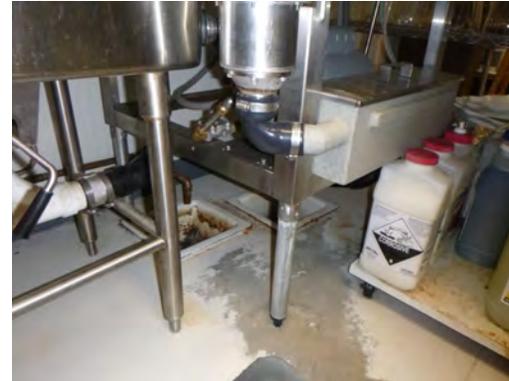
Deficient Material: Grease waste
Grease waste backs up.

Remedial Action:
Clean and service.

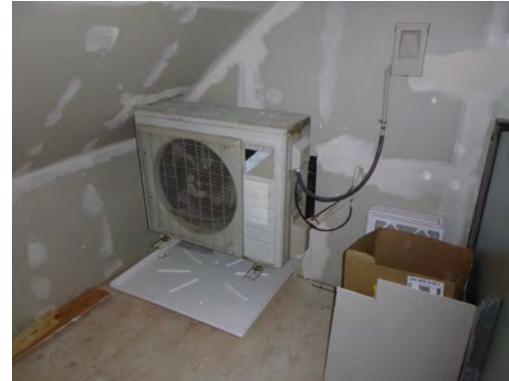
Deficient Material: Condensing unit

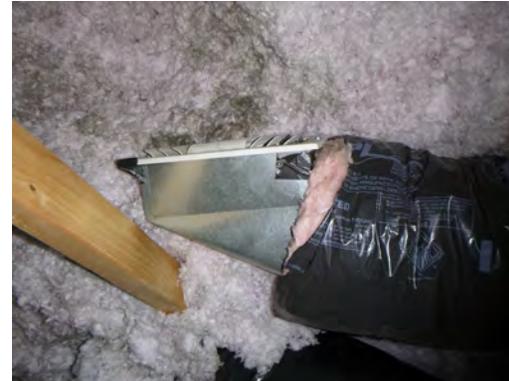
Deficient Material: TAB

Unclear air flow and balance, with signs of air leakage in attic space and reported high energy use.

Conduct test, adjust, and balance and repair as needed to restore design airflows throughout.

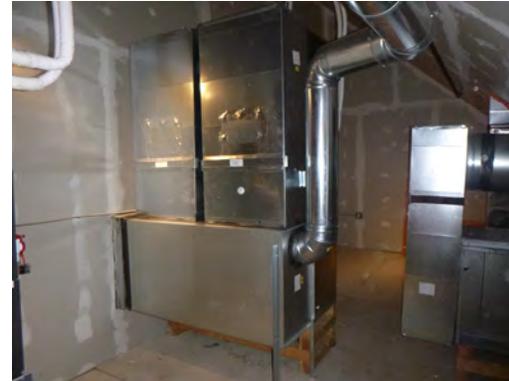
Deficient Material: HVAC controls

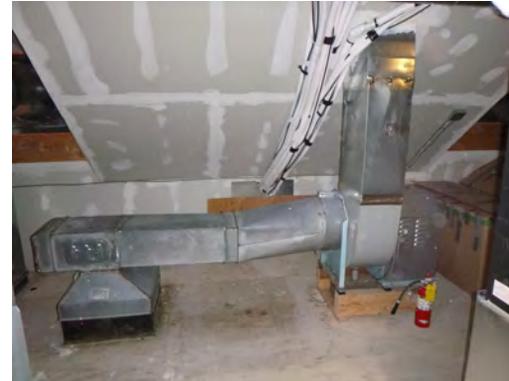
Deficient Material: Grease Exhaust

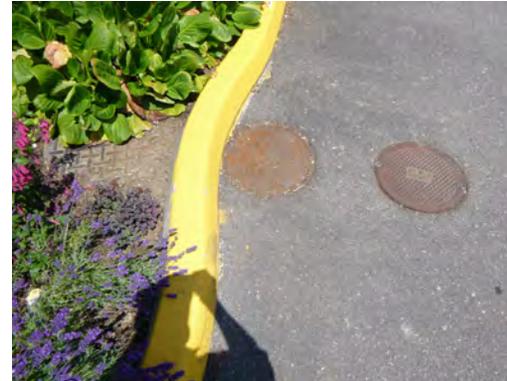
Deficient Material: Grease interceptor

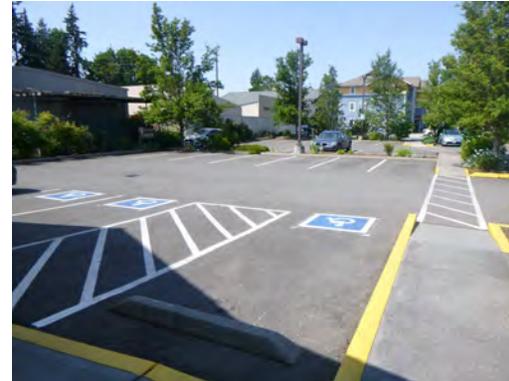
Deficient Material: Site lighting
Insufficient site lighting for patrons.

Remedial Action:
Install additional site lighting to fully support patrons.
