Stormwater Site Plan

Drainage Report

Walsh Hills

Snohomish, Washington

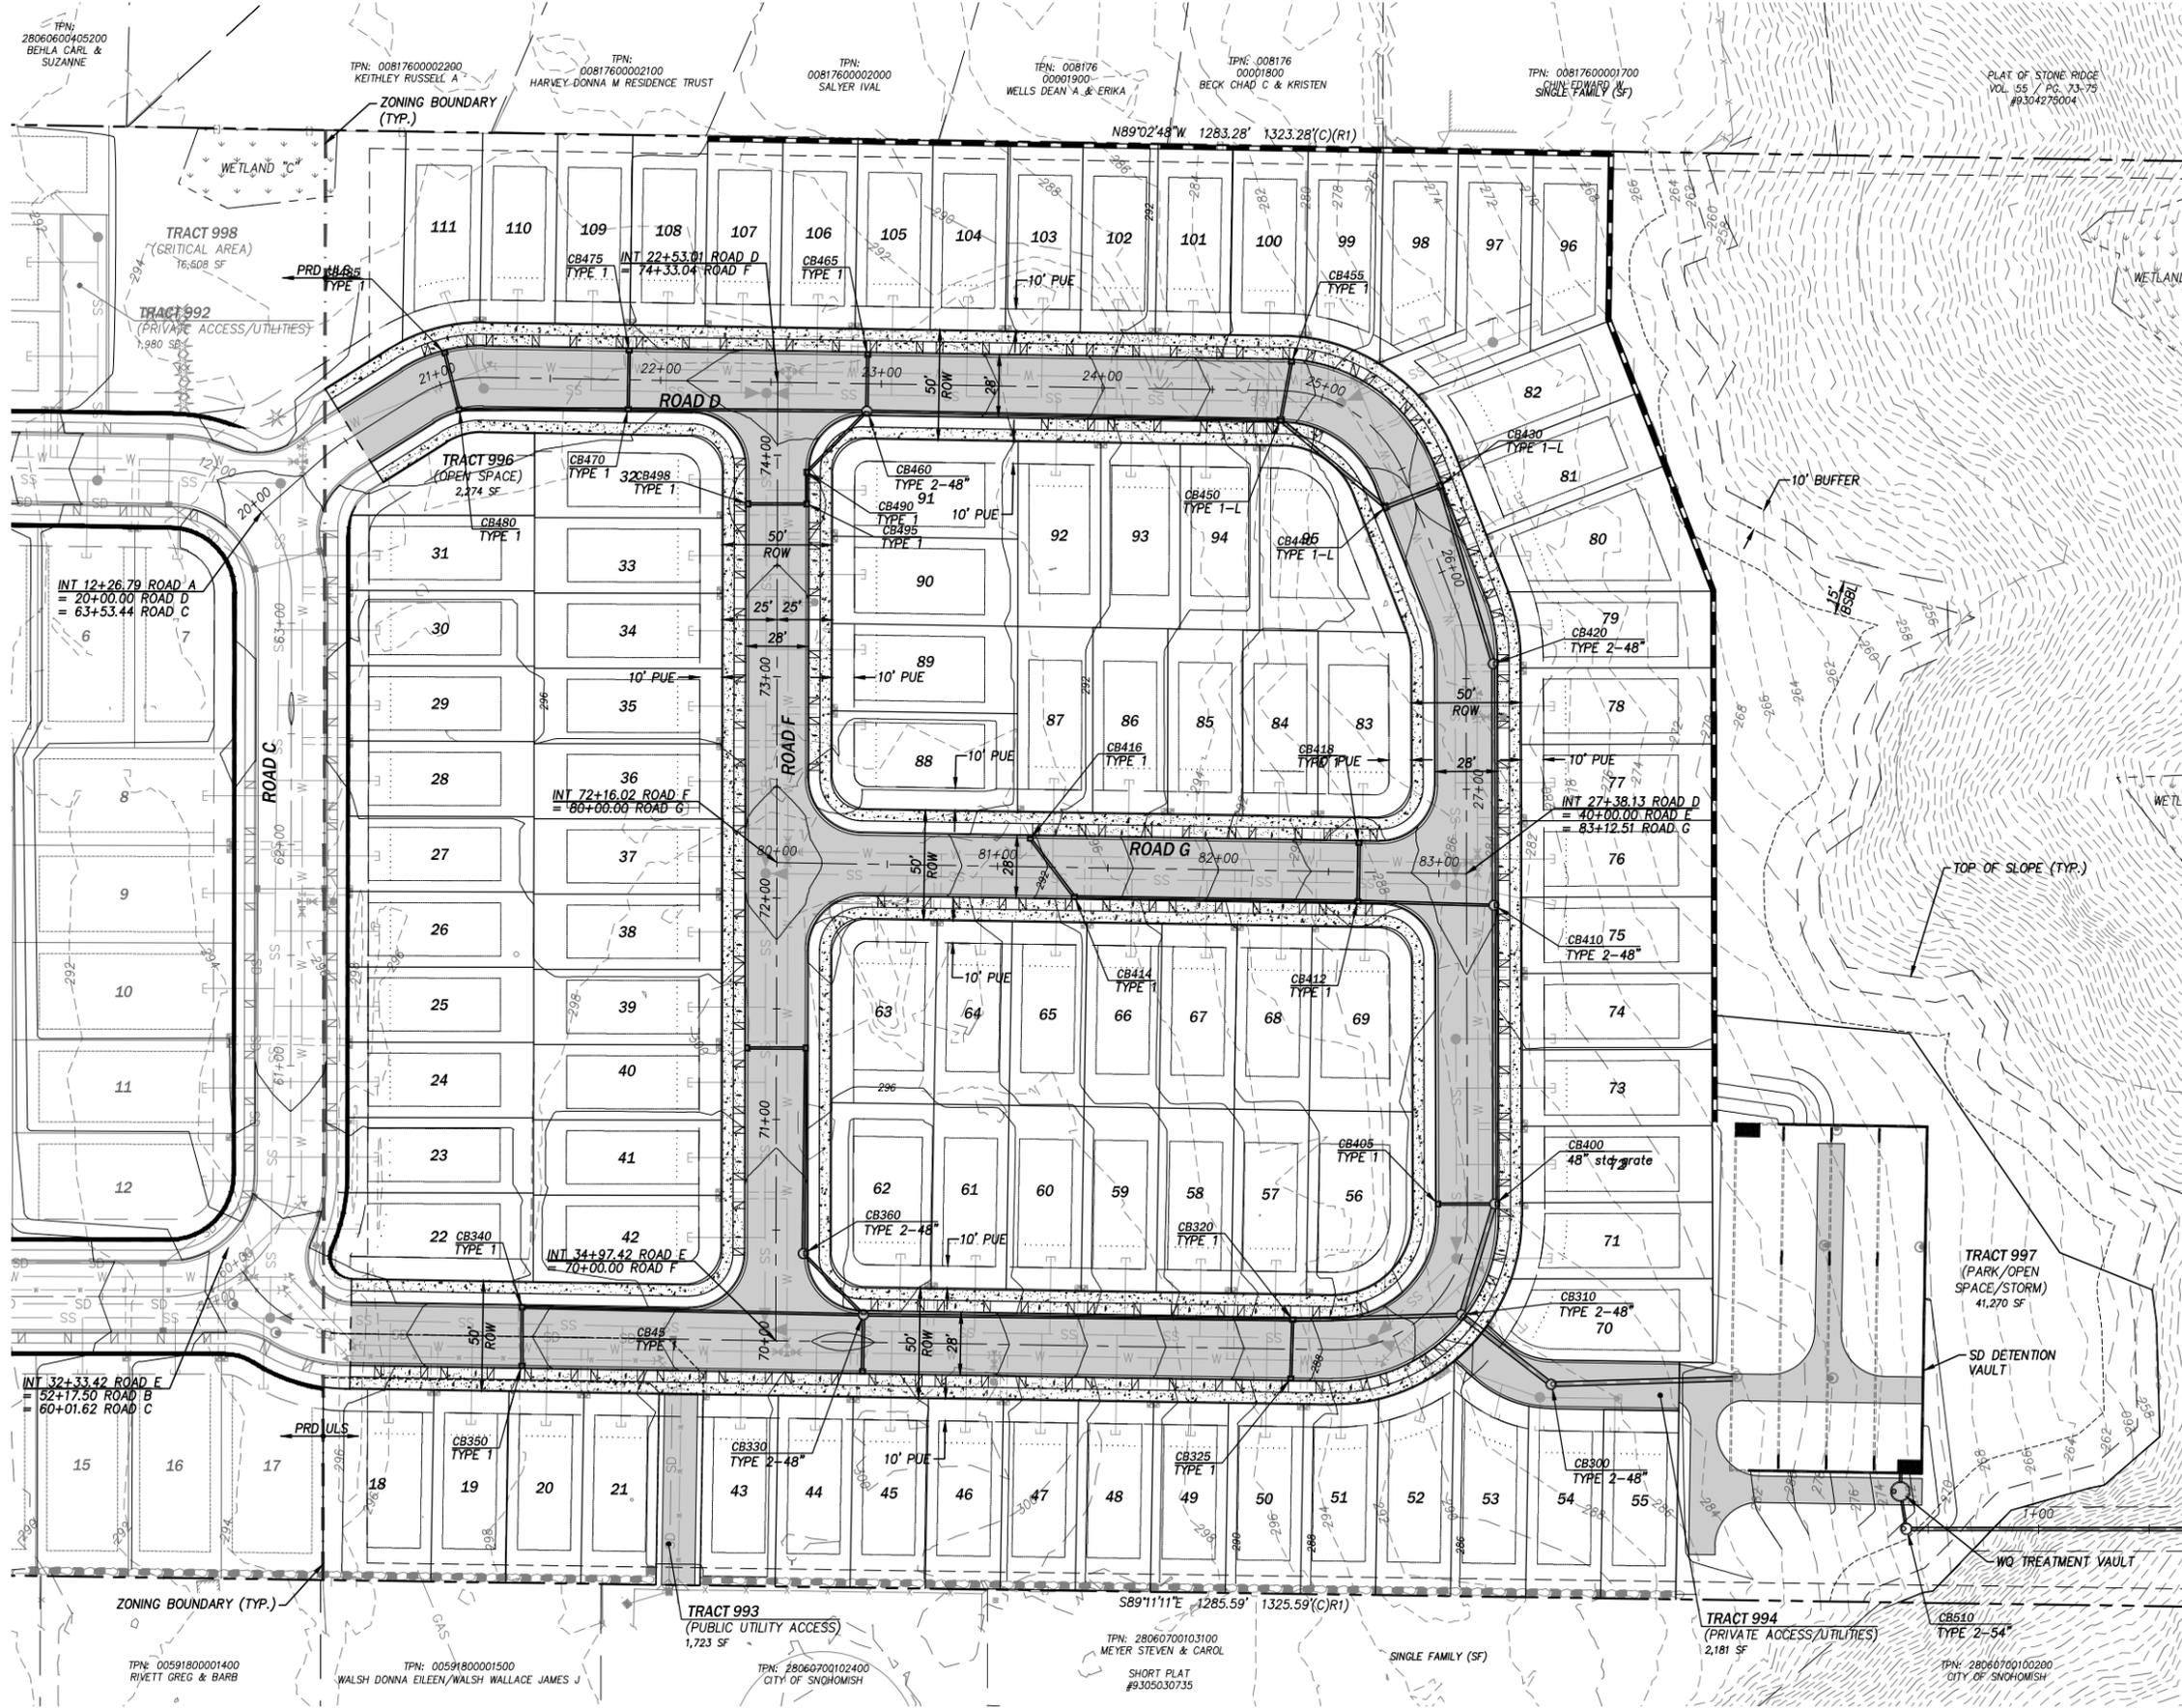
FIGURE 4 - DEVELOPED SITE CONDITIONS (ULS)

- LEGEND**
- MSE RETAINING WALL
 - ROCKERY
 - EXIST. TOPOGRAPHIC CONTOUR
 - PROPOSED GRADE CONTOUR
 - TYPE 1 STORM DRAINAGE CATCH BASIN
 - TYPE 2 STORM DRAINAGE CATCH BASIN
 - YARD DRAIN
 - SD
 - RD

6. **Runoff Treatment:** Basic Water Quality Treatment is required for this project. A proprietary water quality filtration facility located downstream of the detention vault will provide treatment to runoff from the east basin while a wetpool within the west vault will provide treatment for the western basin. A stormfilter catch basin will treat a small portion of the runoff from Terrace Avenue which will bypass detention. Figures 3 and 4 illustrate the developed site plan for the project.

7. **Flow Control:** Stormwater will be detained and released at a controlled rate by two onsite vaults located in the southeast and southwest portion of the developed site area. Design details of the flow control facilities are described in Section 6 of this report and is as required by current storm drainage requirements. Figures 3 and 4 illustrate the developed site plan for the project.

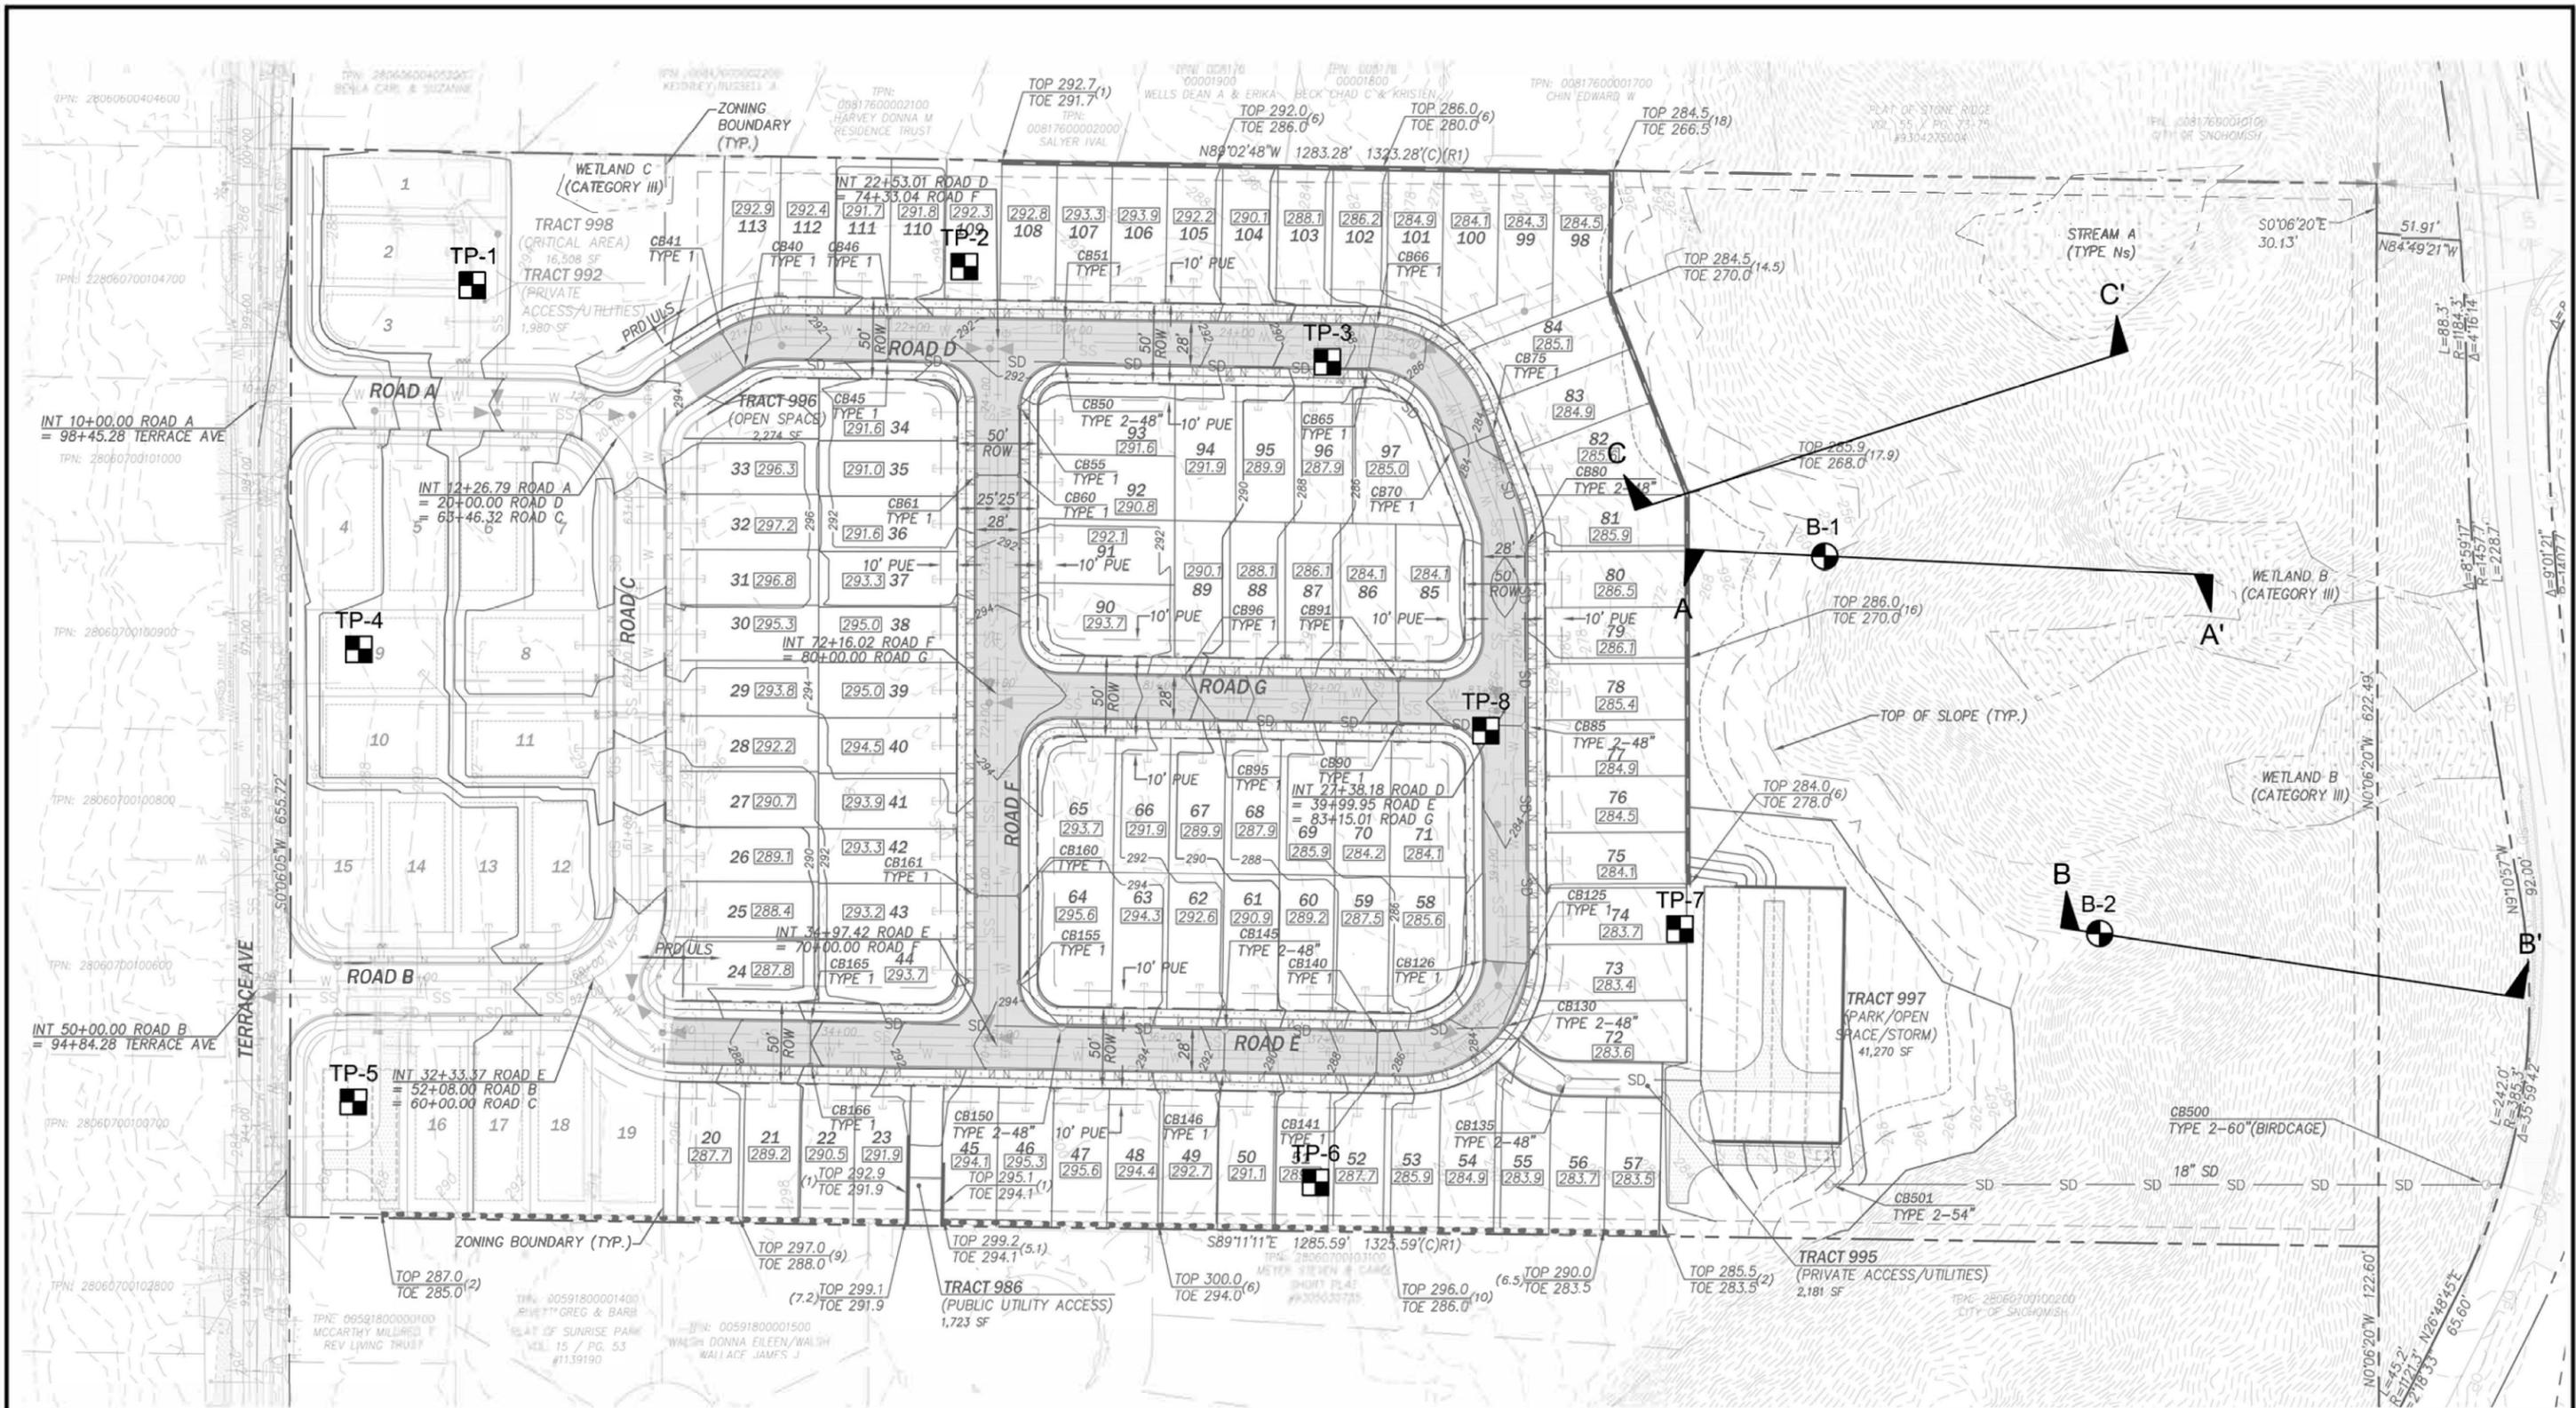
Proj.No. T-8204 Date: MAY 2020 Figure 2

**EXPLORATION LOCATION PLAN
TERRACE AVENUE DEVELOPMENT
SNOHOMISH, WASHINGTON**

Part of our investigation was to determine the appropriate buffers and setbacks for the proposed development from the eastern steep slope. In order to determine the buffers and setbacks, we have completed three slope stability analyses. The analyses were performed at locations designated as Cross Sections A-A', B-B', and C-C' using the computer program Slide 2018. The approximate cross section location is shown on Figure 2.

On August 29, 2019, we investigated subsurface conditions at the site by excavating 8 test pits with a track-mounted mini-excavator to depths of about three to ten feet below existing grades. On September 17, 2019 and September 18, 2019, we supplemented this data by observing soil conditions at 2 borings drilled to depths of about 100 feet below existing surface grades. The test pit and boring locations were approximately determined in the field by sighting and pacing from existing surface features. The approximate test pit and test boring locations are shown on Figure 2. The Test Pit and Test Boring Logs are presented as Figures A-2 through A-11.

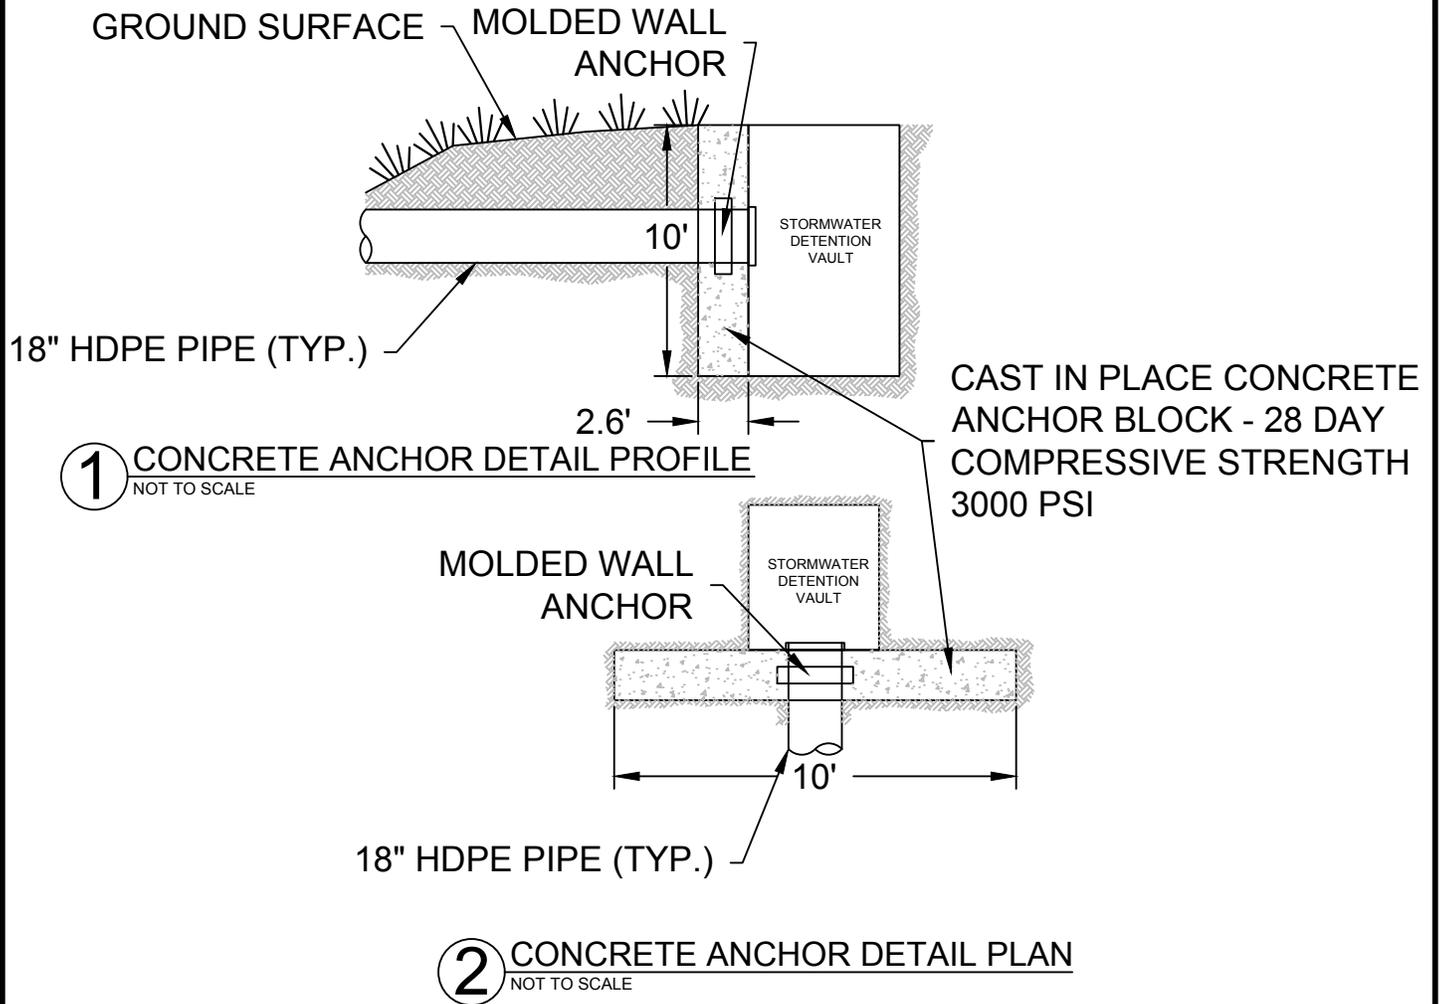
CONCRETE ANCHOR DETAIL
 TERRACE AVENUE DEVELOPMENT
 SNOHOMISH, WASHINGTON

18" HDPE PIPE TO BE PLACED
TANGENT TO THE BOTTOM I.D.
OF THE PIPE CLAMP
(TYP.)

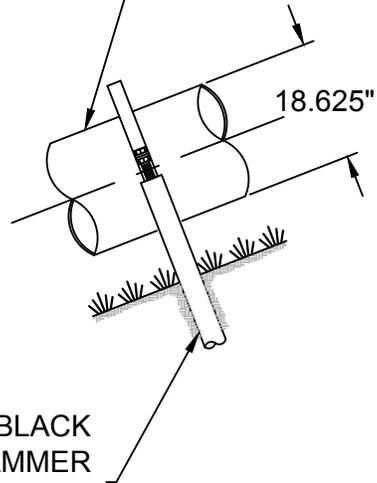
2" DIAMETER EXTRA STONG BLACK
PIPE PILE DRIVEN TO REFUSAL WITH 60 LB JACK HAMMER
- REFUSAL CRITERIA -
1" OF LESS PENETRATION AFTER 60 SECONDS (TYP.)

1 HILLSIDE ANCHOR DETAIL
NOT TO SCALE

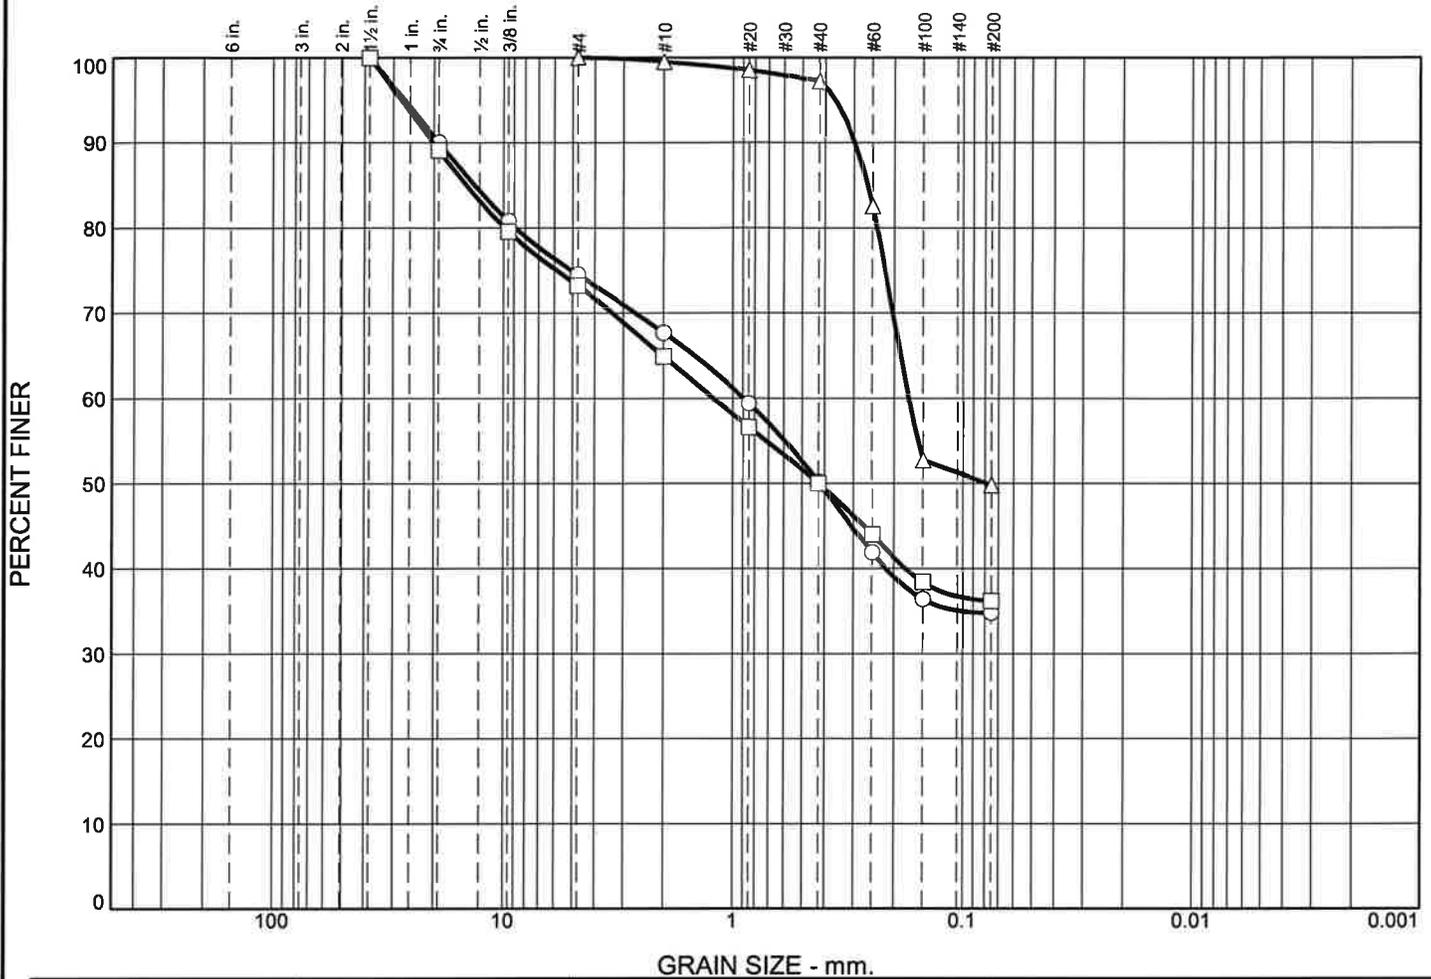
Particle Size Distribution Report

% +3"	% Gravel		% Sand			% Fines			
		Coarse	Fine	Coarse	Medium	Fine	Silt	Clay		
○	0.0	10.0	15.5	6.8	17.5	15.4	34.8			
□	0.0	10.9	15.9	8.3	14.9	13.8	36.2			
△	0.0	0.0	0.0	0.5	2.3	47.4	49.8			
⊗	LL	PL	D ₈₅	D ₆₀	D ₅₀	D ₃₀	D ₁₅	D ₁₀	C _c	C _u
○			13.3443	0.8966	0.4195					
□			14.4649	1.2153	0.4250					
△			0.2631	0.1732	0.0787

Material Description	USCS	AASHTO
○ silty SAND with gravel	SM	
□ silty SAND with gravel	SM	
△ silty SAND	SM

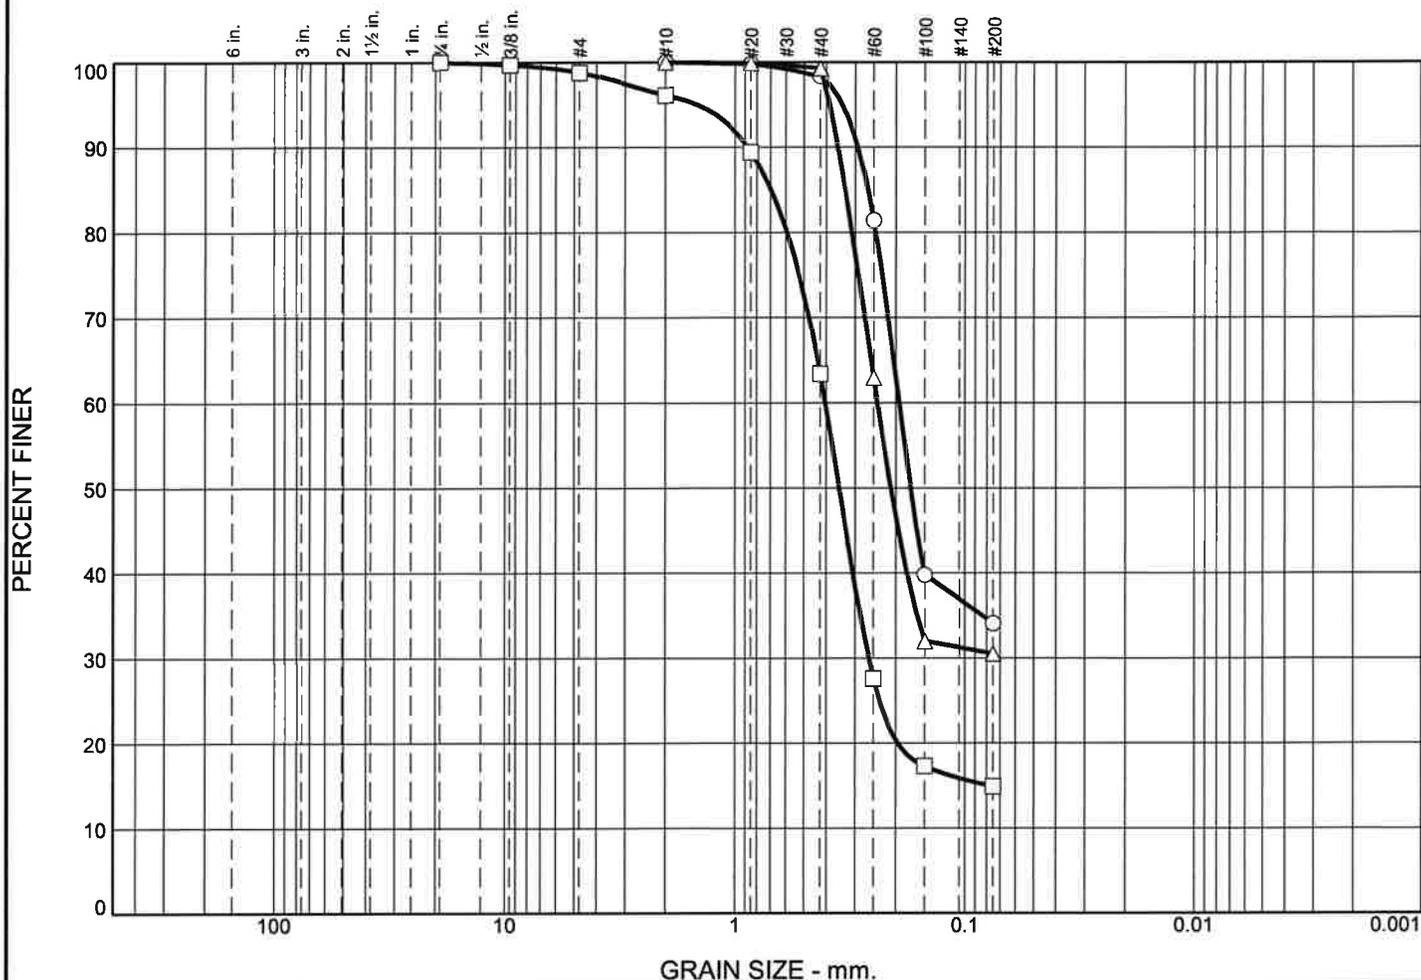
Particle Size Distribution Report

% +3"	% Gravel		% Sand			% Fines			
		Coarse	Fine	Coarse	Medium	Fine	Silt	Clay		
○	0.0	0.0	0.0	0.0	1.7	64.2	34.1			
□	0.0	0.0	1.2	2.7	32.7	48.5	14.9			
△	0.0	0.0	0.0	0.0	0.7	68.8	30.5			
⊗	LL	PL	D ₈₅	D ₆₀	D ₅₀	D ₃₀	D ₁₅	D ₁₀	C _c	C _u
○			0.2647	0.1935	0.1726					
□			0.6963	0.4038	0.3516	0.2619	0.0780			
△			0.3318	0.2408	0.2101

Material Description	USCS	AASHTO
○ Silty SAND	SM	
□ Silty SAND		
△ Silty SAND	SM

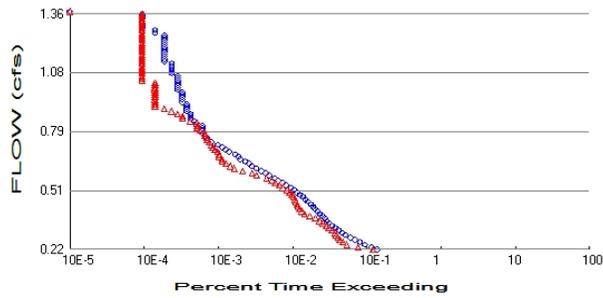
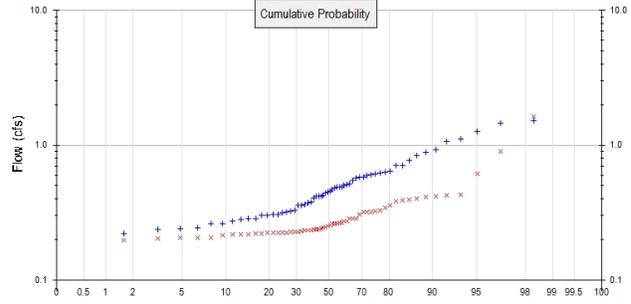
POC 1

+ Predeveloped x Mitigated

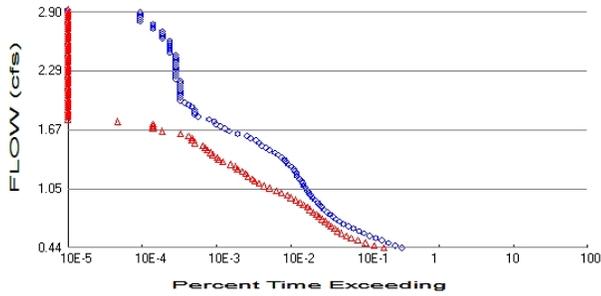
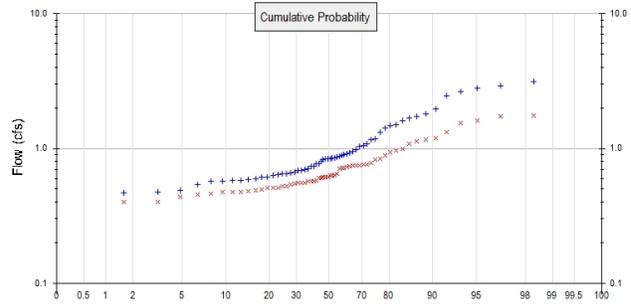
POC 2

+ Predeveloped x Mitigated

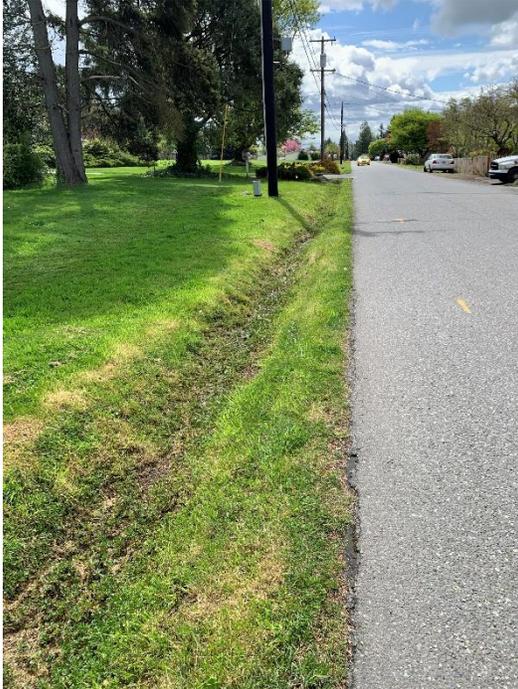
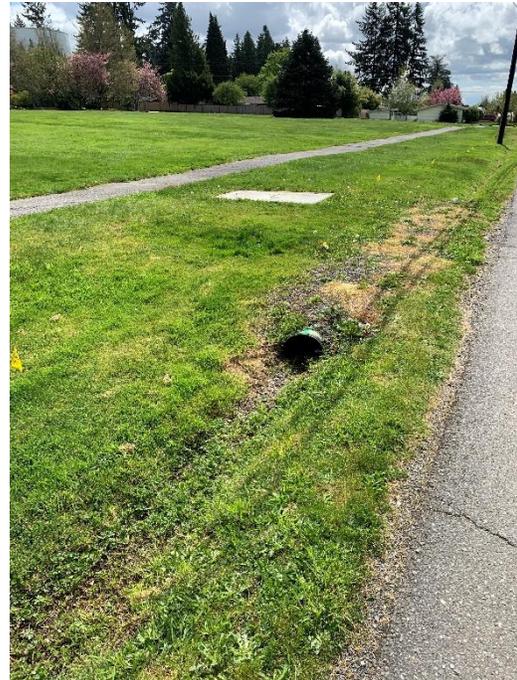
Photo#1 and 2: Roadside ditch and culvert system along the western frontage of the project site, east side of Terrace Avenue.

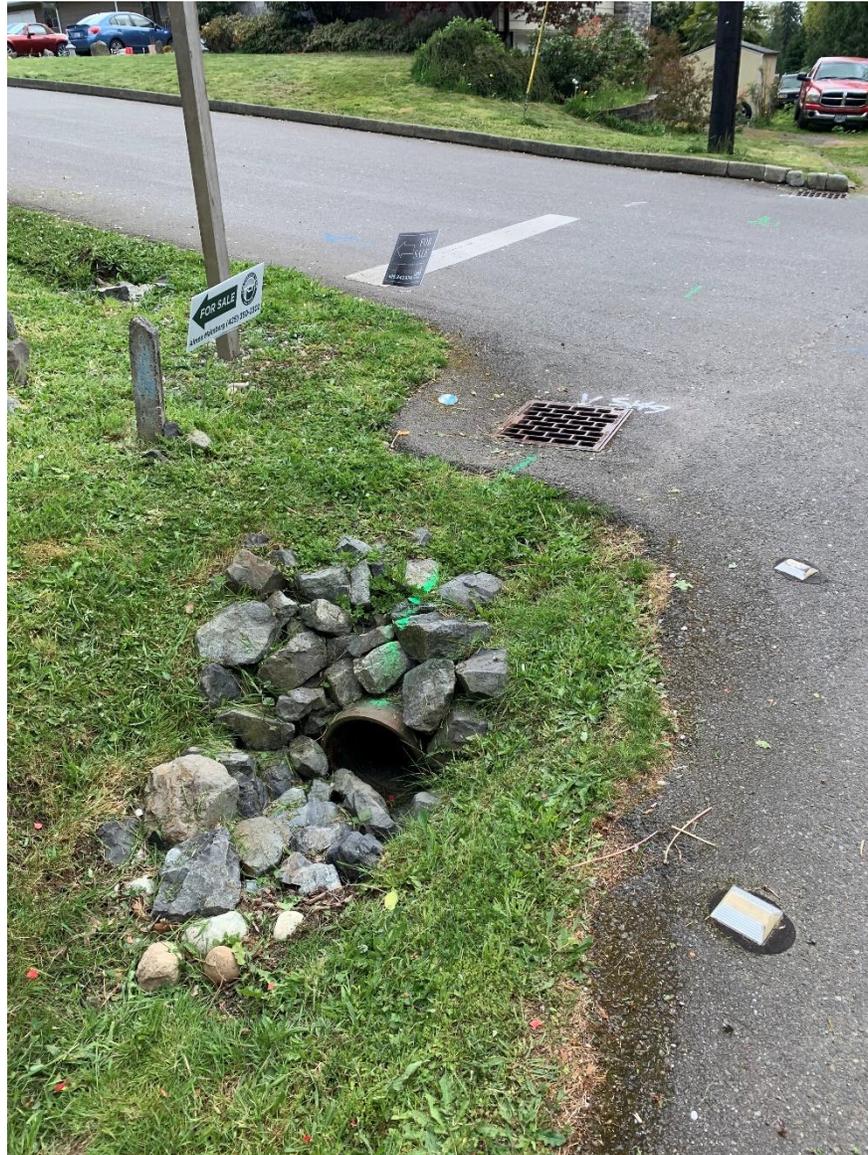
Photo#3: Where runoff enters the closed underground drainage system near the intersection of Terrace Avenue and 16th Street.

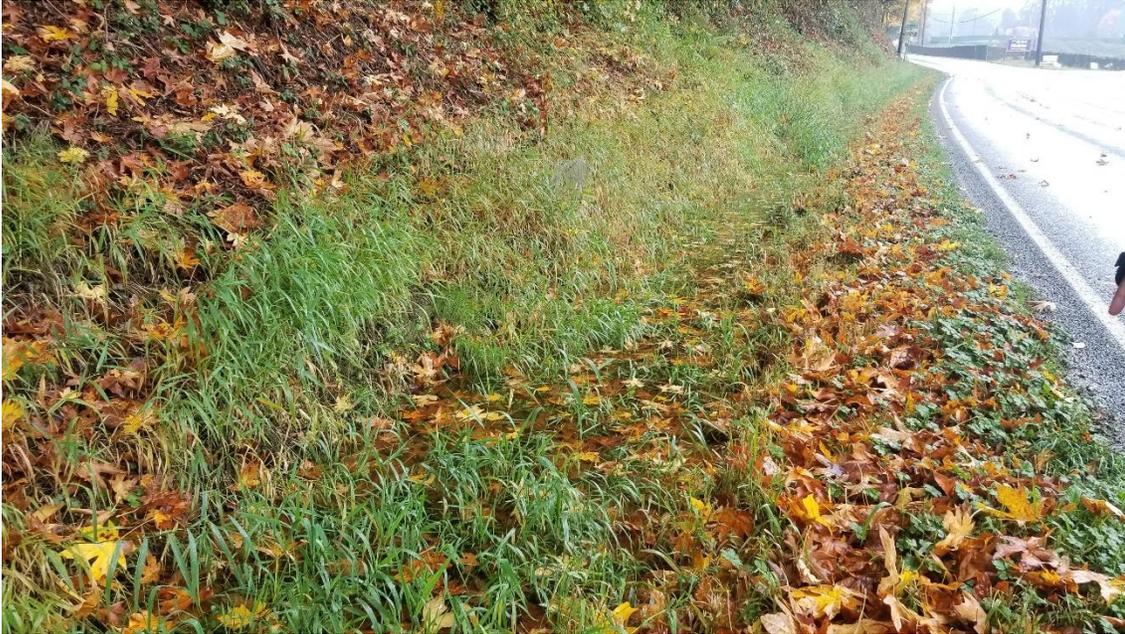
Photo#5: Looking north, roadside ditch along the west side of Machias Road. The steep slopes of the project site are seen on the left side of the photo. Standing water was observed in the ditch.

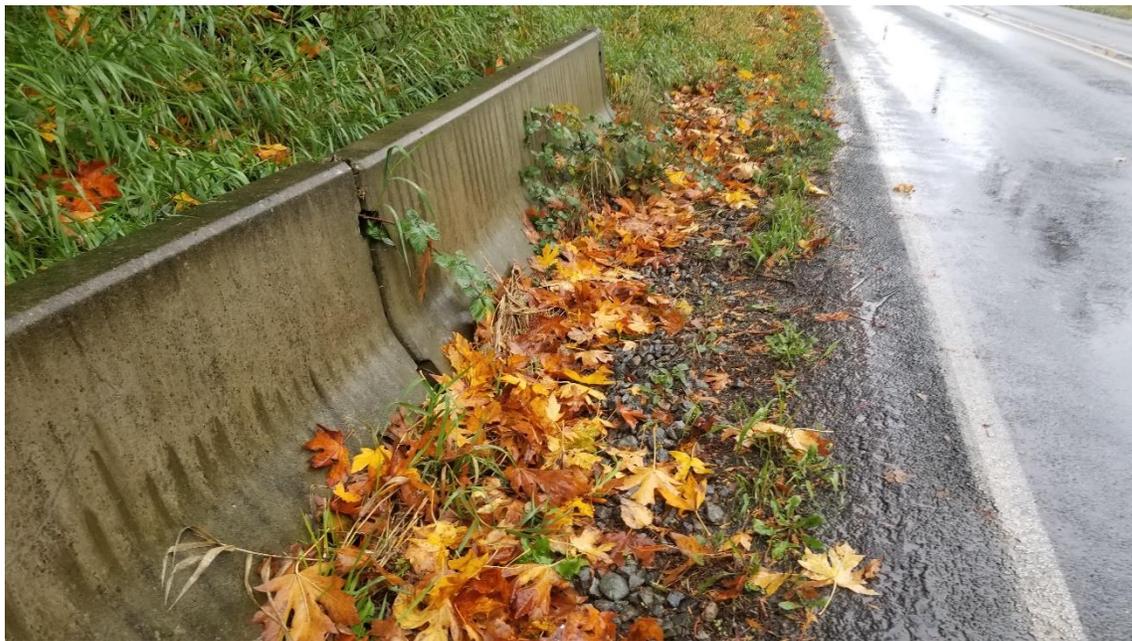
Photo#6: The end of the roadside ditch, where flow is conveyed east under Machias Road.

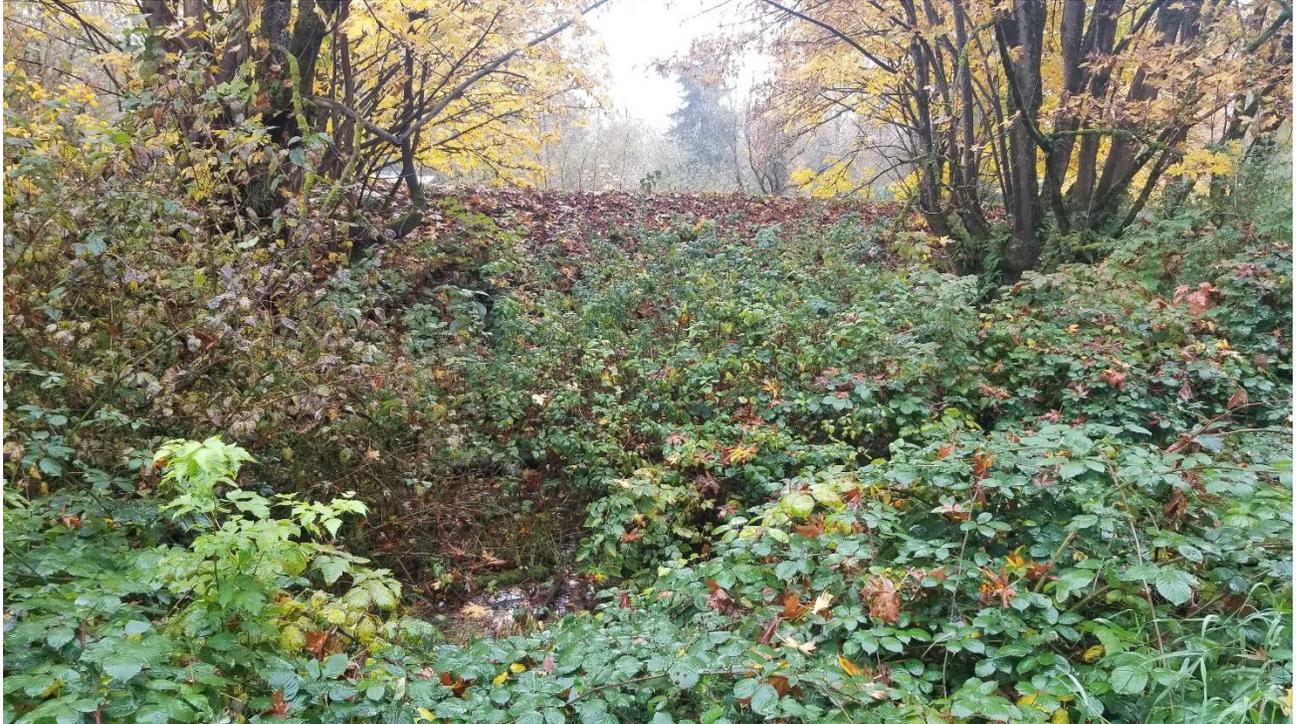
Photo#7: Standing water observed in the closed depression between the east side of Machias Road and the Centennial Trail, where runoff from the project site ultimately discharges.
