## **CRITICAL AREAS REPORT**

**Walsh Hills  
1711 Terrace Avenue  
Snohomish, Washington**

**Project No. T-8204**

**October 23, 2020**

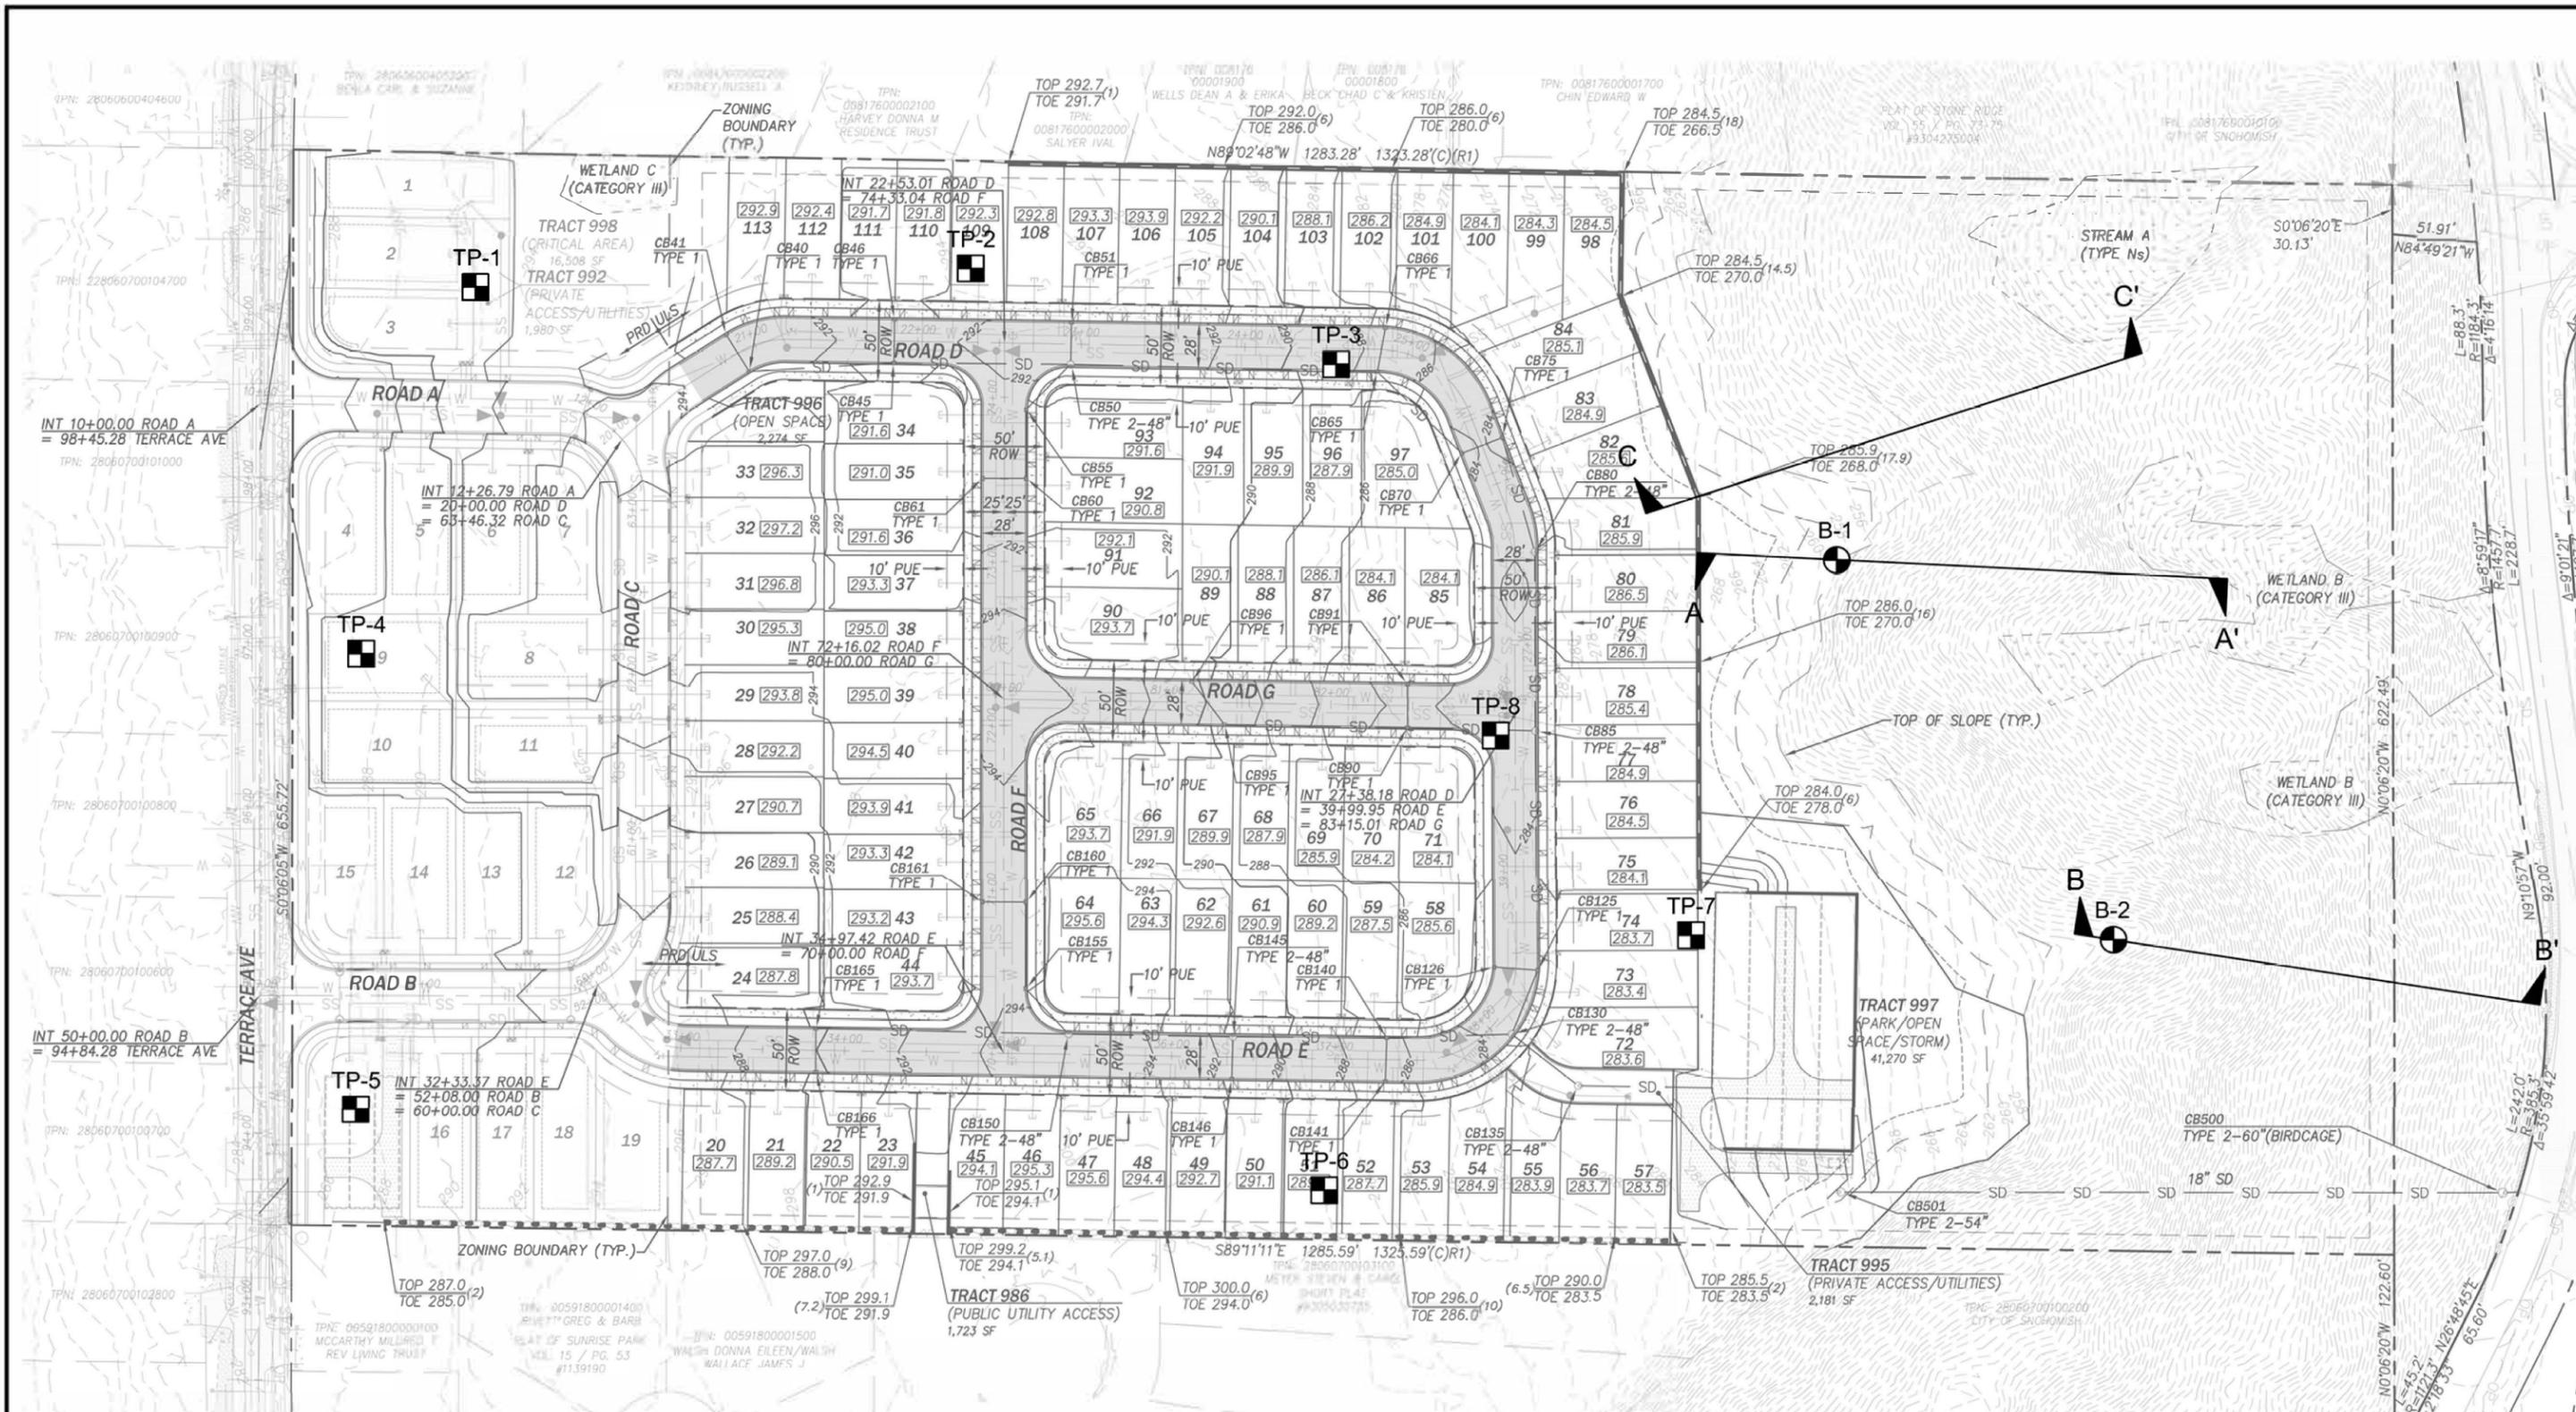
**EXPLORATION LOCATION PLAN  
 WALSH HILLS  
 SNOHOMISH, WASHINGTON**

Proj.No. T-8204	Date: OCT 2020	Figure 2
-----------------	----------------	----------

The preceding is intended to be a general review of the soil conditions encountered. For more detailed descriptions, please refer to the Test Pit and Test Boring Logs in Appendix A. The approximate location of the test pits and test borings is shown on attached Figure 2.

Part of our investigation was to determine the appropriate buffers and setbacks for the proposed development from the eastern steep slope. In order to determine the buffers and setbacks, we have completed three slope stability analyses. The analyses were performed at locations designated as Cross Sections A-A’, B-B’, and C-C’ using the computer program Slide 2018. The approximate cross section location is shown on Figure 2.

On August 29, 2019, we investigated subsurface conditions at the site by excavating 8 test pits with a track-mounted mini-excavator to depths of about 3 to 10 feet below existing grades. On September 17, 2019 and September 18, 2019, we supplemented this data by observing soil conditions at 2 borings drilled to depths of about 100 feet below existing surface grades. The test pit and boring locations were approximately determined in the field by sighting and pacing from existing surface features. The approximate test pit and test boring locations are shown on Figure 2. The Test Pit and Test Boring Logs are presented as Figures A-2 through A-11.

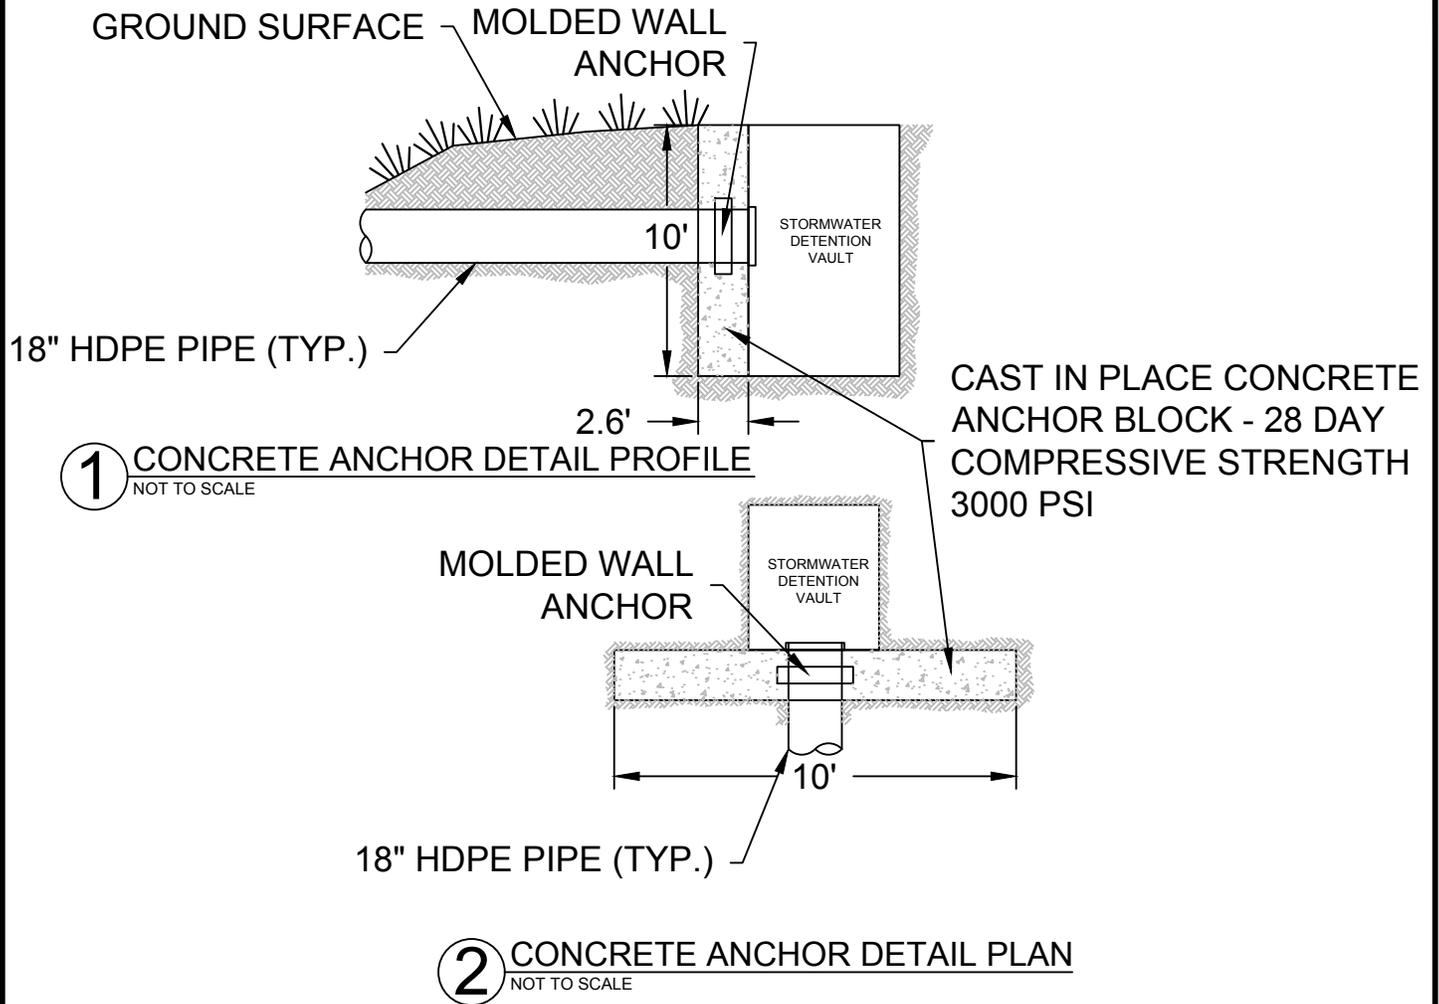
CONCRETE ANCHOR DETAIL  
 WALSH HILLS  
 SNOHOMISH, WASHINGTON

18" HDPE PIPE TO BE PLACED  
TANGENT TO THE BOTTOM I.D.  
OF THE PIPE CLAMP  
(TYP.)

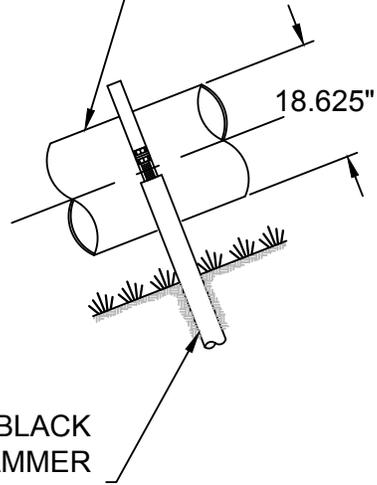
**1** HILLSIDE ANCHOR DETAIL  
NOT TO SCALE

2" DIAMETER EXTRA STONG BLACK  
PIPE PILE DRIVEN TO REFUSAL WITH 60 LB JACK HAMMER  
- REFUSAL CRITERIA -  
1" OF LESS PENETRATION AFTER 60 SECONDS (TYP.)

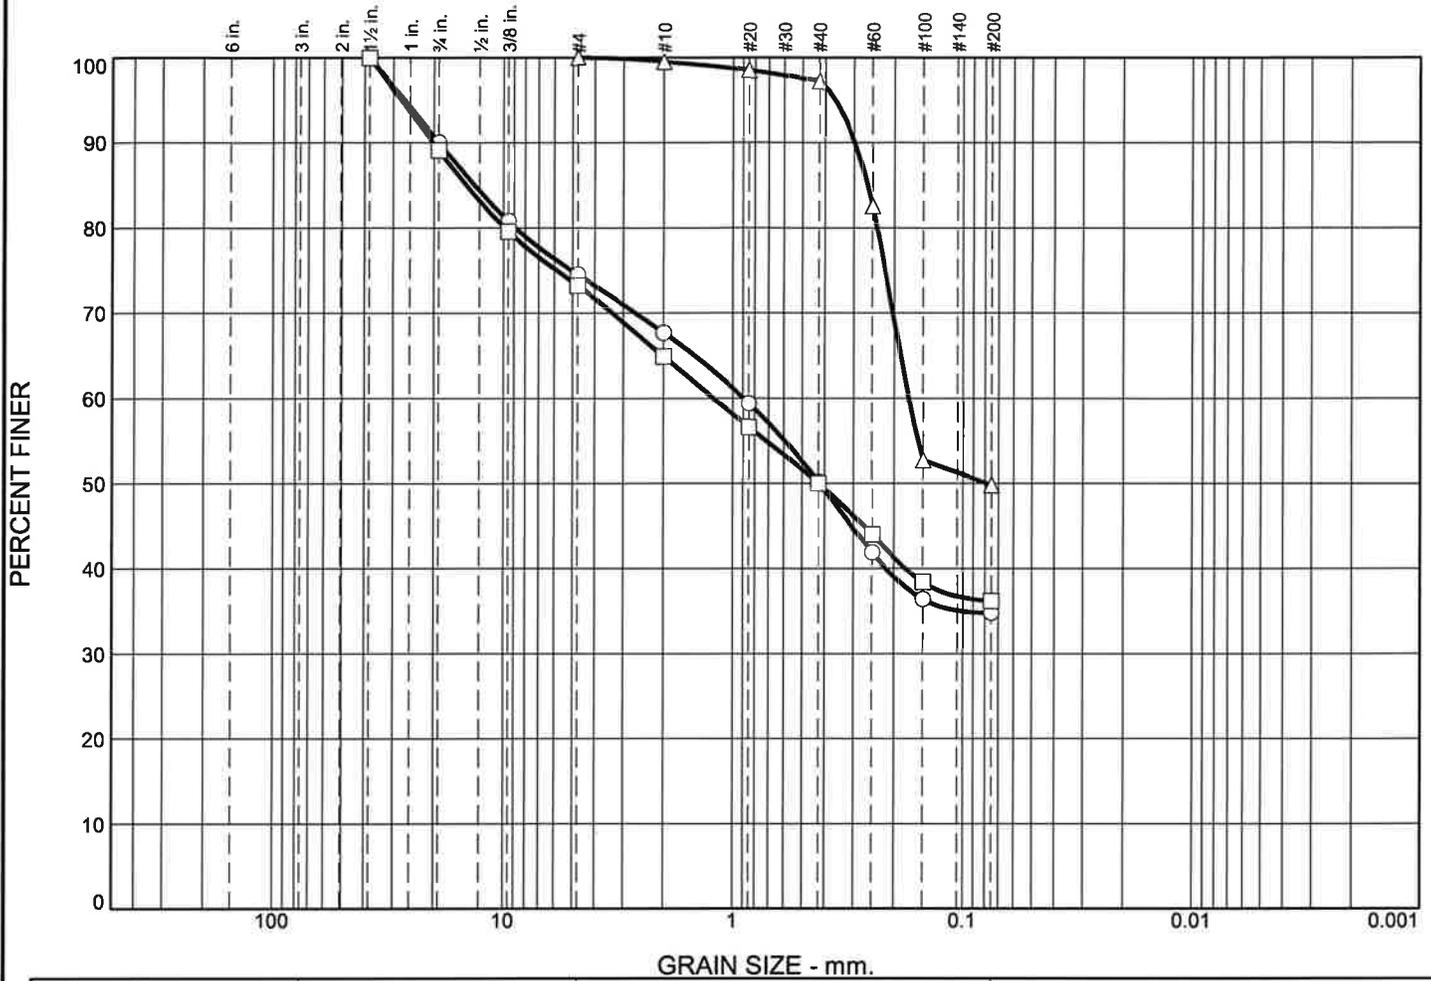
# Particle Size Distribution Report

% +3"	% Gravel		% Sand			% Fines			
		Coarse	Fine	Coarse	Medium	Fine	Silt	Clay		
○	0.0	10.0	15.5	6.8	17.5	15.4	34.8			
□	0.0	10.9	15.9	8.3	14.9	13.8	36.2			
△	0.0	0.0	0.0	0.5	2.3	47.4	49.8			
⊗	LL	PL	D85	D60	D50	D30	D15	D10	C <sub>c</sub>	C <sub>u</sub>
○			13.3443	0.8966	0.4195					
□			14.4649	1.2153	0.4250					
△			0.2631	0.1732	0.0787

Material Description	USCS	AASHTO
○ silty SAND with gravel	SM	
□ silty SAND with gravel	SM	
△ silty SAND	SM

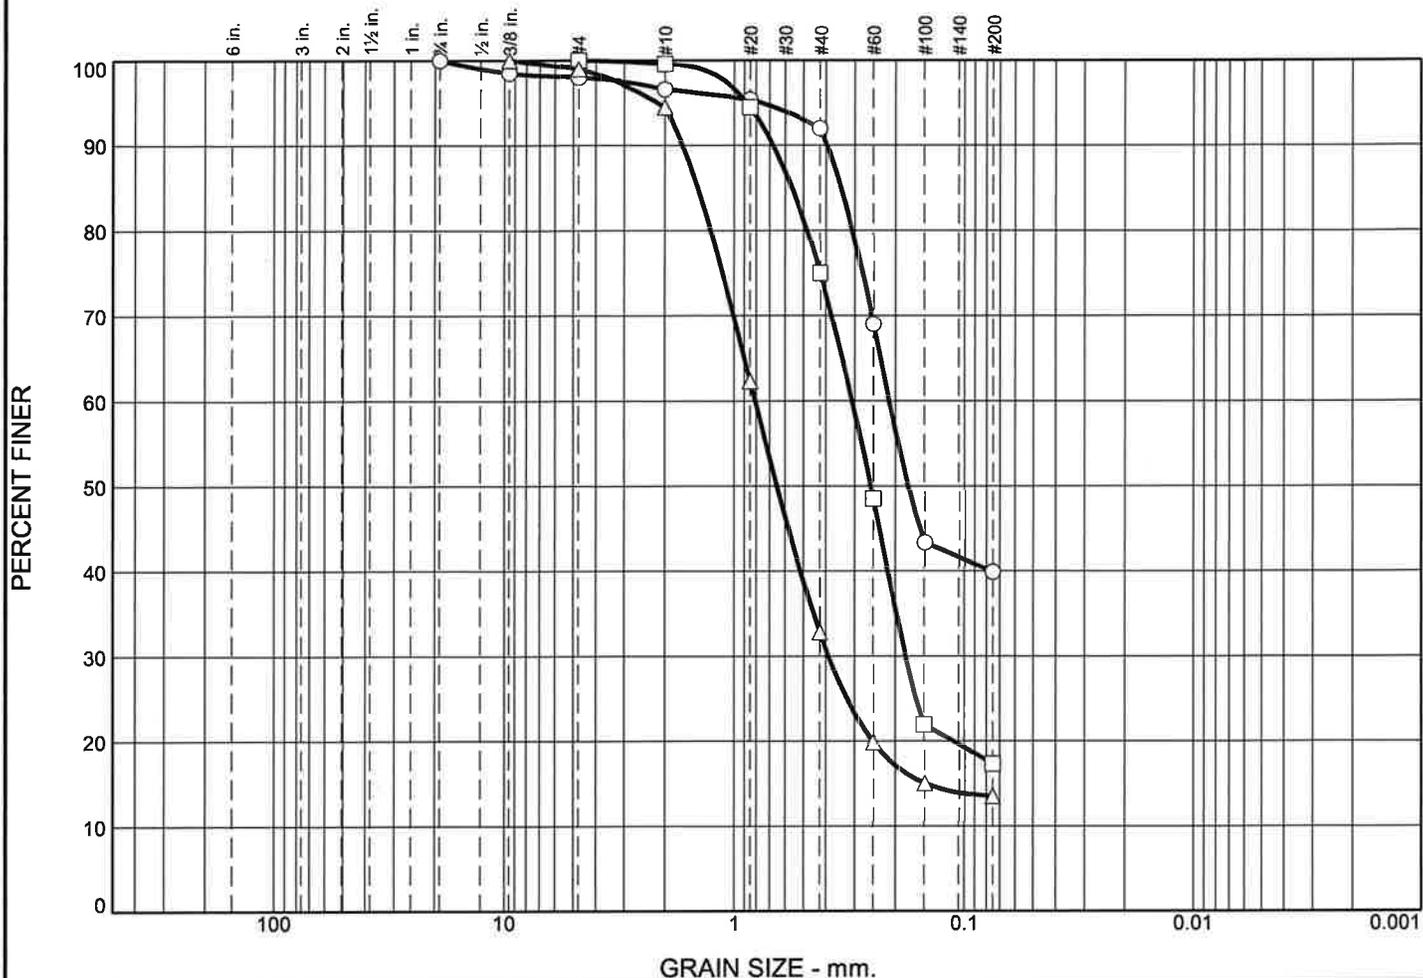
# Particle Size Distribution Report

% +3"	% Gravel		% Sand			% Fines			
		Coarse	Fine	Coarse	Medium	Fine	Silt	Clay		
○	0.0	0.0	2.0	1.4	4.6	52.1	39.9			
□	0.0	0.0	0.0	0.4	24.6	57.7	17.3			
△	0.0	0.0	1.0	4.5	61.7	19.3	13.5			
×	LL	PL	D <sub>85</sub>	D <sub>60</sub>	D <sub>50</sub>	D <sub>30</sub>	D <sub>15</sub>	D <sub>10</sub>	C <sub>c</sub>	C <sub>u</sub>
○			0.3448	0.2133	0.1765					
□			0.5627	0.3082	0.2566	0.1805				
△			1.4424	0.8090	0.6511	0.3896	0.1469

Material Description	USCS	AASHTO
○ silty SAND	SM	
□ Silty SAND	SM	
△ Silty SAND	SM

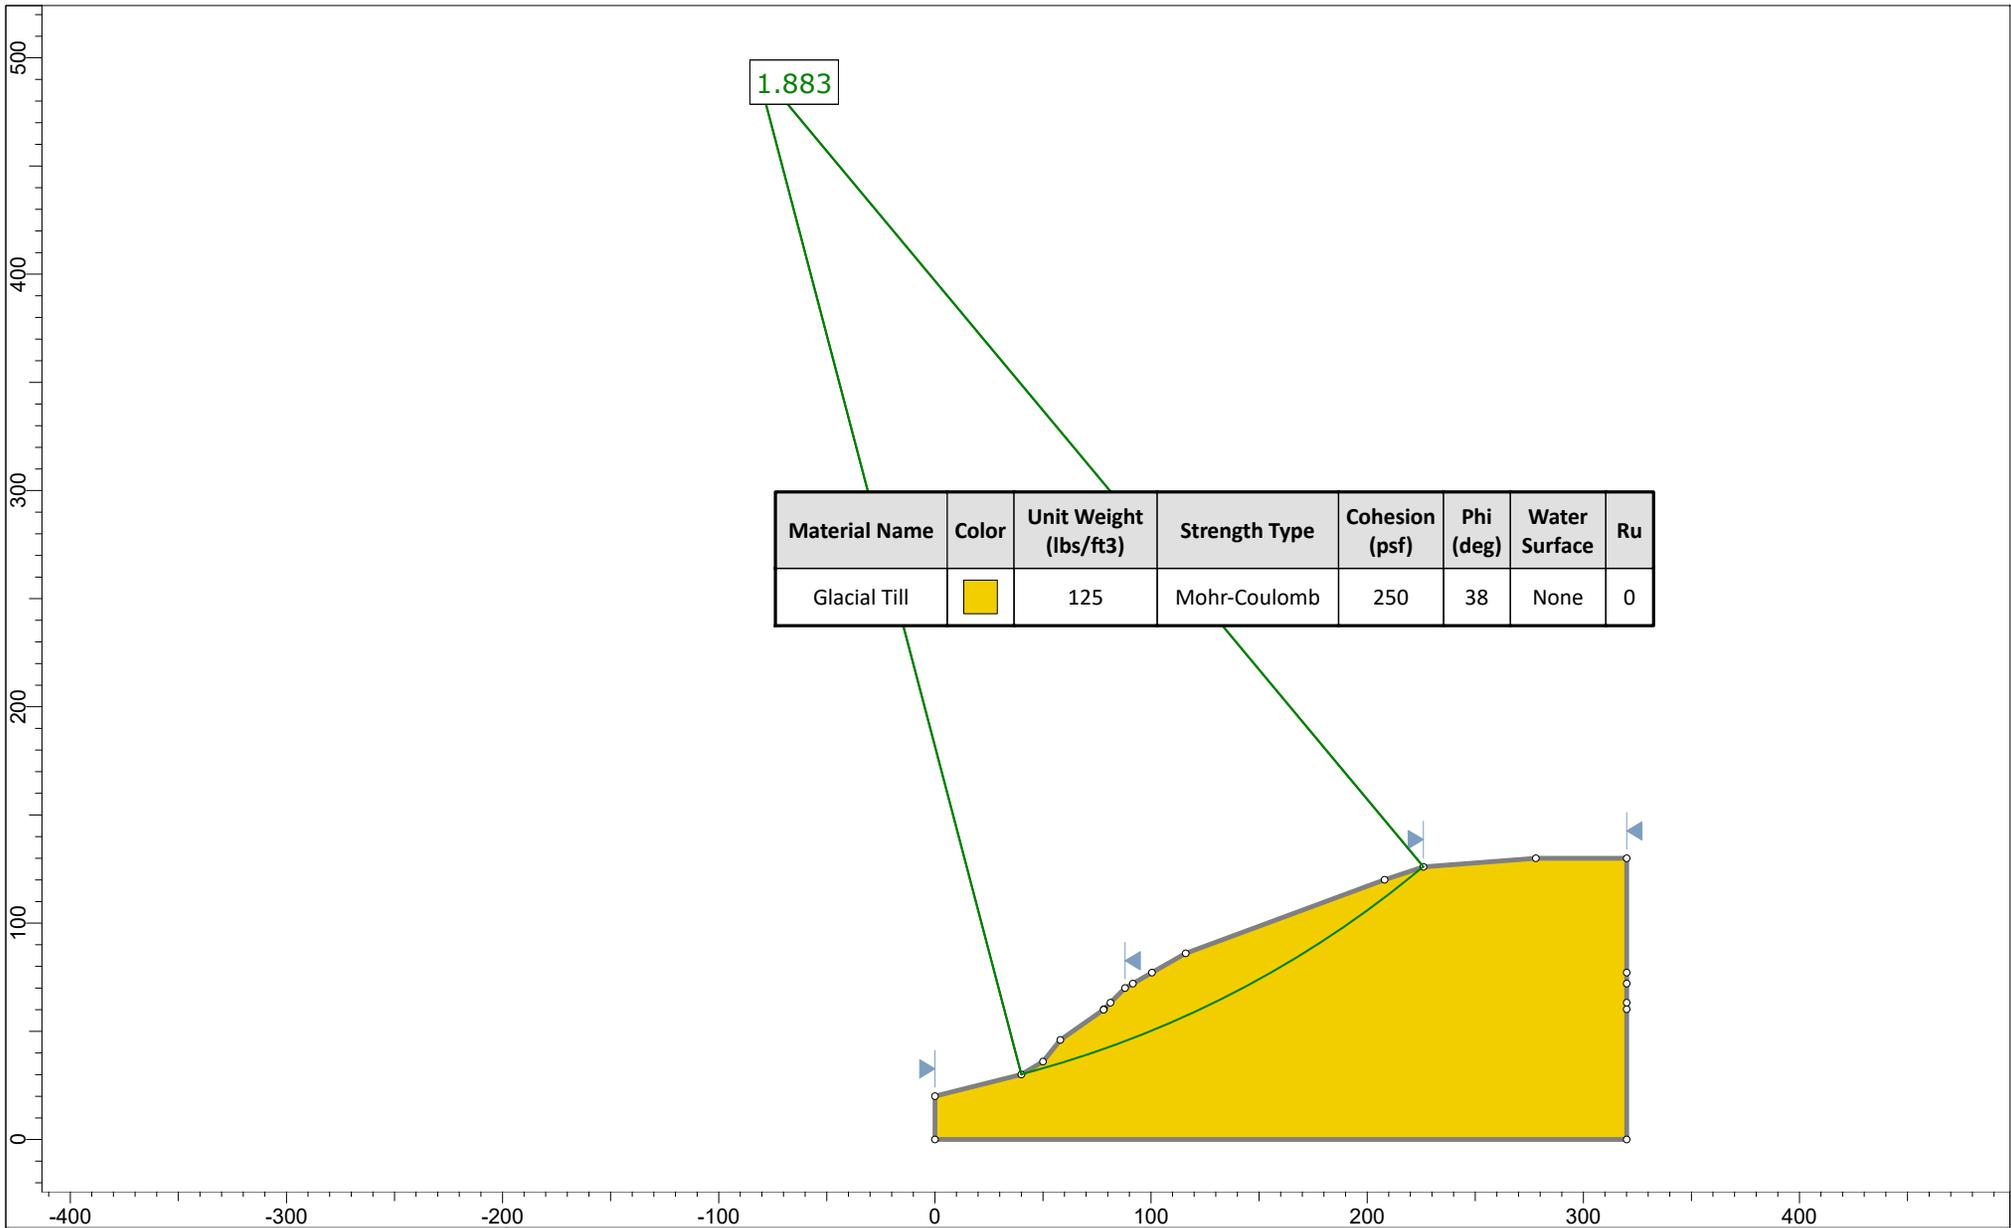
1.883

Material Name	Color	Unit Weight (lbs/ft3)	Strength Type	Cohesion (psf)	Phi (deg)	Water Surface	Ru
Glacial Till	Yellow	125	Mohr-Coulomb	250	38	None	0

Project			<b>Terrace Ave Development</b>		
	Analysis Description			Cross Section A-A' - Existing Conditions		
	Drawn By	C. Decker	Scale	1:1060	Company	Terra Associates, Inc.
	Date	October 2, 2019		File Name	Cross-section A-A'.slmd

<i>Cross Section</i>	<b>Minimum Safety Factors</b>	
	<i>Existing Conditions</i>	<i>Post Construction</i>
A-A’	1.88 (Seismic FS = 1.37)	1.88 (Seismic FS = 1.37)
B-B’	1.57 (Seismic FS = 1.20)	1.57 (Seismic FS = 1.20)
C-C’	2.15 (Seismic FS = 1.54)	1.91 (Seismic FS = 1.38)

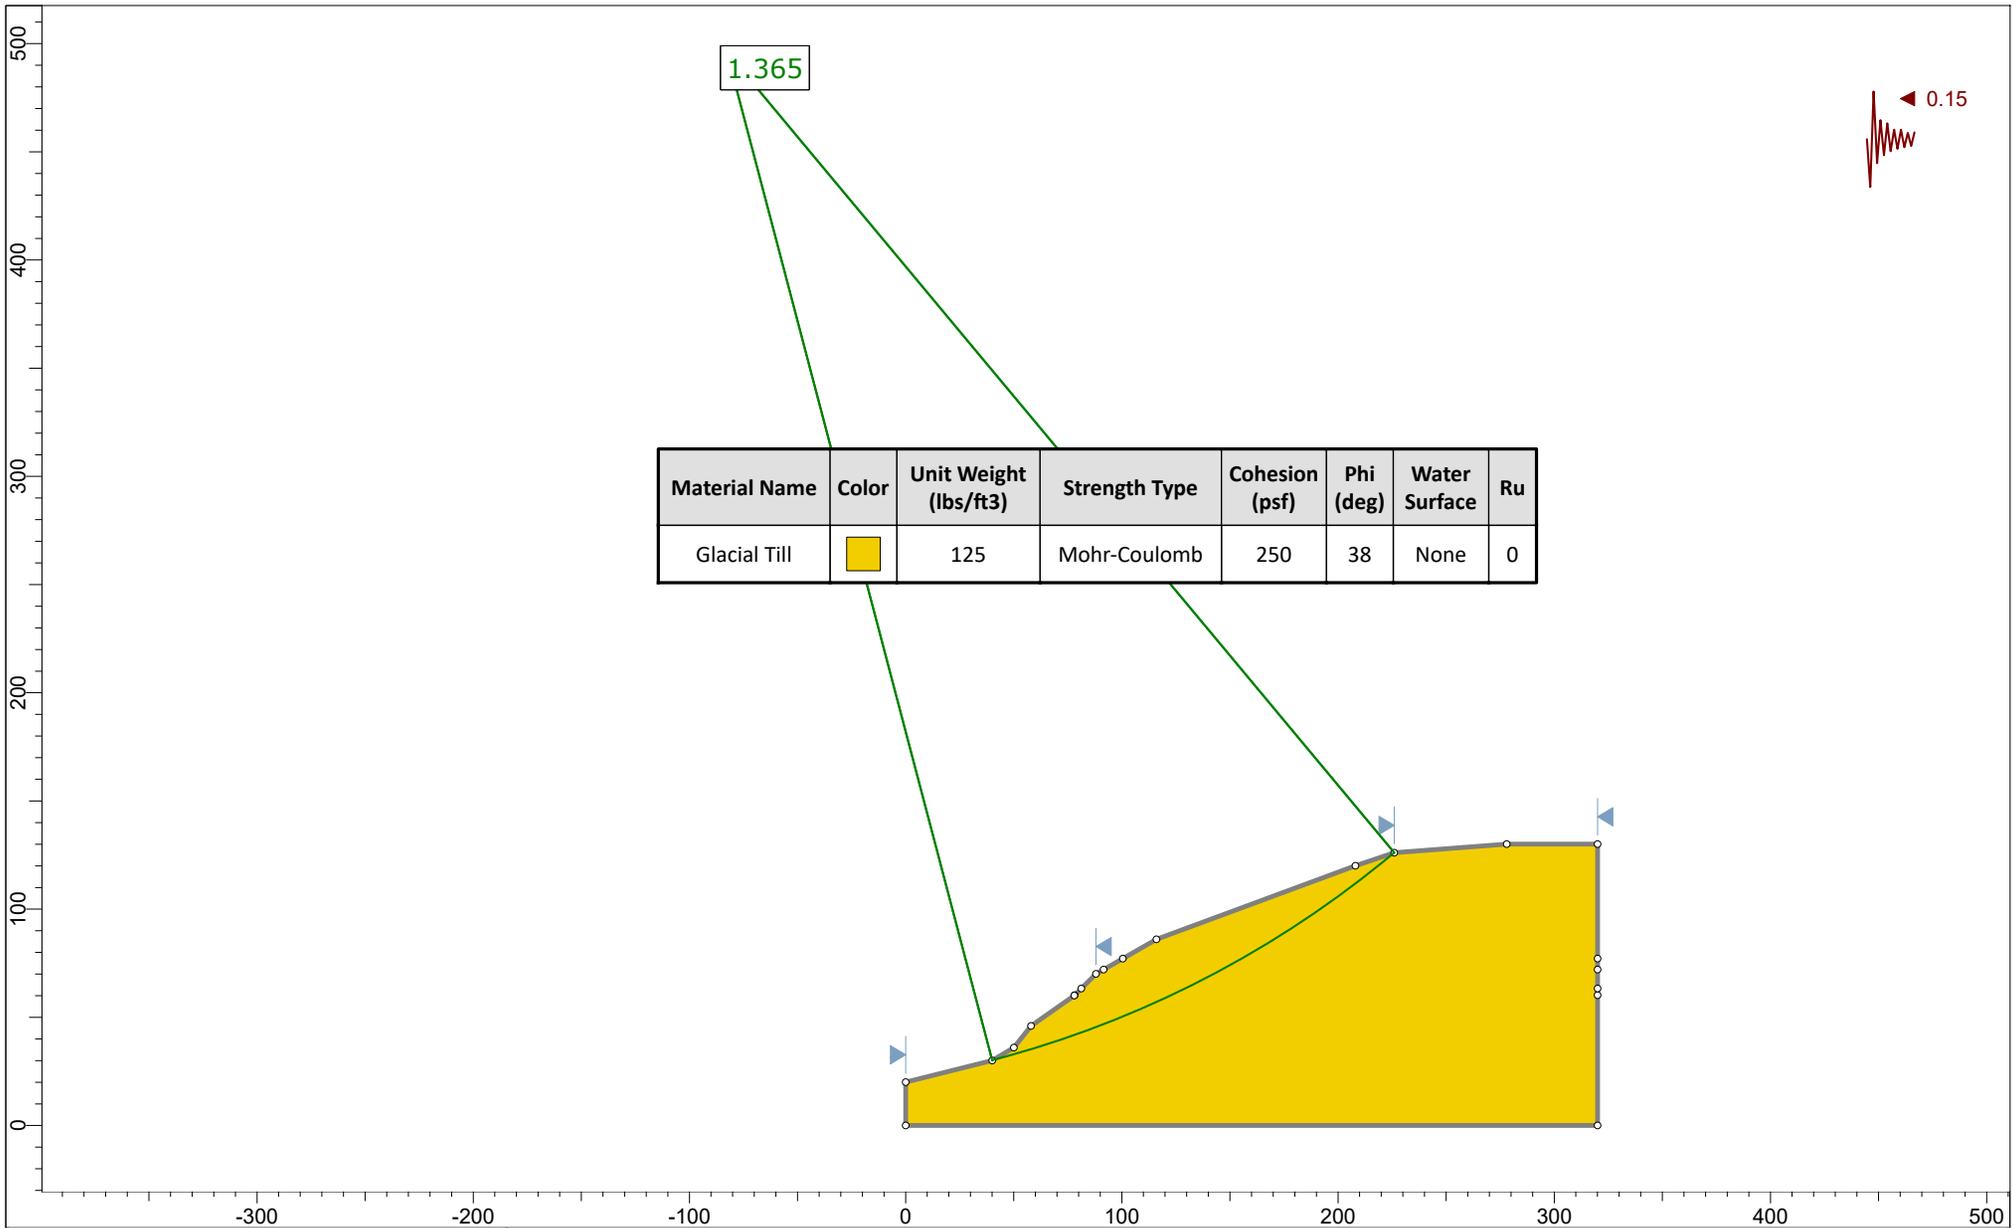
Material Name	Color	Unit Weight (lbs/ft3)	Strength Type	Cohesion (psf)	Phi (deg)	Water Surface	Ru
Glacial Till	<span style="display:inline-block; width:15px; height:15px; background-color:yellow;"></span>	125	Mohr-Coulomb	250	38	None	0

<i>Project</i>			<b>Terrace Ave Development</b>				
	<i>Analysis Description</i>			Cross Section A-A' - Existing Conditions - Seismic				
	<i>Drawn By</i>		C. Decker	<i>Scale</i>		1:1060	<i>Company</i>	Terra Associates, Inc.
	<i>Date</i>			October 2, 2019		<i>File Name</i>		Cross-section A-A'.slmd

Our analysis considered both static and pseudostatic (seismic) conditions. A horizontal acceleration of 0.15g was used in the pseudostatic analysis to simulate slope performance under earthquake loading. This value is based on the maximum considered earthquake (MCE) peak ground acceleration (PGA) adjusted for pseudostatic analysis following procedures outlined in Section 6.2.2 of the FHWA-NHI-11-032 Seismic Design – Geotechnical Features Manual.

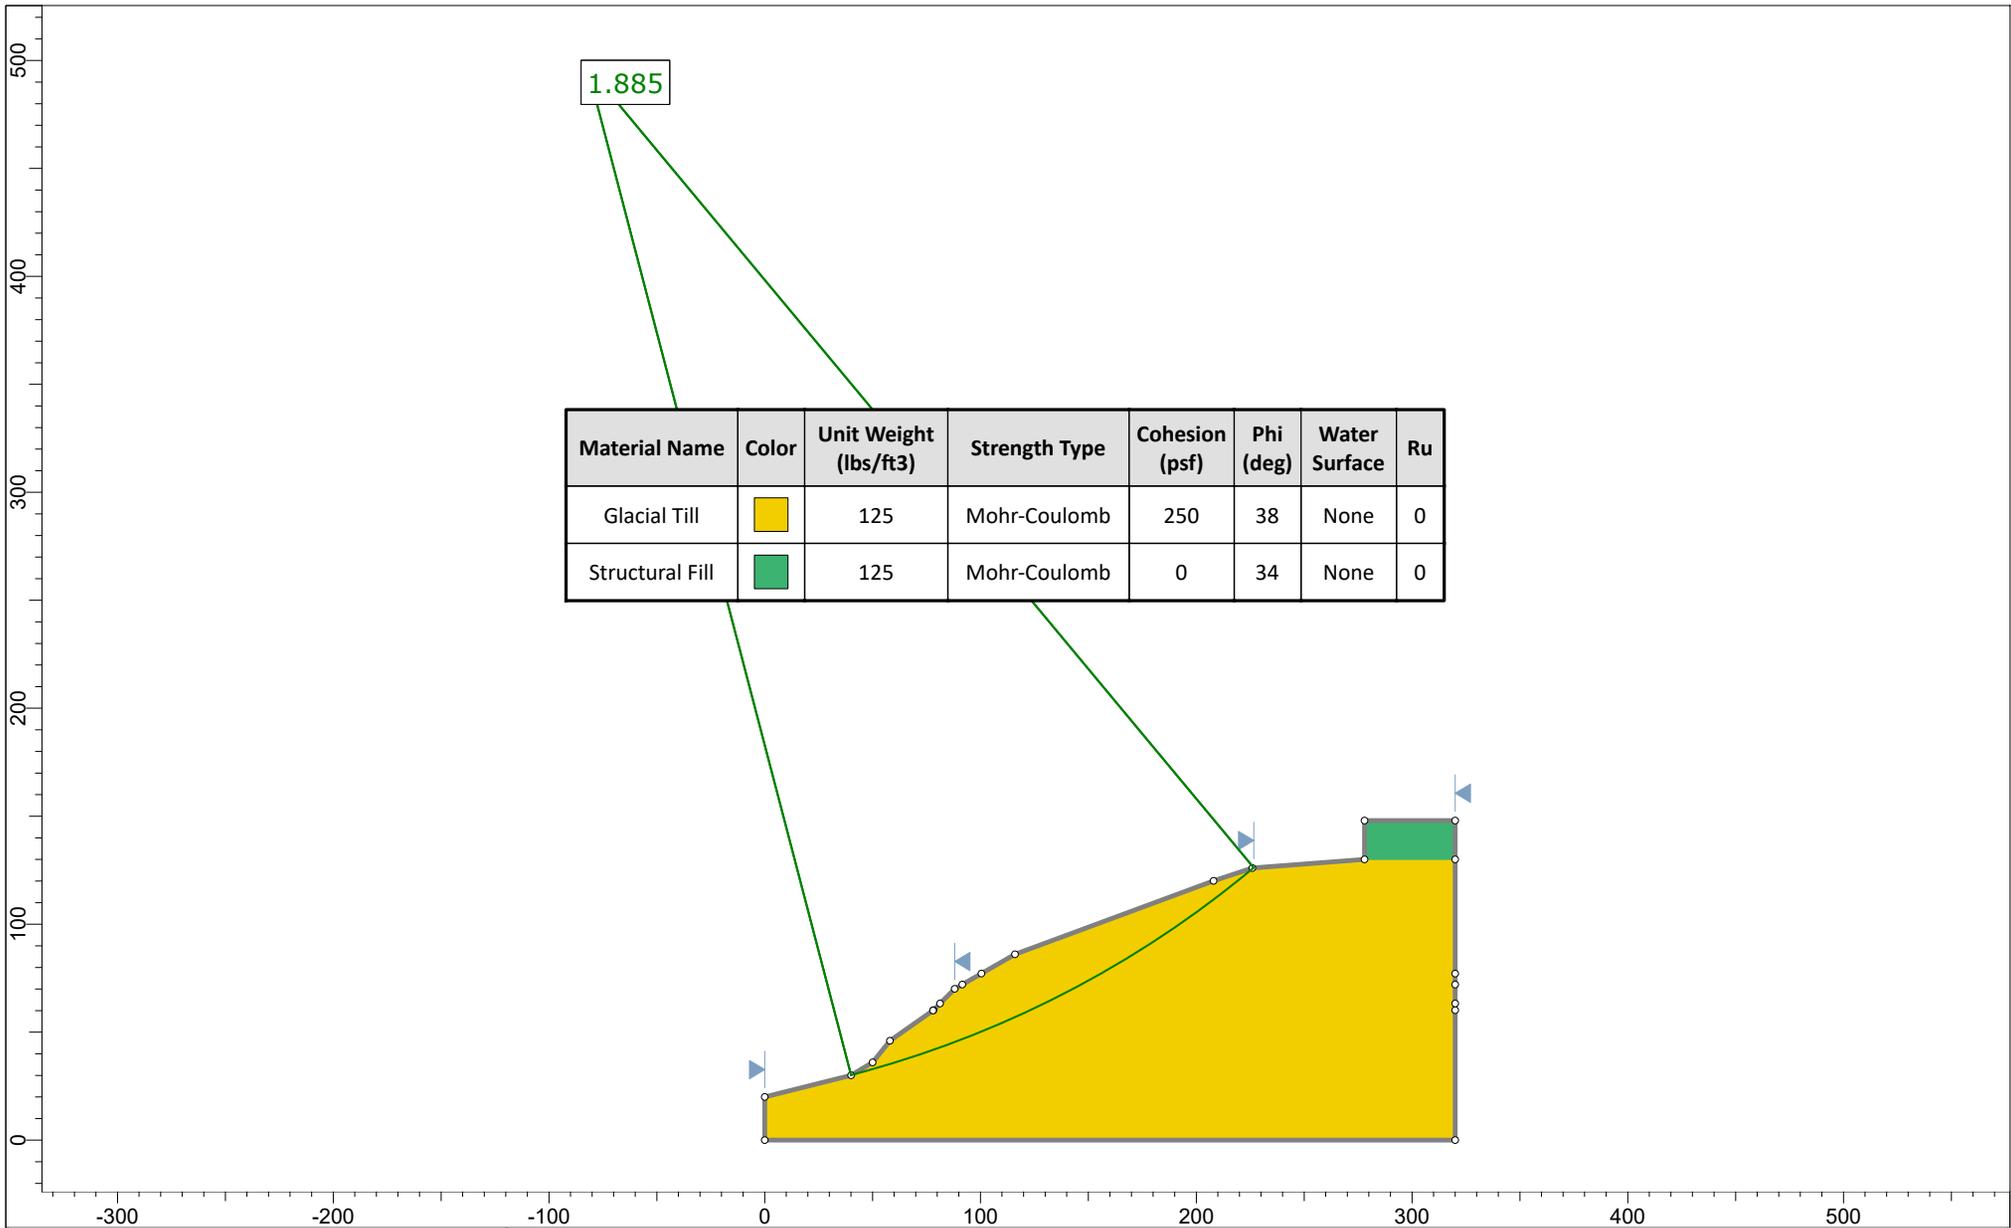
Material Name	Color	Unit Weight (lbs/ft <sup>3</sup> )	Strength Type	Cohesion (psf)	Phi (deg)	Water Surface	Ru
Glacial Till	<span style="color: yellow;">■</span>	125	Mohr-Coulomb	250	38	None	0
Structural Fill	<span style="color: green;">■</span>	125	Mohr-Coulomb	0	34	None	0

<i>Project</i> <b>Terrace Ave Development</b>		
	<i>Analysis Description</i> Cross Section A-A' - Post Construction		
	<i>Drawn By</i> C. Decker	<i>Scale</i> 1:1062	<i>Company</i> Terra Associates, Inc.
	<i>Date</i> May 15, 2020		<i>File Name</i> Cross-section A-A'.slmd

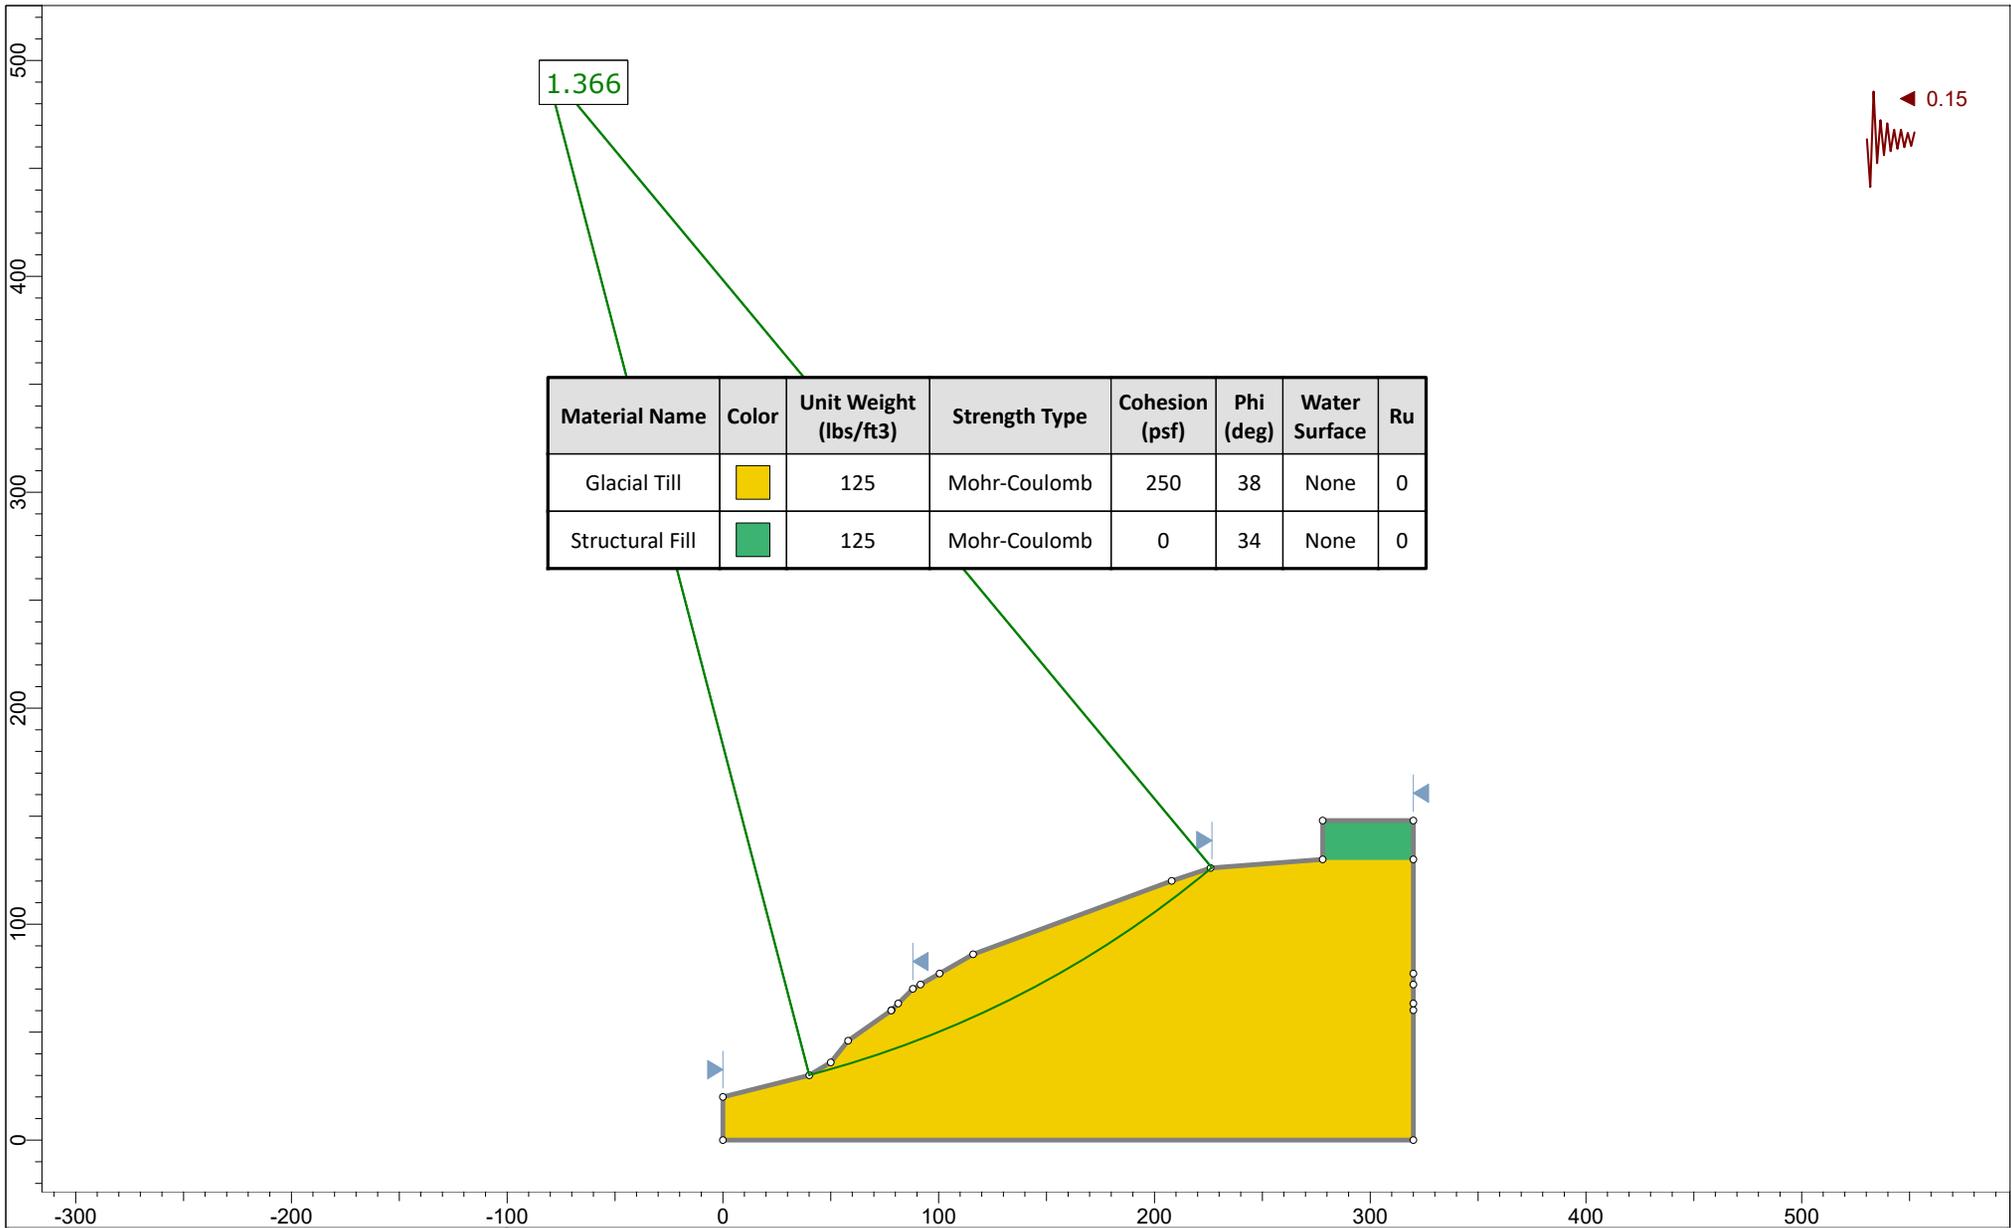
Material Name	Color	Unit Weight (lbs/ft3)	Strength Type	Cohesion (psf)	Phi (deg)	Water Surface	Ru
Glacial Till	<span style="display:inline-block; width:15px; height:15px; background-color:yellow;"></span>	125	Mohr-Coulomb	250	38	None	0
Structural Fill	<span style="display:inline-block; width:15px; height:15px; background-color:green;"></span>	125	Mohr-Coulomb	0	34	None	0

Project			<b>Terrace Ave Development</b>		
	Analysis Description			Cross Section A-A' - Post Construction - Seismic		
	Drawn By	C. Decker	Scale	1:1062	Company	Terra Associates, Inc.
	Date	May 15, 2020		File Name	Cross-section A-A'.slmd

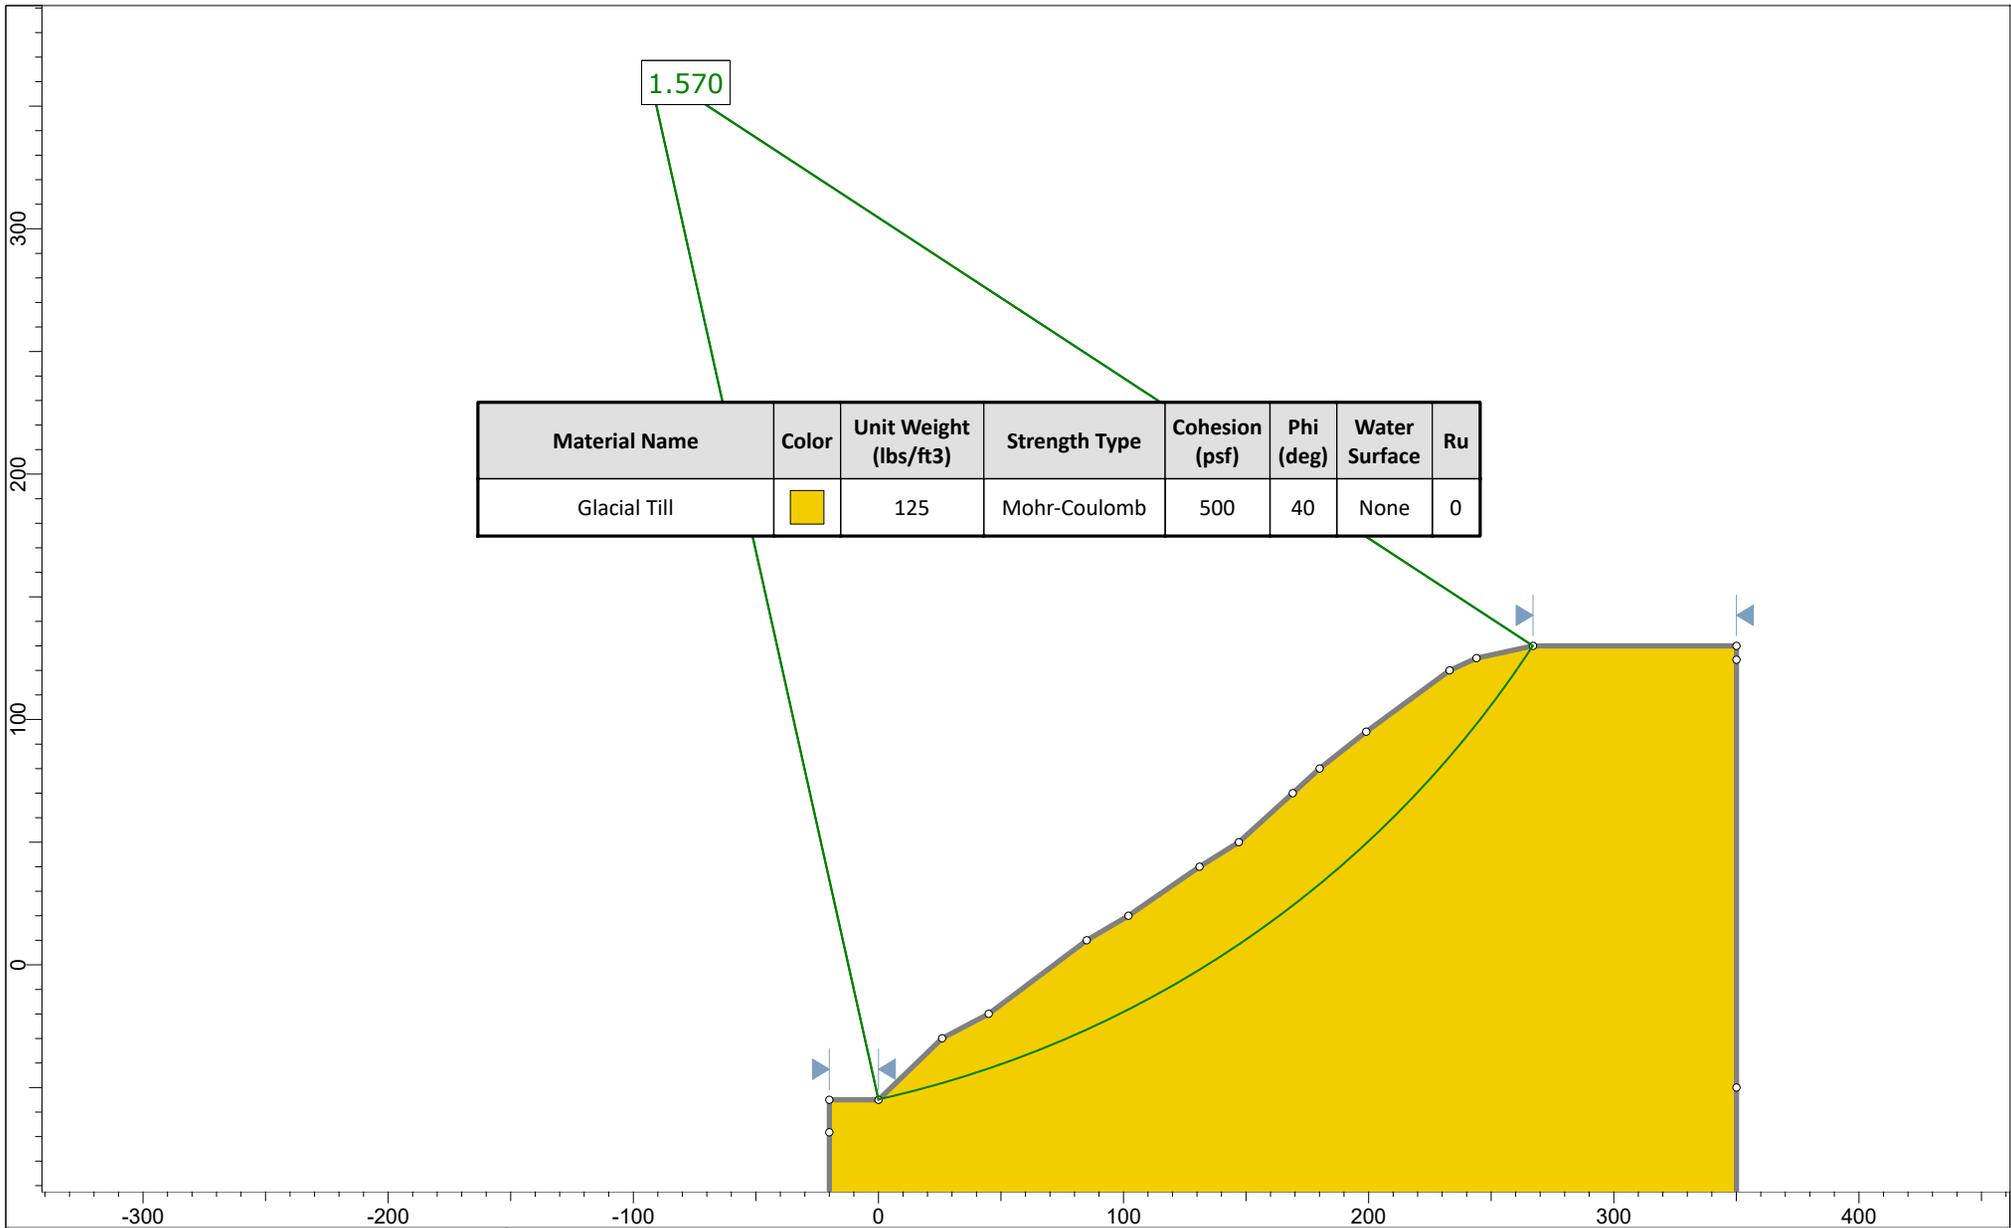
Material Name	Color	Unit Weight (lbs/ft3)	Strength Type	Cohesion (psf)	Phi (deg)	Water Surface	Ru
Glacial Till	<span style="display:inline-block; width:15px; height:15px; background-color:yellow;"></span>	125	Mohr-Coulomb	500	40	None	0

Project		<b>Terrace Ave Development</b>	
	Analysis Description		Cross Section B-B' - Existing Conditions	
	Drawn By	C. Decker	Scale	1:934
	Date	May 15, 2020	Company	Terra Associates, Inc.
			File Name	Cross Section B-B Detention Vault.slm
