## **CRITICAL AREAS REPORT**

**Walsh Hills  
1711 Terrace Avenue  
Snohomish, Washington**

**Project No. T-8204**

**October 23, 2020**

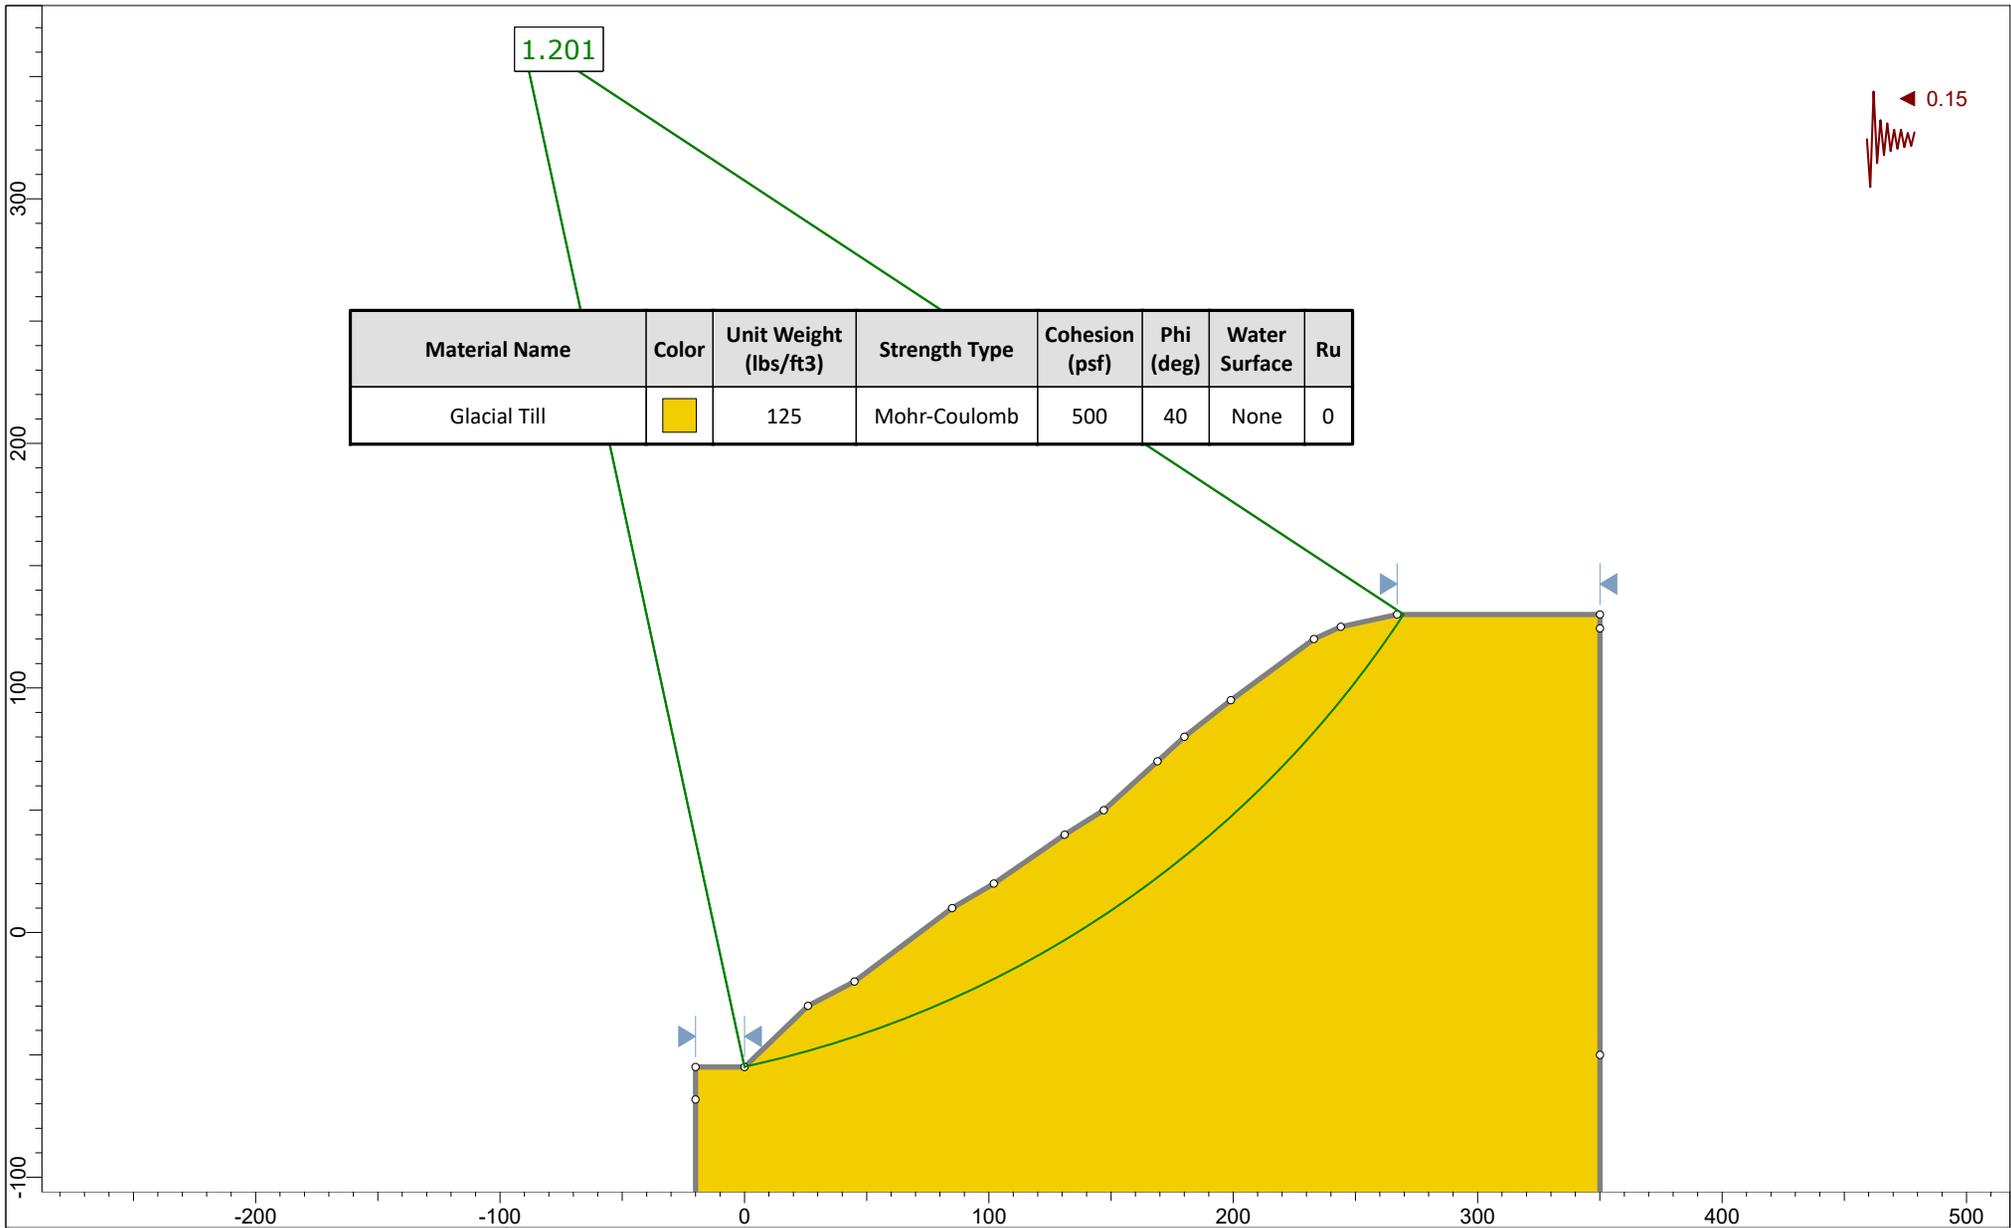
Material Name	Color	Unit Weight (lbs/ft3)	Strength Type	Cohesion (psf)	Phi (deg)	Water Surface	Ru
Glacial Till	<span style="display:inline-block; width:15px; height:15px; background-color:yellow;"></span>	125	Mohr-Coulomb	500	40	None	0

<i>Project</i>			<b>Terrace Ave Development</b>		
	<i>Analysis Description</i>			Cross Section B-B' - Existing Conditions - Seismic		
	<i>Drawn By</i>	C. Decker	<i>Scale</i>	1:937	<i>Company</i>	Terra Associates, Inc.
	<i>Date</i>	May 15, 2020		<i>File Name</i>	Cross Section B-B Detention Vault.slm

<i>Cross Section</i>	<b>Minimum Safety Factors</b>	
	<i>Existing Conditions</i>	<i>Post Construction</i>
A-A’	1.88 (Seismic FS = 1.37)	1.88 (Seismic FS = 1.37)
B-B’	1.57 (Seismic FS = 1.20)	1.57 (Seismic FS = 1.20)
C-C’	2.15 (Seismic FS = 1.54)	1.91 (Seismic FS = 1.38)

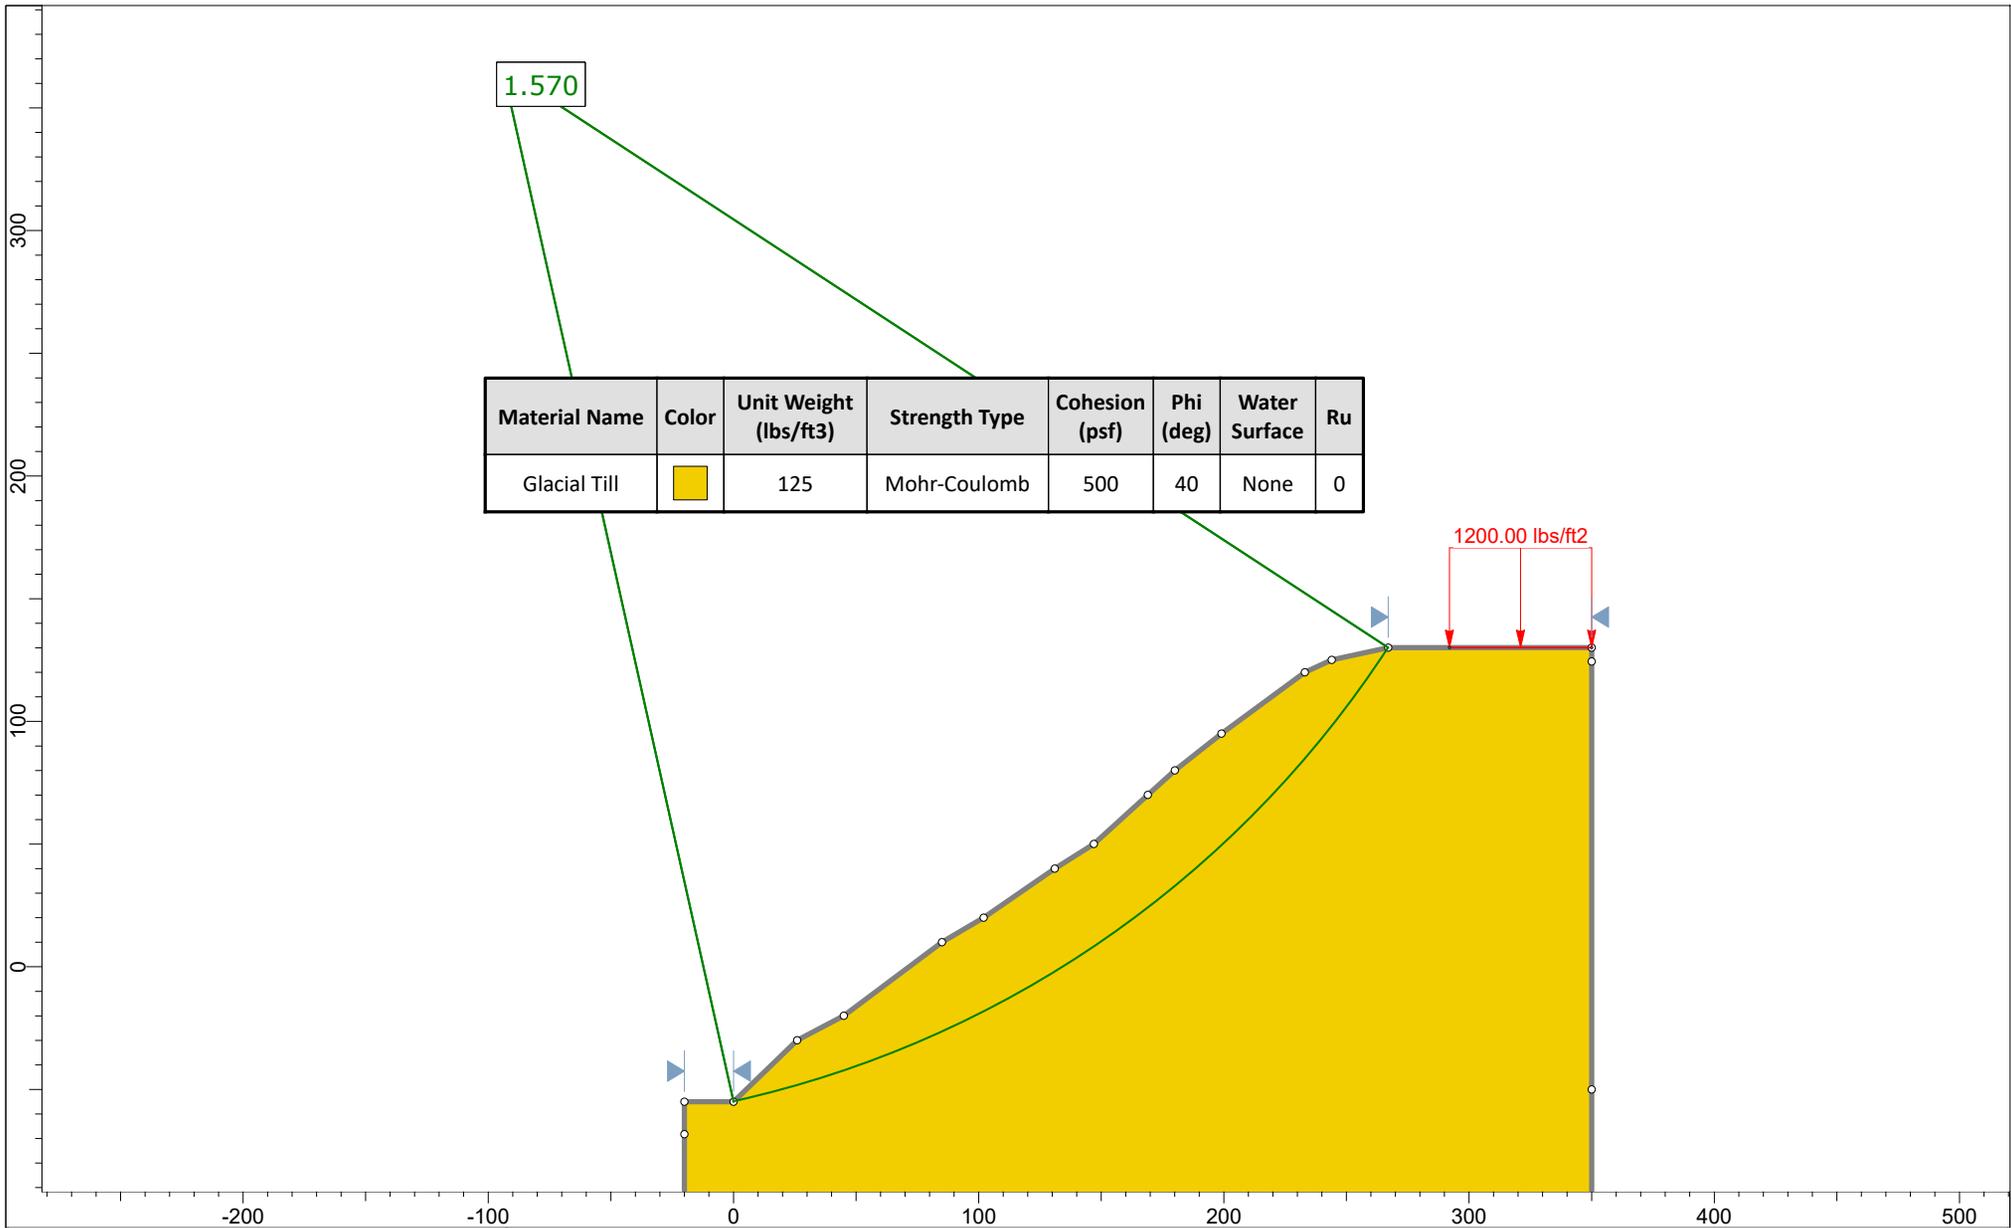
Material Name	Color	Unit Weight (lbs/ft3)	Strength Type	Cohesion (psf)	Phi (deg)	Water Surface	Ru
Glacial Till	<span style="display:inline-block; width:15px; height:15px; background-color:yellow;"></span>	125	Mohr-Coulomb	500	40	None	0

Project			<b>Terrace Ave Development</b>		
	Analysis Description			Cross Section B-B' - Post Construction		
	Drawn By	C. Decker	Scale	1:934	Company	Terra Associates, Inc.
	Date	May 15, 2020		File Name	Cross Section B-B Detention Vault.slm

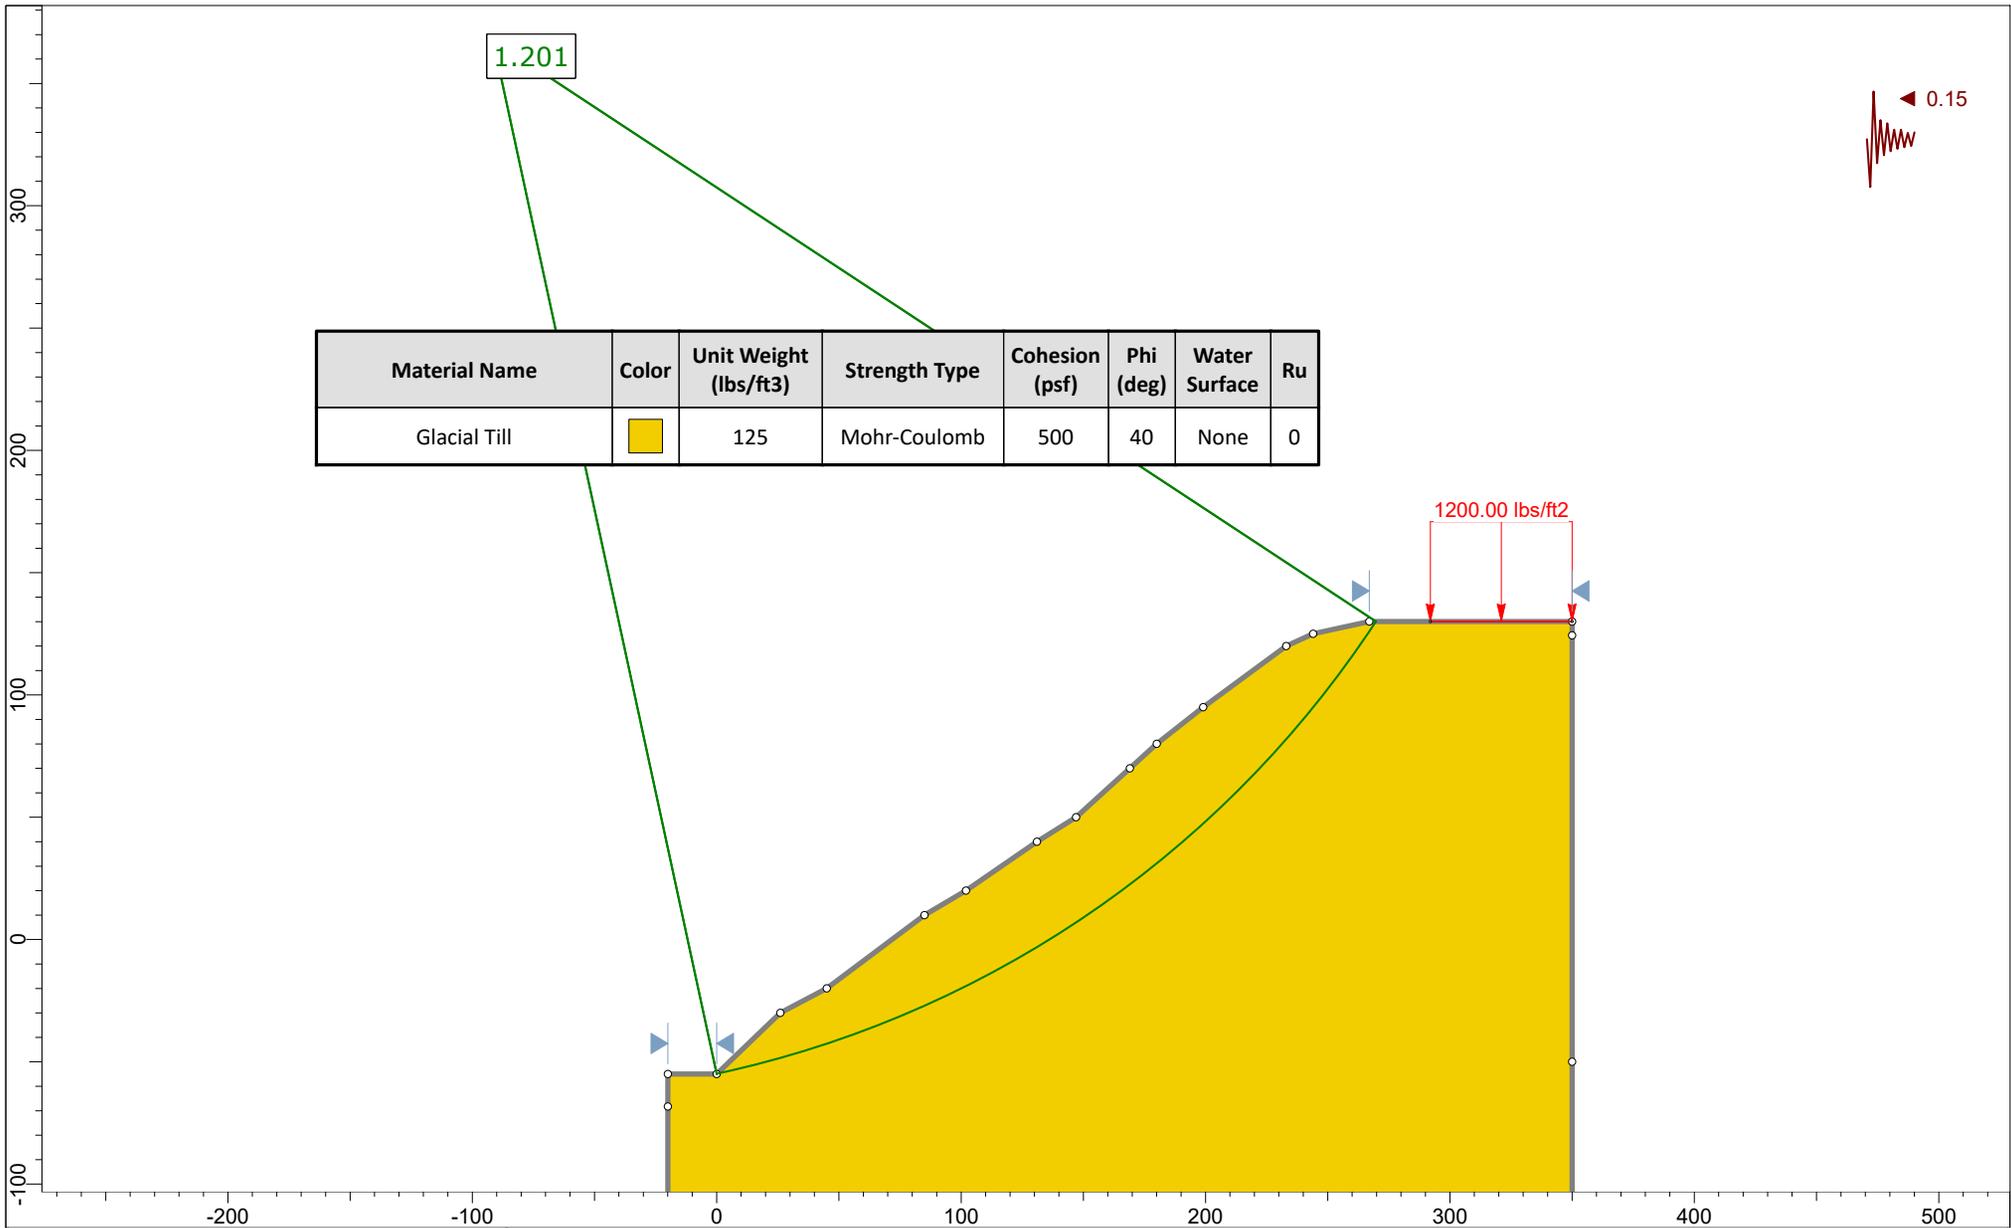
Material Name	Color	Unit Weight (lbs/ft3)	Strength Type	Cohesion (psf)	Phi (deg)	Water Surface	Ru
Glacial Till	Yellow	125	Mohr-Coulomb	500	40	None	0

Project			<b>Terrace Ave Development</b>		
	Analysis Description			Cross Section B-B' - Post Construction - Seismic		
	Drawn By	C. Decker	Scale	1:937	Company	Terra Associates, Inc.
	Date	May 15, 2020		File Name	Cross Section B-B Detention Vault.slmd

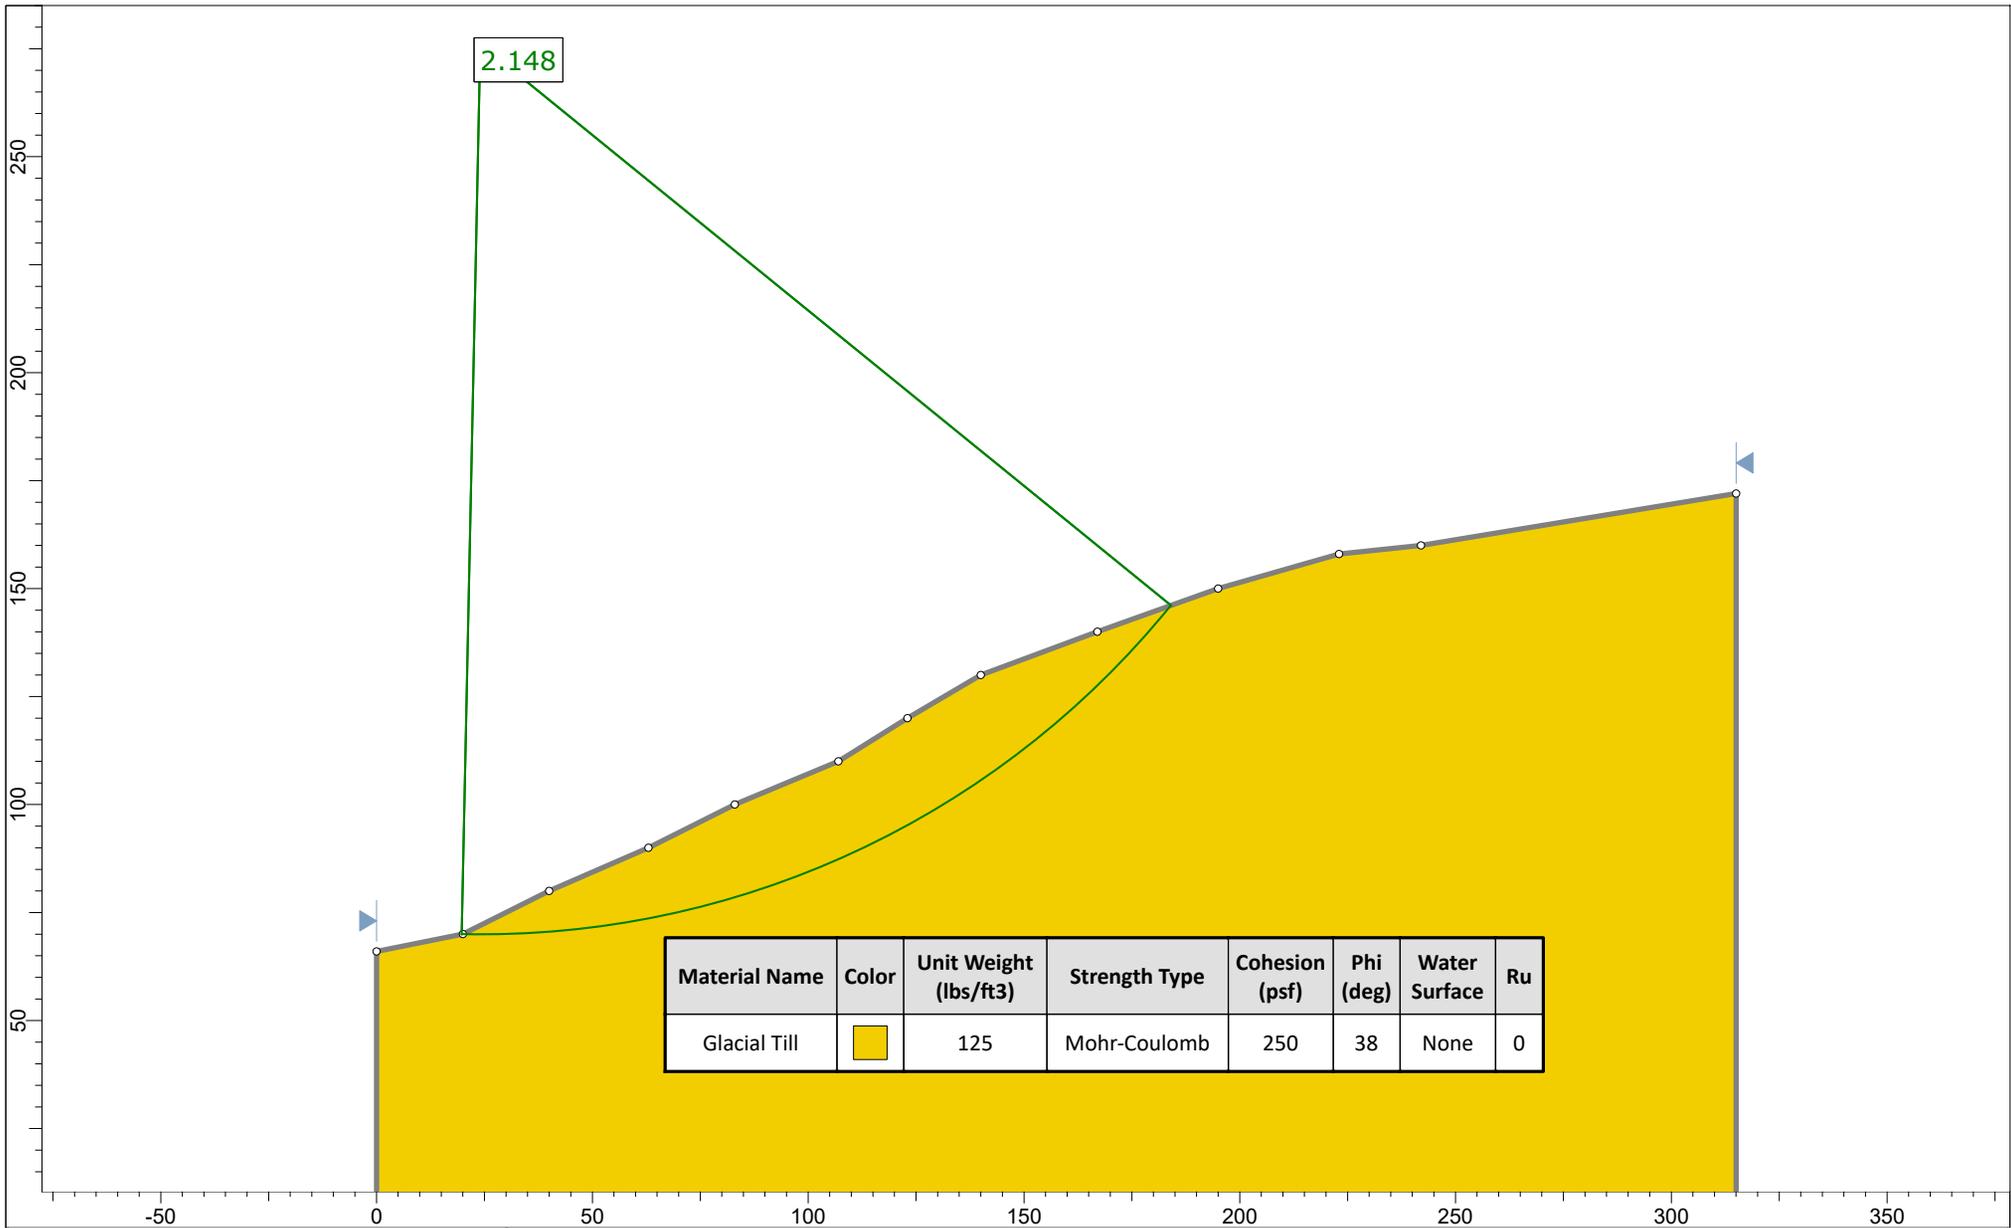
Material Name	Color	Unit Weight (lbs/ft <sup>3</sup> )	Strength Type	Cohesion (psf)	Phi (deg)	Water Surface	Ru
Glacial Till	<span style="display:inline-block; width:15px; height:15px; background-color:yellow;"></span>	125	Mohr-Coulomb	250	38	None	0

Project			<b>Terrace Avenue</b>		
	Analysis Description			Cross Section C-C' - Existing Conditions		
	Drawn By	C. Decker	Scale	1:531	Company	Terra Associates, Inc.
	Date	5/6/2020, 2:14:41 PM		File Name	Cross Section C-C'.slmd

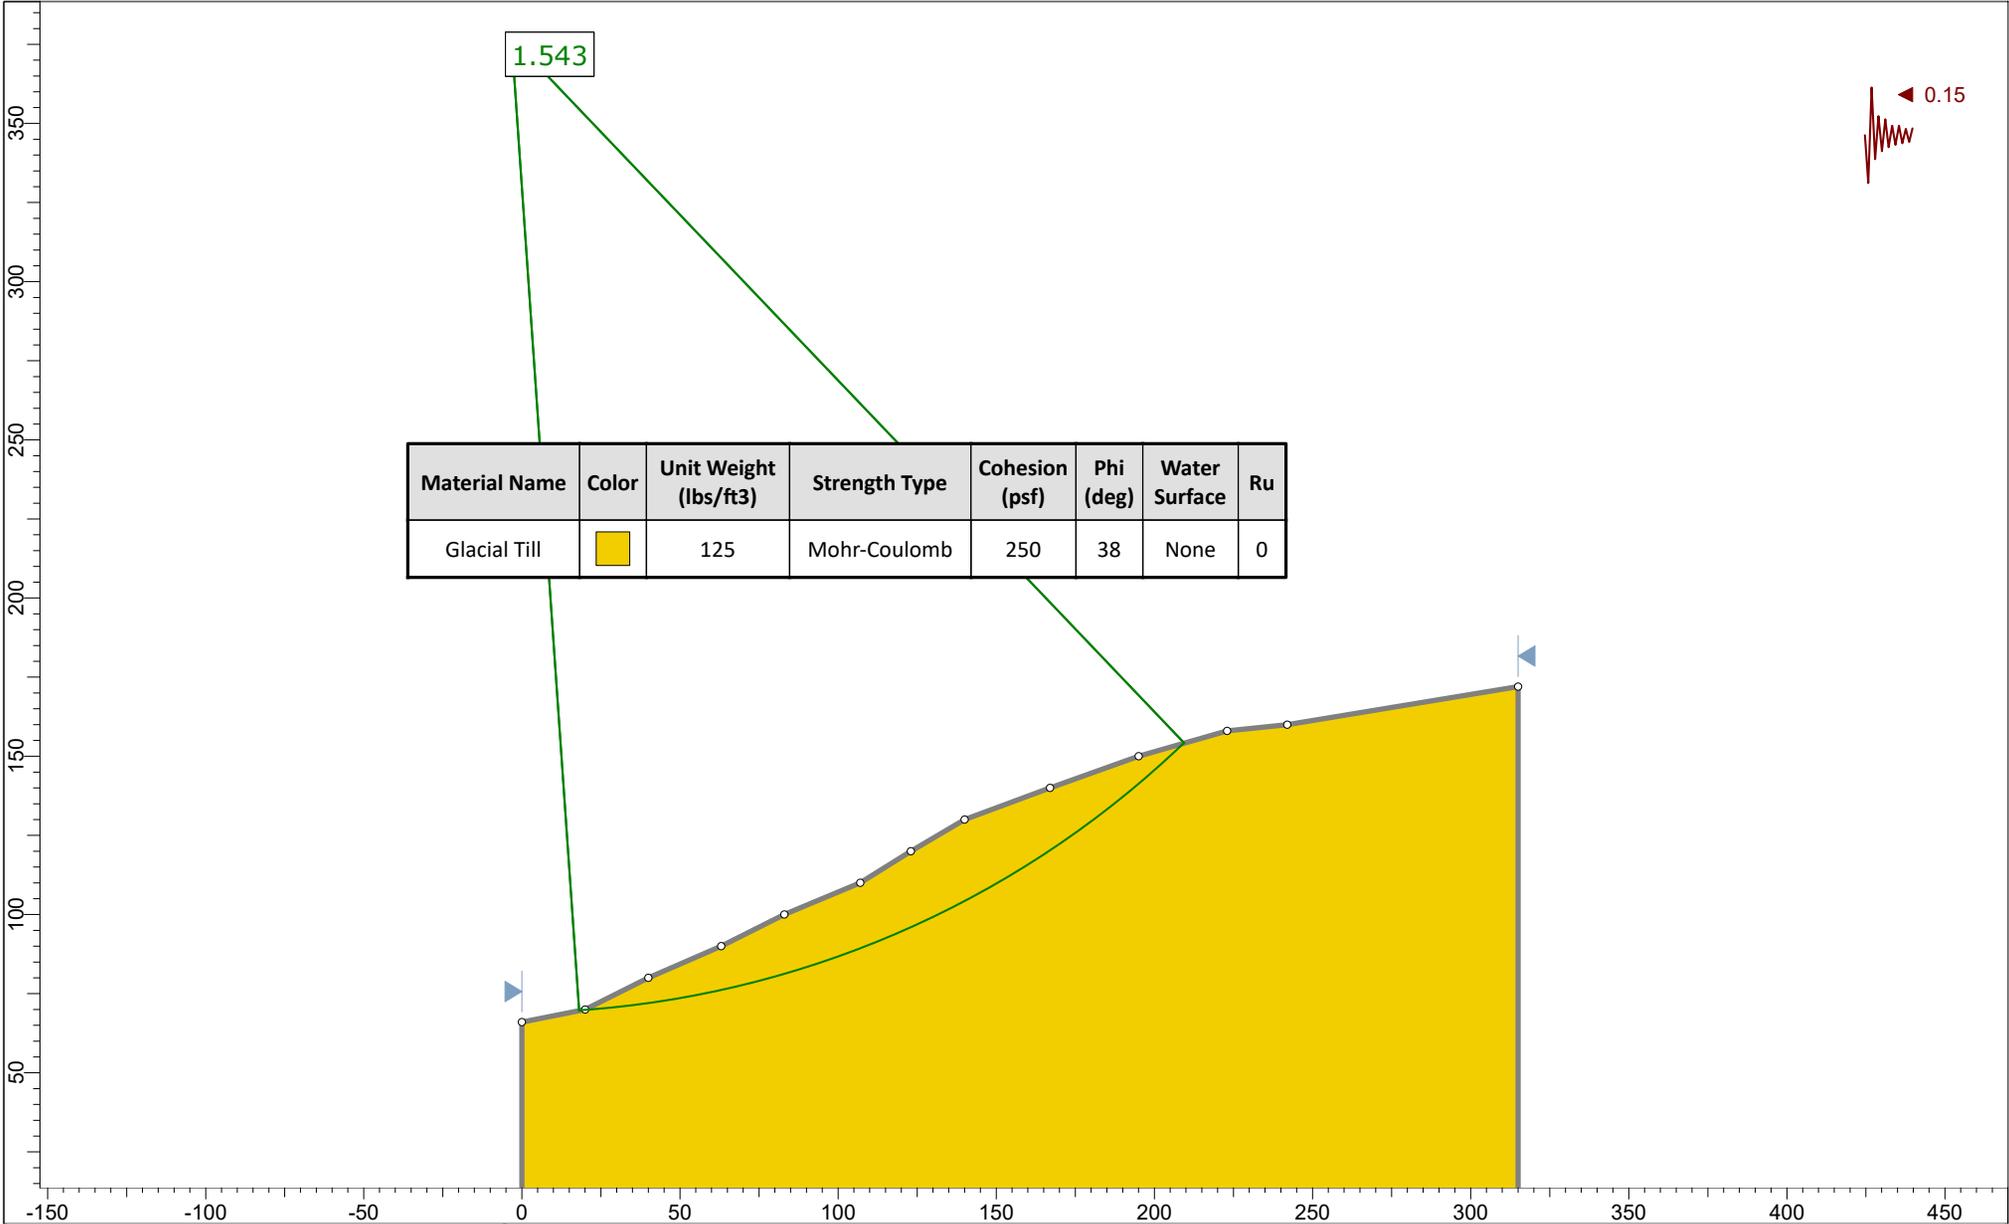
Material Name	Color	Unit Weight (lbs/ft3)	Strength Type	Cohesion (psf)	Phi (deg)	Water Surface	Ru
Glacial Till	<span style="display:inline-block; width:15px; height:15px; background-color:yellow;"></span>	125	Mohr-Coulomb	250	38	None	0

Project			<b>Terrace Avenue</b>		
	Analysis Description			Cross Section C-C' - Existing Conditions - Seismic		
	Drawn By	C. Decker	Scale	1:724	Company	Terra Associates, Inc.
	Date	5/6/2020, 2:14:41 PM		File Name	Cross Section C-C'.slmd

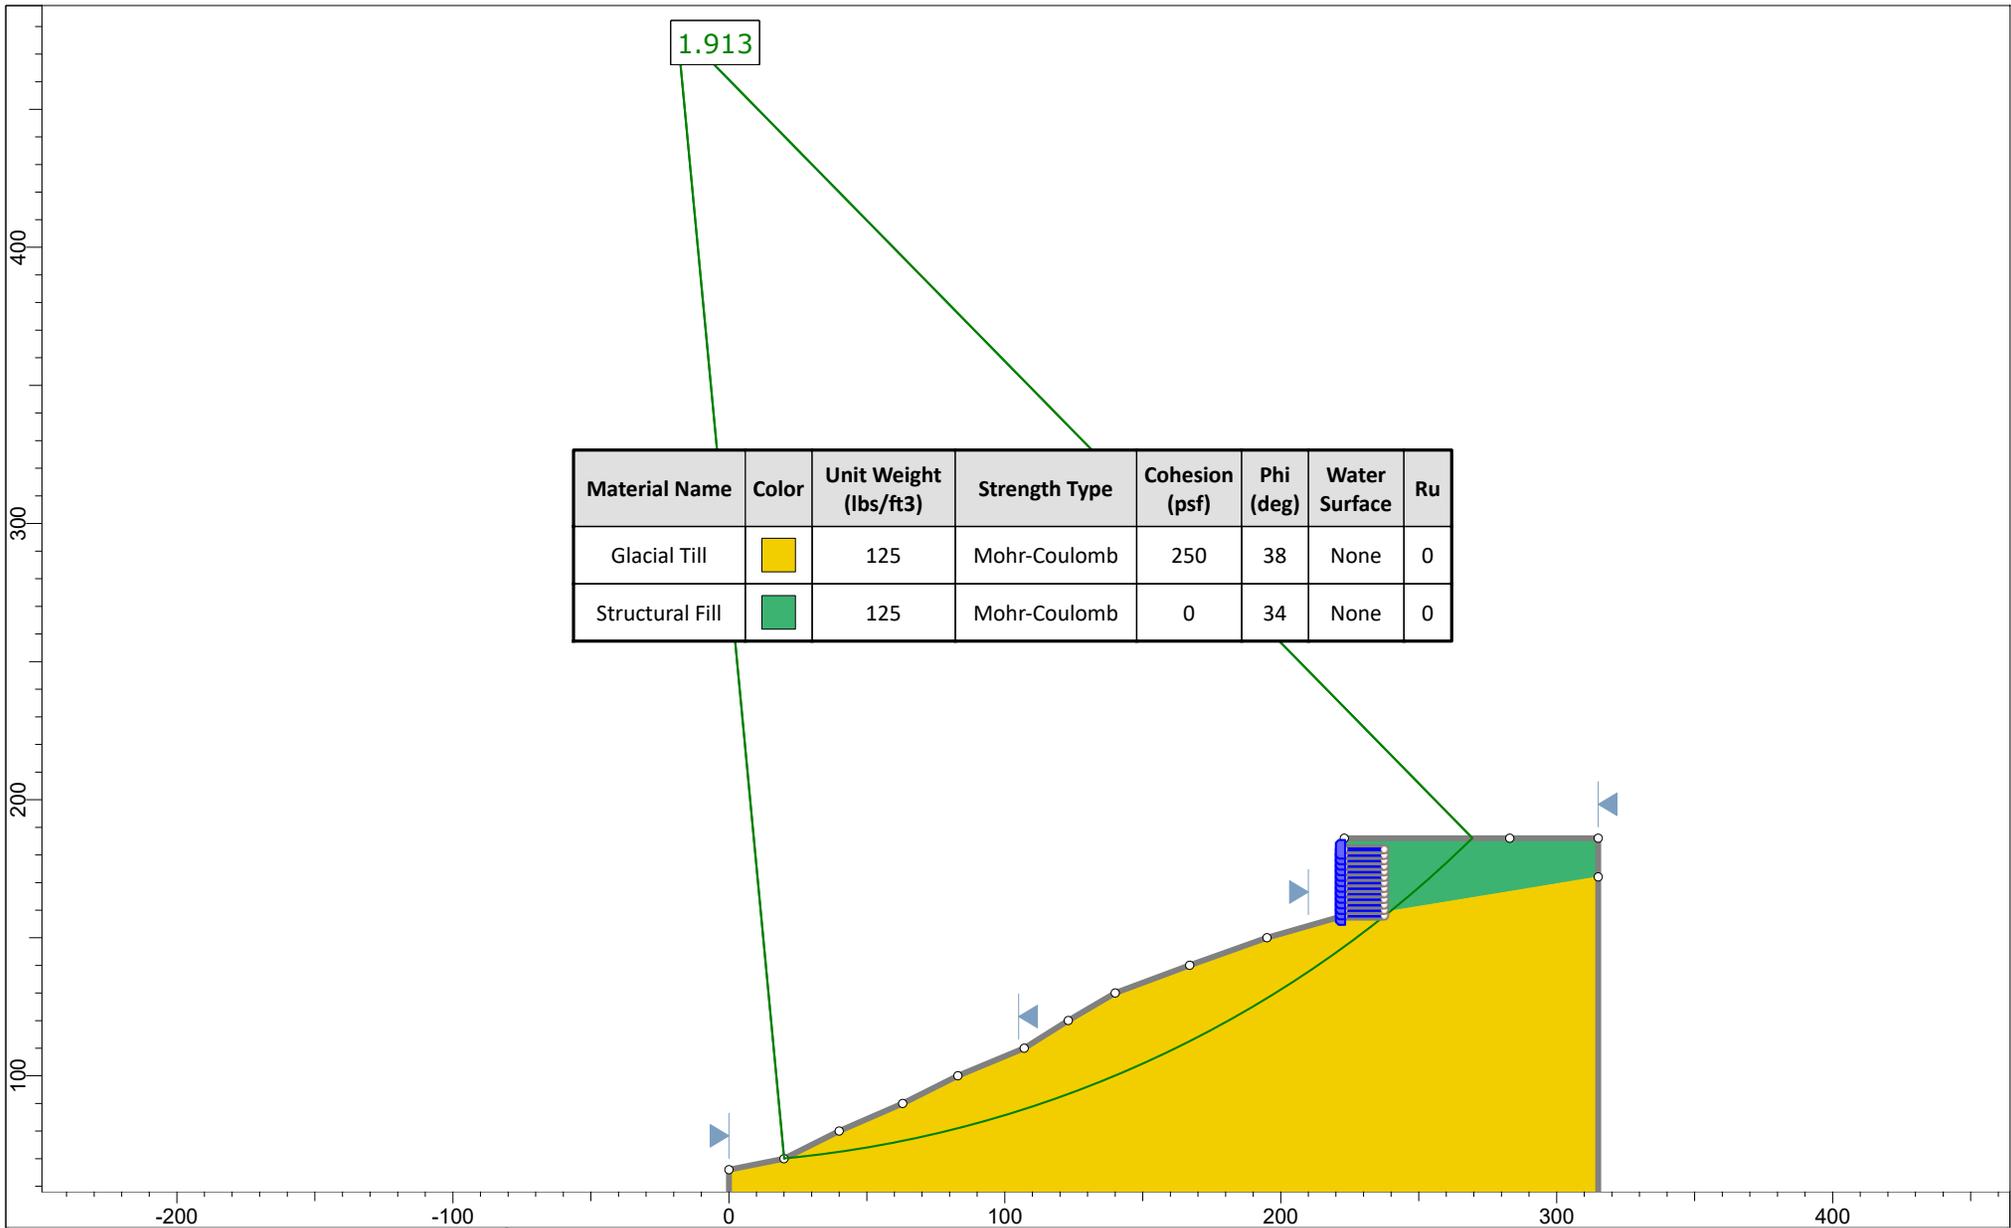
Material Name	Color	Unit Weight (lbs/ft3)	Strength Type	Cohesion (psf)	Phi (deg)	Water Surface	Ru
Glacial Till	<span style="color: yellow;">■</span>	125	Mohr-Coulomb	250	38	None	0
Structural Fill	<span style="color: green;">■</span>	125	Mohr-Coulomb	0	34	None	0

<i>Project</i>			<b>Terrace Avenue</b>		
	<i>Analysis Description</i>			Cross Section C-C' - Post Construction Conditions		
	<i>Drawn By</i>	C. Decker	<i>Scale</i>	1:830	<i>Company</i>	Terra Associates, Inc.
	<i>Date</i>	5/6/2020, 2:14:41 PM		<i>File Name</i>	Cross Section C-C'.slmd

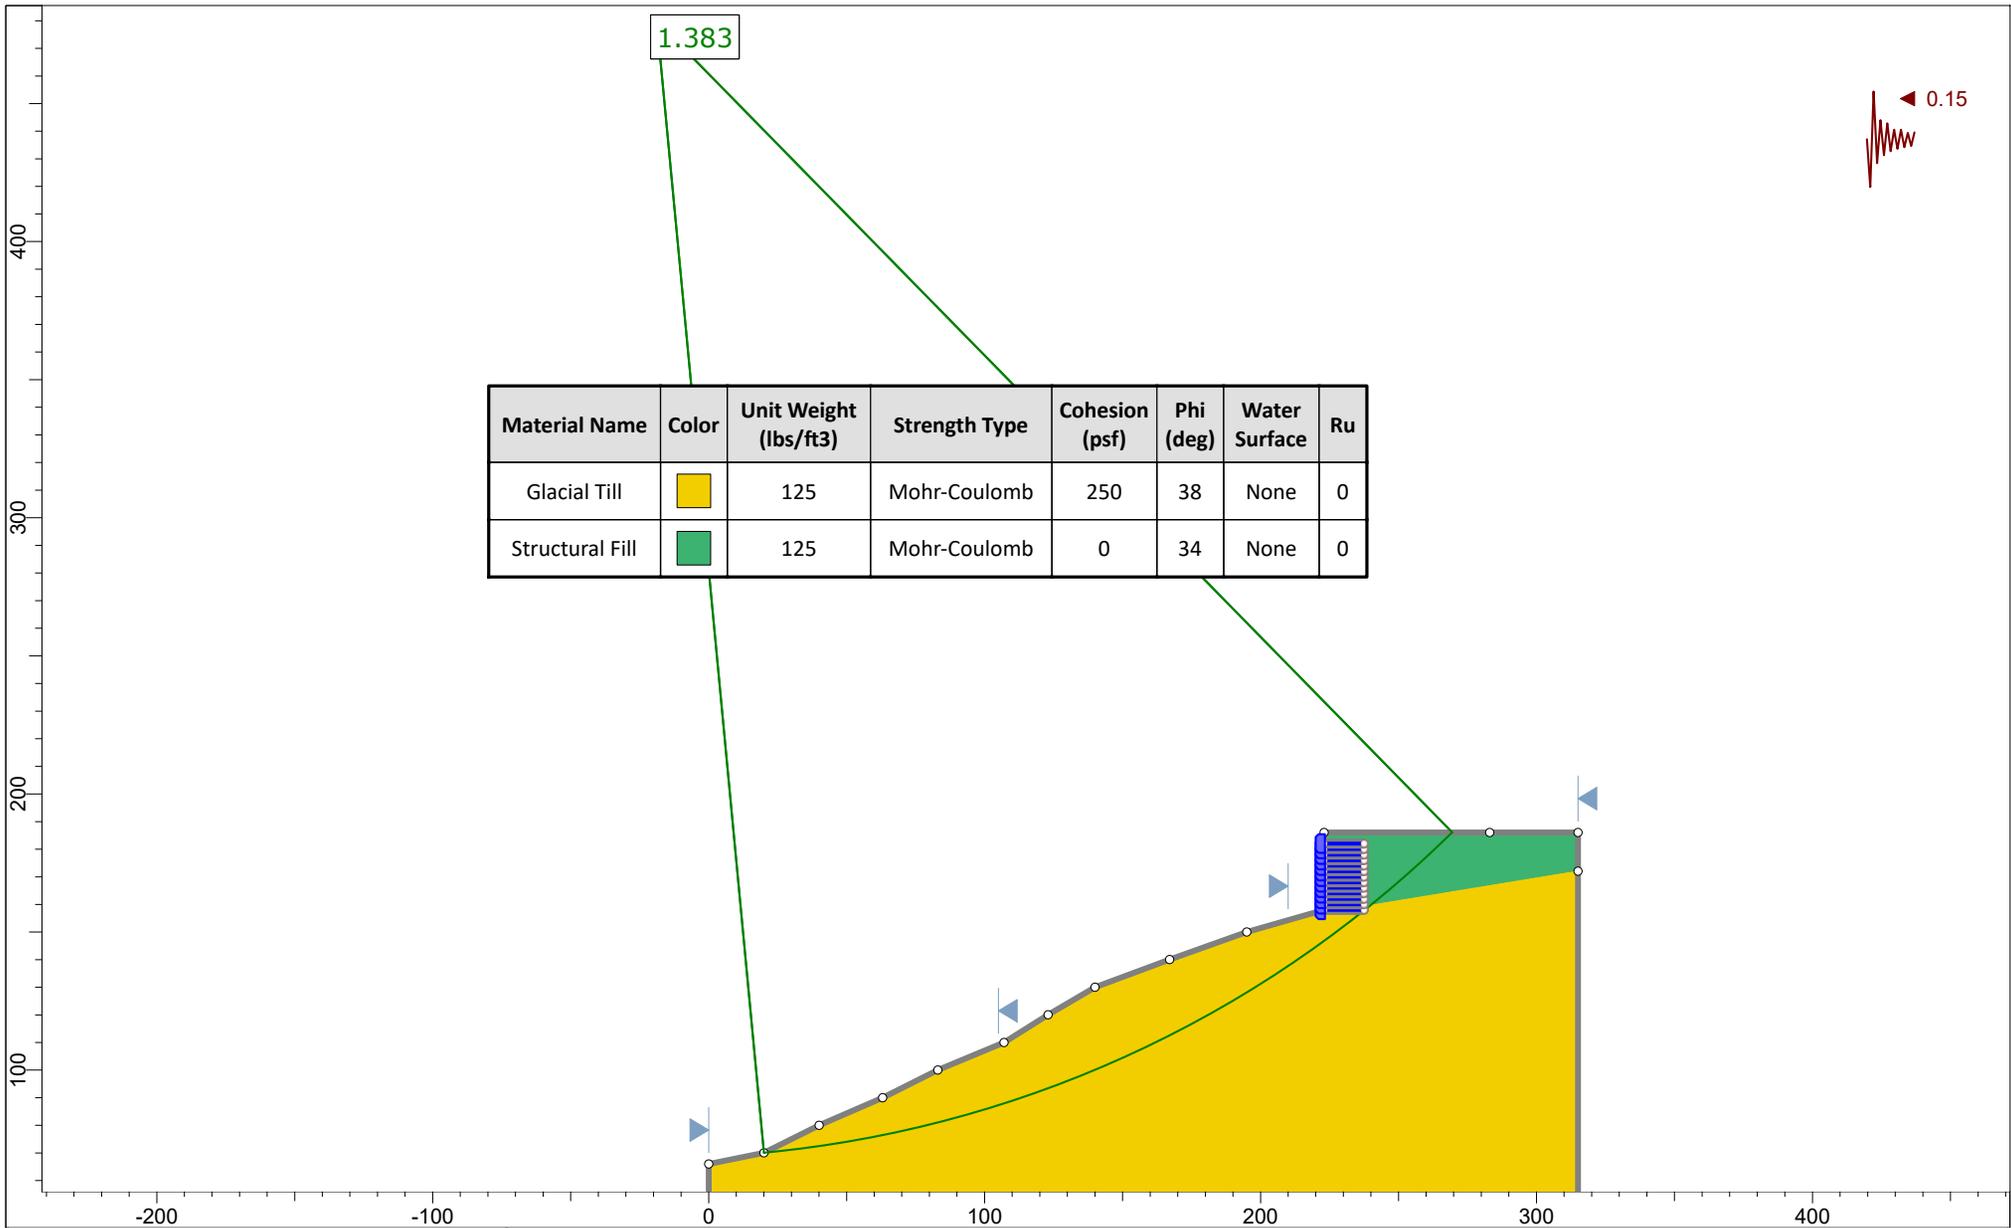
Material Name	Color	Unit Weight (lbs/ft3)	Strength Type	Cohesion (psf)	Phi (deg)	Water Surface	Ru
Glacial Till	<span style="color: yellow;">■</span>	125	Mohr-Coulomb	250	38	None	0
Structural Fill	<span style="color: green;">■</span>	125	Mohr-Coulomb	0	34	None	0

<i>Project</i> <b>Terrace Avenue</b>		
	<i>Analysis Description</i> Cross Section C-C' - Post Construction Conditions - Seismic		
	<i>Drawn By</i> C. Decker	<i>Scale</i> 1:830	<i>Company</i> Terra Associates, Inc.
	<i>Date</i> 5/6/2020, 2:14:41 PM	<i>File Name</i> Cross Section C-C'.slmd
